Arizona Department of Agriculture
Pest Management Division
WOOD DESTROYING INSECT INSPECTION REPORT

3A. NAME OF INSPECTION COMPANY ACTION Termite & Pest Control		5A. NAME OF PROPERTY OWNER/SELLER Graystone Auctions LLC	
3B. ADDRESS OF INSPECTION COMPANY (Street, City, ZIP) 1101 W Melinda Ln Bldg. B, Phoenix, 85027		5B. PROPERTY ADDRESS (Street, City, ZIP) 10055 N 142nd St, Scottsdale, 85259	
3C. TELEPHONE NUMBER (Include Area Code) 6028992222	4. BUSINESS LICENSE # 8285	6A. INSPECTED STRUCTURES Condominium

PROPERTY NAME/ADDRESS Graystone Auctions LLC	DATE OF INSPECTION 02/06/2024
10055 N 142nd St, Scottsdale, 85259	
AT THE TIME OF THE INSPECTION THE PROPERTY WAS: <input checked="" type="checkbox"/> Vacant <input type="checkbox"/> Occupied <input checked="" type="checkbox"/> Unfurnished <input type="checkbox"/> Furnished	
<u>CONDITIONS CONDUCTIVE TO INFESTATION</u>

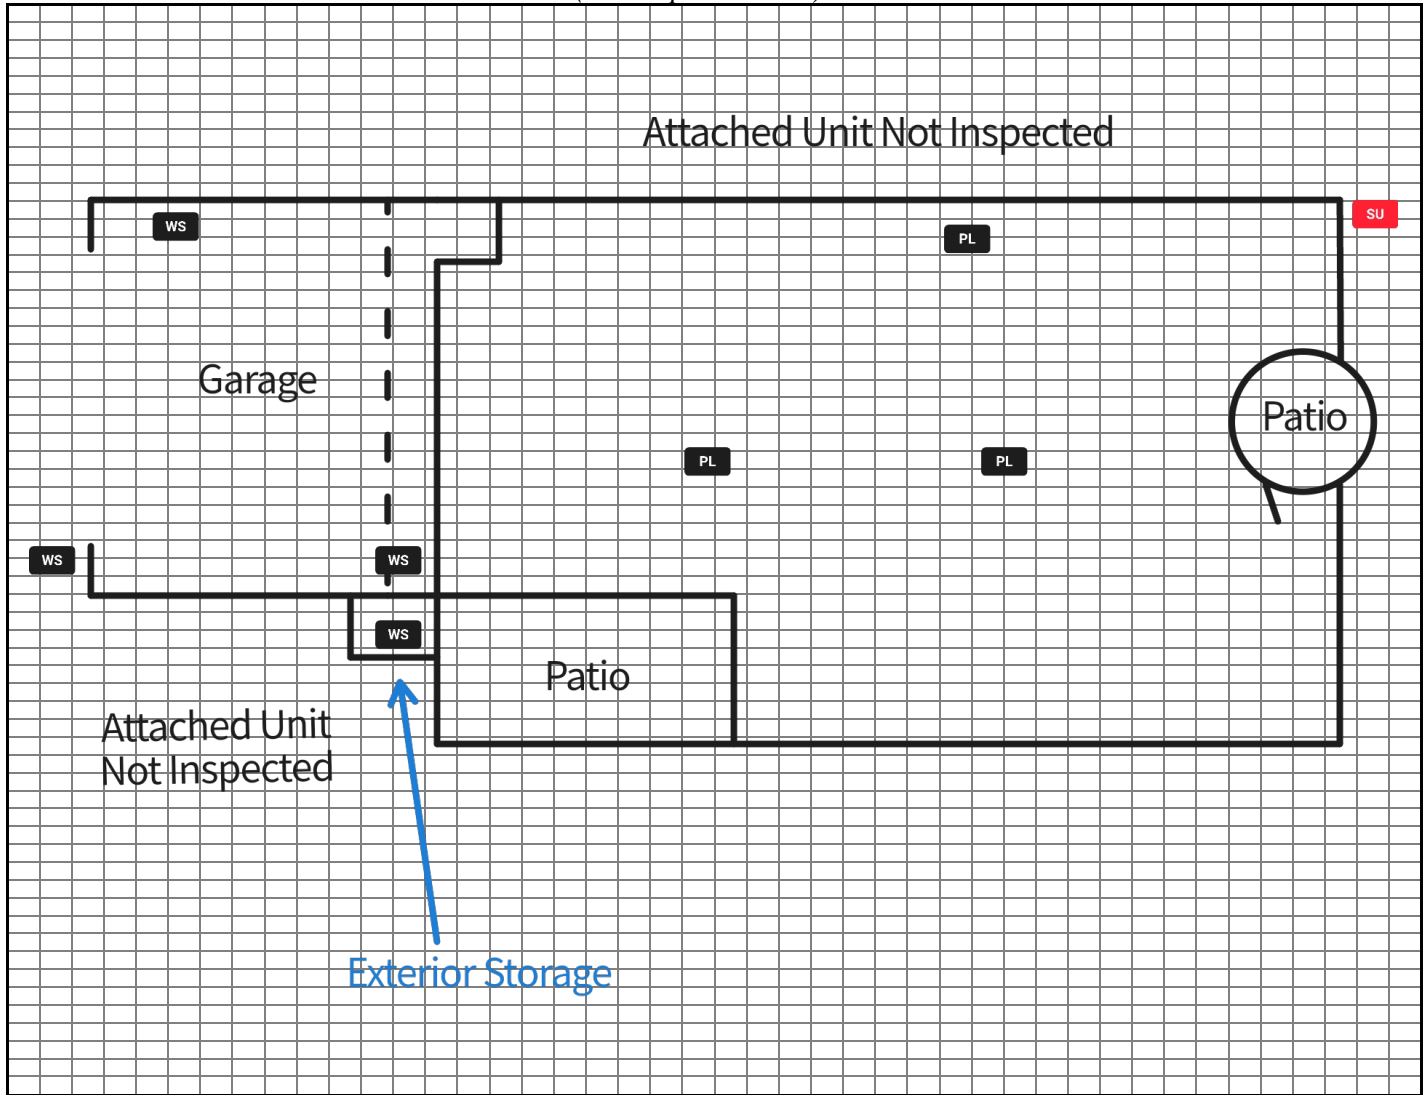
GRAPH OF STRUCTURE(S)

- A. Visible evidence of wood-destroying insects was observed.
Describe evidence observed: Subterranean termites tube stain(s) _____
Type of Wood-Destroying Insects observed: None observed at time of inspection _____
- B. No visible evidence of infestation from wood-destroying insects was observed.
- C. Visible evidence of infestation as noted in 8A. Proper control measures were performed on (date): _____
- D. Visible damage due to _____ was observed in the following areas: _____
- E. Visible evidence of previous treatment was observed. List evidence. (See also Item 20, page 2.): _____

18. <u>EXCESSIVE MOISTURE (EM)</u> <input checked="" type="checkbox"/> YES <input type="checkbox"/> NO <i>(If YES, check mark and explain conditions conducive)</i>	
<input type="checkbox"/> Standing Water <input type="checkbox"/> Water Damage <input type="checkbox"/> Bath/Shower/Toilet Leaking <input type="checkbox"/> Inadequate Ventilation <input type="checkbox"/> Sprinklers Hitting Structure <input checked="" type="checkbox"/> Water Stain <input checked="" type="checkbox"/> Plumbing Leaks <input type="checkbox"/> Other _____ <input type="checkbox"/> Crawl Space/Water Leaking <input type="checkbox"/> Improper Condensate Drainage <input type="checkbox"/> Attic/Roof Leak	
Comments: See Diagram

19. <u>INACCESSIBLE AREAS (IA)</u> <input checked="" type="checkbox"/> YES <input type="checkbox"/> NO <i>(If YES, check mark and explain)</i>	
<input checked="" type="checkbox"/> Attic – All <input checked="" type="checkbox"/> Floors <input type="checkbox"/> Sub/Crawl Space Area -- Clearance <input checked="" type="checkbox"/> Attic – Joists <input checked="" type="checkbox"/> Wall Interiors <input type="checkbox"/> Sub Area/Crawl Space No Access <input type="checkbox"/> Attic – Partial <input type="checkbox"/> Enclosed Stairwell <input type="checkbox"/> Areas Obstructed By Furniture Or Stored Articles <input checked="" type="checkbox"/> Plumbing Traps <input type="checkbox"/> Dropped Ceilings <input type="checkbox"/> Other _____	
Comments: See Diagram

CODE	SEE GRAPH PAGE (3)		CODE	SEE GRAPH PAGE (3)		CODE	SEE GRAPH PAGE (3)		CODE	SEE GRAPH PAGE (3)
✓	SU	Subterranean Termites		OW	Other Wood Destroying Insects (*)		OB	Obstructions		WD	Water Damage
	DR	Drywood Termites		FG	Faulty Grade		IA	Inaccessible Areas	✓	WS	Water Stains
	DA	Dampwood Termites		EC	Wood To Earth Contact		IV	Inadequate Ventilation		RL	Roof Leaks
	BE	Wood Destroying Beetles		CD	Cellulose Debris	✓	PL	Plumbing Leaks		EM	Excessive Moisture
	CA	Carpenter Ants		PA	Plantings Abutting Structure		SP	Sprinkler Hitting Structure		FI	Further Inspection Needed
(*) Other Wood Destroying Insects (list)
