Arizona Department of Agriculture Pest Management Division WOOD DESTROYING INSECT INSPECTION REPORT

3A. NAME OF INSPECTION COMPANY ACTION Termite & Pest Control	5A. NAME OF PROPERTY OWNER/SELLER Liz Miller			
3B. ADDRESS OF INSPECTION COMPANY (Street, City, ZIP)	5B. PROPERTY ADDRESS (Street, City, ZIP)			
1101 W Melinda Ln Bldg. B, Phoenix, 85027	4637 South 21st Street			
3C. TELEPHONE NUMBER (Include Area Code)	4. BUSINESS LICENSE #	6A. INSPECTED STRUCTURES		
6028992222	House			
6B. LIST ALL UN-INSPECTED STRUCTURES Not Applicable	9

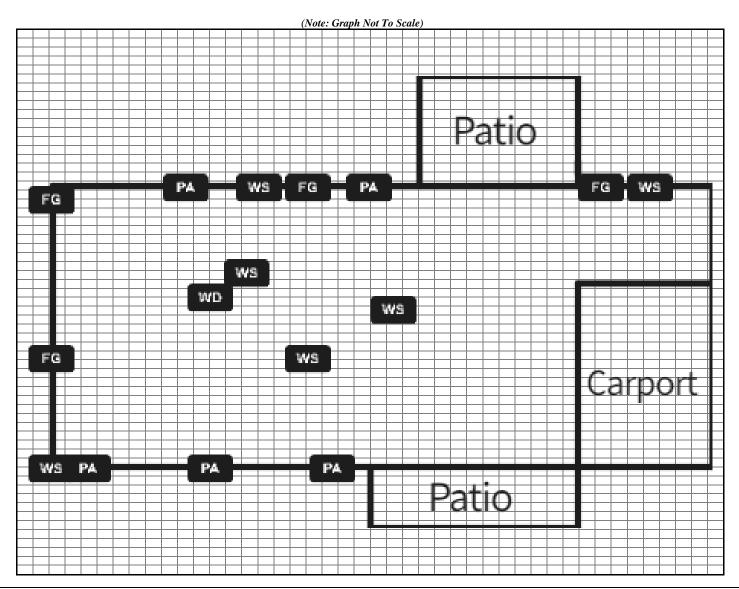
GRAPH OF STRUCTURE(S)

15. WOOD TO EARTH CONTACT (EC)	■ YES			k and explain condition	ons conducive)	
☐ Concrete Form Boards	Pier Posts Porch Stairs Trellis	☑ Plants/ □ Other_	Trees Contacting S	Structure

19. INACCESSIBLE AREAS (IA)	■ YES	□ NO	(If YES, check ma	rk and explain)		
☐ Attic - All ☐ Attic - Joists ☐ Attic - Partial ☐ Plumbing Traps ☐ OtherSee Comments Comments: Behind cabinets and appliances, behind	□ Drop	Interiors osed Stairwei ped Ceilings	3	☐ Sub Area/Crav ☐ Areas Obstruc	ace Area Clearance wl Space No Access eted By Furniture Or S	tored Articles
				_
