Arizona Department of Agriculture
Pest Management Division
WOOD DESTROYING INSECT INSPECTION REPORT

3A. NAME OF INSPECTION COMPANY ACTION Termite & Pest Control		5A. NAME OF PROPERTY OWNER/SELLER Liz Miller
3B. ADDRESS OF INSPECTION COMPANY (Street, City, ZIP) 1101 W Melinda Ln Bldg. B, Phoenix, 85027		5B. PROPERTY ADDRESS (Street, City, ZIP) 2519 N 71st Dr, Phoenix, 85035
3C. TELEPHONE NUMBER (Include Area Code) 6028992222	4. BUSINESS LICENSE # 8285	6A. INSPECTED STRUCTURES House

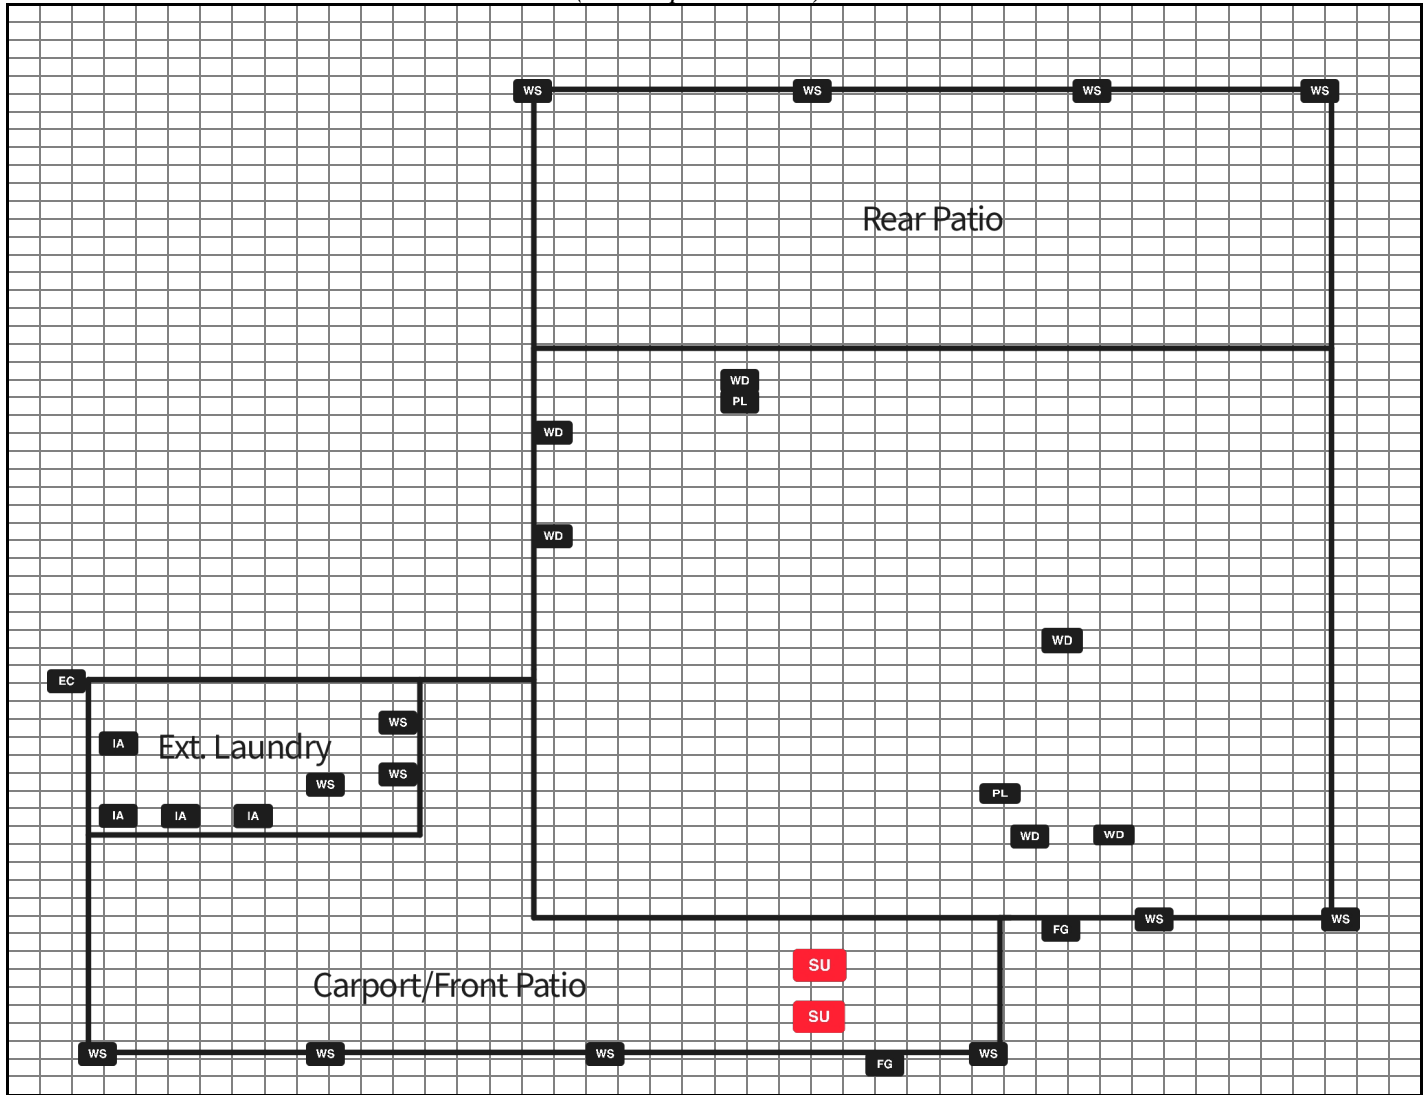
GRAPH OF STRUCTURE(S)

- A. Visible evidence of wood-destroying insects was observed.
Describe evidence observed: Subterranean termites damage, Subterranean termites tubes(s)
Type of Wood-Destroying Insects observed: None observed at time of inspection
- B. No visible evidence of infestation from wood-destroying insects was observed.
- C. Visible evidence of infestation as noted in 8A. Proper control measures were performed on (date): _____
- D. Visible damage due to Subterranean Termites was observed in the following areas: Front beam
- E. Visible evidence of previous treatment was observed. List evidence. (See also Item 20, page 2.): _____

15. <u>WOOD TO EARTH CONTACT (EC)</u> <input checked="" type="checkbox"/> YES <input type="checkbox"/> NO <i>(If YES, check mark and explain conditions conducive)</i>	
<input checked="" type="checkbox"/> Fence Abutting Structure <input type="checkbox"/> Pier Posts <input type="checkbox"/> Plants/Trees Contacting Structure <input type="checkbox"/> Concrete Form Boards <input type="checkbox"/> Porch Stairs <input type="checkbox"/> Other _____ <input type="checkbox"/> Porch Post <input type="checkbox"/> Trellis	
Comments: See diagram

17. <u>FAULTY GRADES (FG)</u> <input checked="" type="checkbox"/> YES <input type="checkbox"/> NO <i>(If YES, check mark and explain conditions conducive)</i>	
<input type="checkbox"/> Evidence of surface water draining toward house <input type="checkbox"/> Stucco at or below grade <input checked="" type="checkbox"/> Floor level or planters at or below grade <input type="checkbox"/> Joists in crawl space less than 24" above grade <input type="checkbox"/> Wood siding below grade <input type="checkbox"/> Other _____	
Comments: See diagram

18. <u>EXCESSIVE MOISTURE (EM)</u> <input checked="" type="checkbox"/> YES <input type="checkbox"/> NO <i>(If YES, check mark and explain conditions conducive)</i>	
<input type="checkbox"/> Standing Water <input checked="" type="checkbox"/> Water Damage <input checked="" type="checkbox"/> Bath/Shower/Toilet Leaking <input type="checkbox"/> Inadequate Ventilation <input type="checkbox"/> Sprinklers Hitting Structure <input checked="" type="checkbox"/> Water Stain <input checked="" type="checkbox"/> Plumbing Leaks <input type="checkbox"/> Other _____ <input type="checkbox"/> Crawl Space/Water Leaking <input checked="" type="checkbox"/> Improper Condensate Drainage <input type="checkbox"/> Attic/Roof Leak	
Comments: See diagram

19. <u>INACCESSIBLE AREAS (IA)</u> <input checked="" type="checkbox"/> YES <input type="checkbox"/> NO <i>(If YES, check mark and explain)</i>	
<input type="checkbox"/> Attic – All <input checked="" type="checkbox"/> Floors <input type="checkbox"/> Sub/Crawl Space Area -- Clearance <input type="checkbox"/> Attic – Joists <input checked="" type="checkbox"/> Wall Interiors <input type="checkbox"/> Sub Area/Crawl Space No Access <input checked="" type="checkbox"/> Attic – Partial <input type="checkbox"/> Enclosed Stairwell <input type="checkbox"/> Areas Obstructed By Furniture Or Stored Articles <input checked="" type="checkbox"/> Plumbing Traps <input type="checkbox"/> Dropped Ceilings <input type="checkbox"/> Other _____	
Comments: Drywall and flooring installed at time of inspection. Attic was inspected from a ladder, visibility was limited.
