Arizona Department of Agriculture
Pest Management Division
WOOD DESTROYING INSECT INSPECTION REPORT

3A. NAME OF INSPECTION COMPANY ACTION Termite & Pest Control		5A. NAME OF PROPERTY OWNER/SELLER Liz Miller
3B. ADDRESS OF INSPECTION COMPANY (Street, City, ZIP) 1101 W Melinda Ln Bldg. B, Phoenix, 85027		5B. PROPERTY ADDRESS (Street, City, ZIP) 532 North Hassayampa Drive, Prescott, 86303
3C. TELEPHONE NUMBER (Include Area Code) 6028992222	4. BUSINESS LICENSE # 8285	6A. INSPECTED STRUCTURES House

PROPERTY NAME/ADDRESS Liz Miller	DATE OF INSPECTION 03/01/2024
532 North Hassayampa Drive, Prescott, 86303	
AT THE TIME OF THE INSPECTION THE PROPERTY WAS: <input checked="" type="checkbox"/> Vacant <input type="checkbox"/> Occupied <input type="checkbox"/> Unfurnished <input checked="" type="checkbox"/> Furnished	
<u>CONDITIONS CONDUCTIVE TO INFESTATION</u>

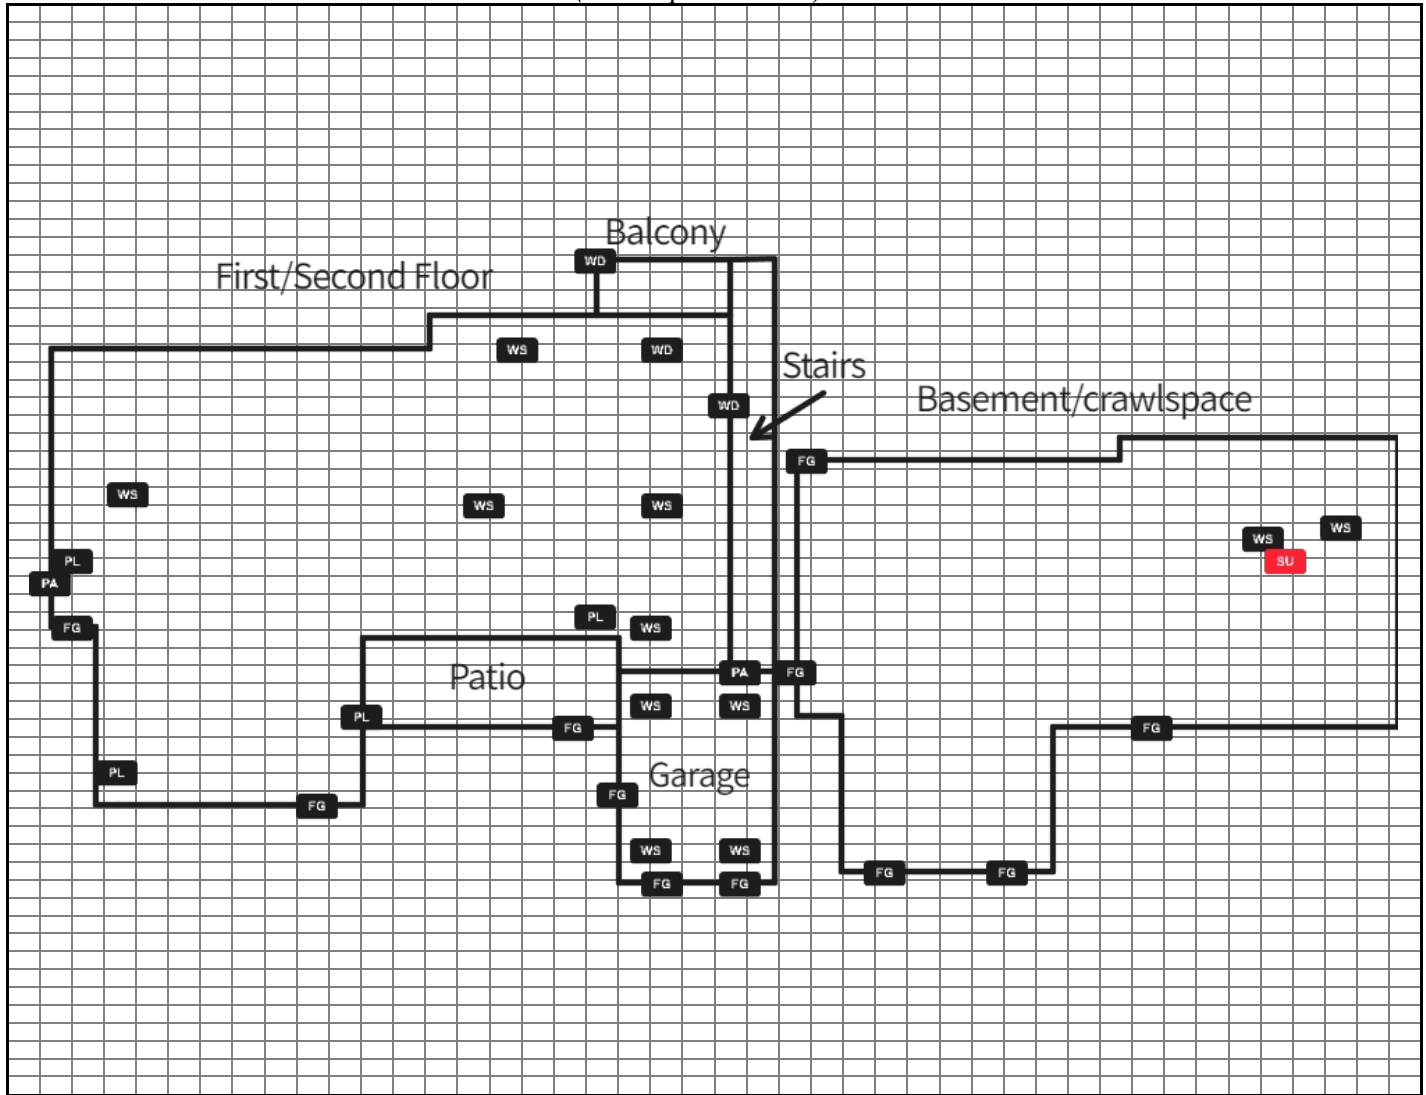
GRAPH OF STRUCTURE(S)

- A. Visible evidence of wood-destroying insects was observed.
Describe evidence observed: Subterranean termites damage
Type of Wood-Destroying Insects observed: None observed at time of inspection
- B. No visible evidence of infestation from wood-destroying insects was observed.
- C. Visible evidence of infestation as noted in 8A. Proper control measures were performed on (date): _____
- D. Visible damage due to Subterranean Termites was observed in the following areas: Basement pier
- E. Visible evidence of previous treatment was observed. List evidence. (See also Item 20, page 2.): _____

15. <u>WOOD TO EARTH CONTACT (EC)</u> <input checked="" type="checkbox"/> YES <input type="checkbox"/> NO <i>(If YES, check mark and explain conditions conducive)</i>	
<input type="checkbox"/> Fence Abutting Structure <input type="checkbox"/> Pier Posts <input checked="" type="checkbox"/> Plants/Trees Contacting Structure <input type="checkbox"/> Concrete Form Boards <input type="checkbox"/> Porch Stairs <input type="checkbox"/> Other _____ <input type="checkbox"/> Porch Post <input type="checkbox"/> Trellis	
Comments: See Diagram

17. <u>FAULTY GRADES (FG)</u> <input checked="" type="checkbox"/> YES <input type="checkbox"/> NO <i>(If YES, check mark and explain conditions conducive)</i>	
<input checked="" type="checkbox"/> Evidence of surface water draining toward house <input type="checkbox"/> Stucco at or below grade <input checked="" type="checkbox"/> Floor level or planters at or below grade <input type="checkbox"/> Joists in crawl space less than 24" above grade <input type="checkbox"/> Wood siding below grade <input checked="" type="checkbox"/> Other See Comments _____	
Comments: Grading/hardscape sloped towards home. See Diagram

18. <u>EXCESSIVE MOISTURE (EM)</u> <input checked="" type="checkbox"/> YES <input type="checkbox"/> NO <i>(If YES, check mark and explain conditions conducive)</i>	
<input type="checkbox"/> Standing Water <input checked="" type="checkbox"/> Water Damage <input type="checkbox"/> Bath/Shower/Toilet Leaking <input checked="" type="checkbox"/> Inadequate Ventilation <input type="checkbox"/> Sprinklers Hitting Structure <input checked="" type="checkbox"/> Water Stain <input checked="" type="checkbox"/> Plumbing Leaks <input type="checkbox"/> Other _____ <input type="checkbox"/> Crawl Space/Water Leaking <input checked="" type="checkbox"/> Improper Condensate Drainage <input type="checkbox"/> Attic/Roof Leak	
Comments: No means of ventilation installed for crawlspace/unfinished basement. See Diagram

19. <u>INACCESSIBLE AREAS (IA)</u> <input checked="" type="checkbox"/> YES <input type="checkbox"/> NO <i>(If YES, check mark and explain)</i>	
<input type="checkbox"/> Attic – All <input checked="" type="checkbox"/> Floors <input checked="" type="checkbox"/> Sub/Crawl Space Area -- Clearance <input checked="" type="checkbox"/> Attic – Joists <input checked="" type="checkbox"/> Wall Interiors <input type="checkbox"/> Sub Area/Crawl Space No Access <input checked="" type="checkbox"/> Attic – Partial <input type="checkbox"/> Enclosed Stairwell <input checked="" type="checkbox"/> Areas Obstructed By Furniture Or Stored Articles <input checked="" type="checkbox"/> Plumbing Traps <input type="checkbox"/> Dropped Ceilings <input checked="" type="checkbox"/> Other See Comments _____	
Comments: Behind cabinets and appliances, behind interior window coverings, behind stored items inside cabinetry, behind faulty grade conditions documented.
