Arizona Department of Agriculture
Pest Management Division
WOOD DESTROYING INSECT INSPECTION REPORT
 agriculture.az.gov

3A. NAME OF INSPECTION COMPANY ACTION Termite & Pest Control		5A. NAME OF PROPERTY OWNER/SELLER Grant Getman
3B. ADDRESS OF INSPECTION COMPANY (Street, City, ZIP) 1101 W Melinda Ln Bldg. B, Phoenix, 85027		5B. PROPERTY ADDRESS (Street, City, ZIP) 7218 N Via De Paesia, Scottsdale, 85258
3C. TELEPHONE NUMBER (Include Area Code) 6028992222	4. BUSINESS LICENSE # 8285	6A. INSPECTED STRUCTURES Townhouse

PROPERTY NAME/ADDRESS Grant Getman	7218 N Via De Paesia, Scottsdale, 85258	DATE OF INSPECTION 01/18/2024
AT THE TIME OF THE INSPECTION THE PROPERTY WAS: <input checked="" type="checkbox"/> Vacant <input type="checkbox"/> Occupied <input type="checkbox"/> Unfurnished <input checked="" type="checkbox"/> Furnished		
<u>CONDITIONS CONDUCTIVE TO INFESTATION</u>

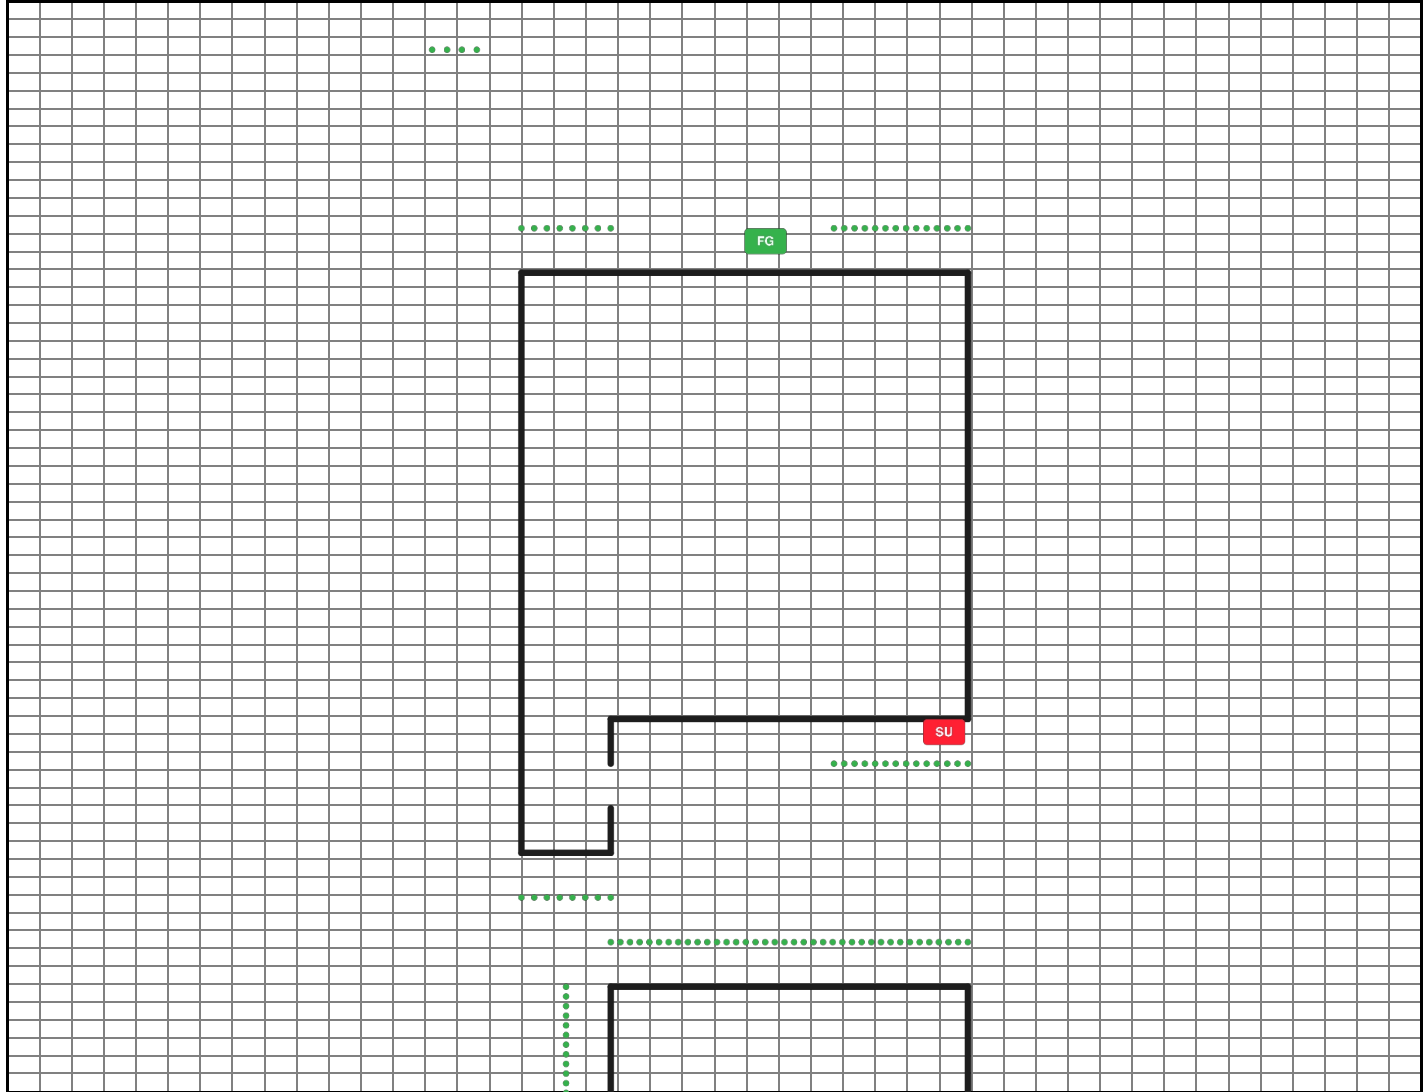
GRAPH OF STRUCTURE(S)

- A. Visible evidence of wood-destroying insects was observed.
 Describe evidence observed: Subterranean termites tubes(s) _____
 Type of Wood-Destroying Insects observed: None observed at time of inspection _____
- B. No visible evidence of infestation from wood-destroying insects was observed.
- C. Visible evidence of infestation as noted in 8A. Proper control measures were performed on (date): 01/18/2024 _____
- D. Visible damage due to _____ was observed in the following areas: _____
- E. Visible evidence of previous treatment was observed. List evidence. (See also Item 20, page 2.): _____

17. <u>FAULTY GRADES (FG)</u> <input checked="" type="checkbox"/> YES <input type="checkbox"/> NO <i>(If YES, check mark and explain conditions conducive)</i> <input type="checkbox"/> Evidence of surface water draining toward house <input checked="" type="checkbox"/> Stucco at or below grade <input type="checkbox"/> Floor level or planters at or below grade <input type="checkbox"/> Joists in crawl space less than 24" above grade <input type="checkbox"/> Wood siding below grade <input type="checkbox"/> Other _____ Comments:

19. <u>INACCESSIBLE AREAS (IA)</u> <input checked="" type="checkbox"/> YES <input type="checkbox"/> NO <i>(If YES, check mark and explain)</i> <input type="checkbox"/> Attic – All <input checked="" type="checkbox"/> Floors <input type="checkbox"/> Sub/Crawl Space Area -- Clearance <input type="checkbox"/> Attic – Joists <input checked="" type="checkbox"/> Wall Interiors <input type="checkbox"/> Sub Area/Crawl Space No Access <input checked="" type="checkbox"/> Attic – Partial <input type="checkbox"/> Enclosed Stairwell <input type="checkbox"/> Areas Obstructed By Furniture Or Stored Articles <input checked="" type="checkbox"/> Plumbing Traps <input type="checkbox"/> Dropped Ceilings <input type="checkbox"/> Other _____ Comments:
