## RESIDENTIAL HOME INSPECTION REPORT

10055 N 142nd St 1060  
Scottsdale, AZ 85259

FEBRUARY 6, 2024

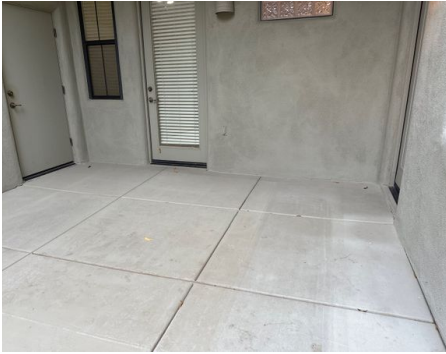
**Foundation: Hardscape covering foundation**

The foundation was not able to be observed in some areas where exterior hardscape materials are installed. Please note that the condition could allow wood destroying organism activity to go unnoticed. It is important to maintain a pest control treatment schedule as prescribed by a qualified extermination company.

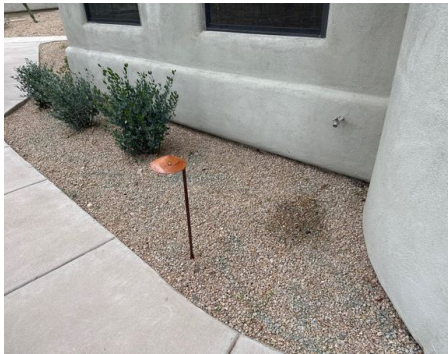
**Vegetation, Grading, Drainage & Retaining Walls: Grade slightly high**

Exterior grade is slightly high however is not contacting exterior siding. It is recommended that a minimum clearance of at least (approximately) 4 inches be maintained between exterior siding and exterior grade so that foundation conditions as well as potential wood destroying organism/insect activity can be monitored.

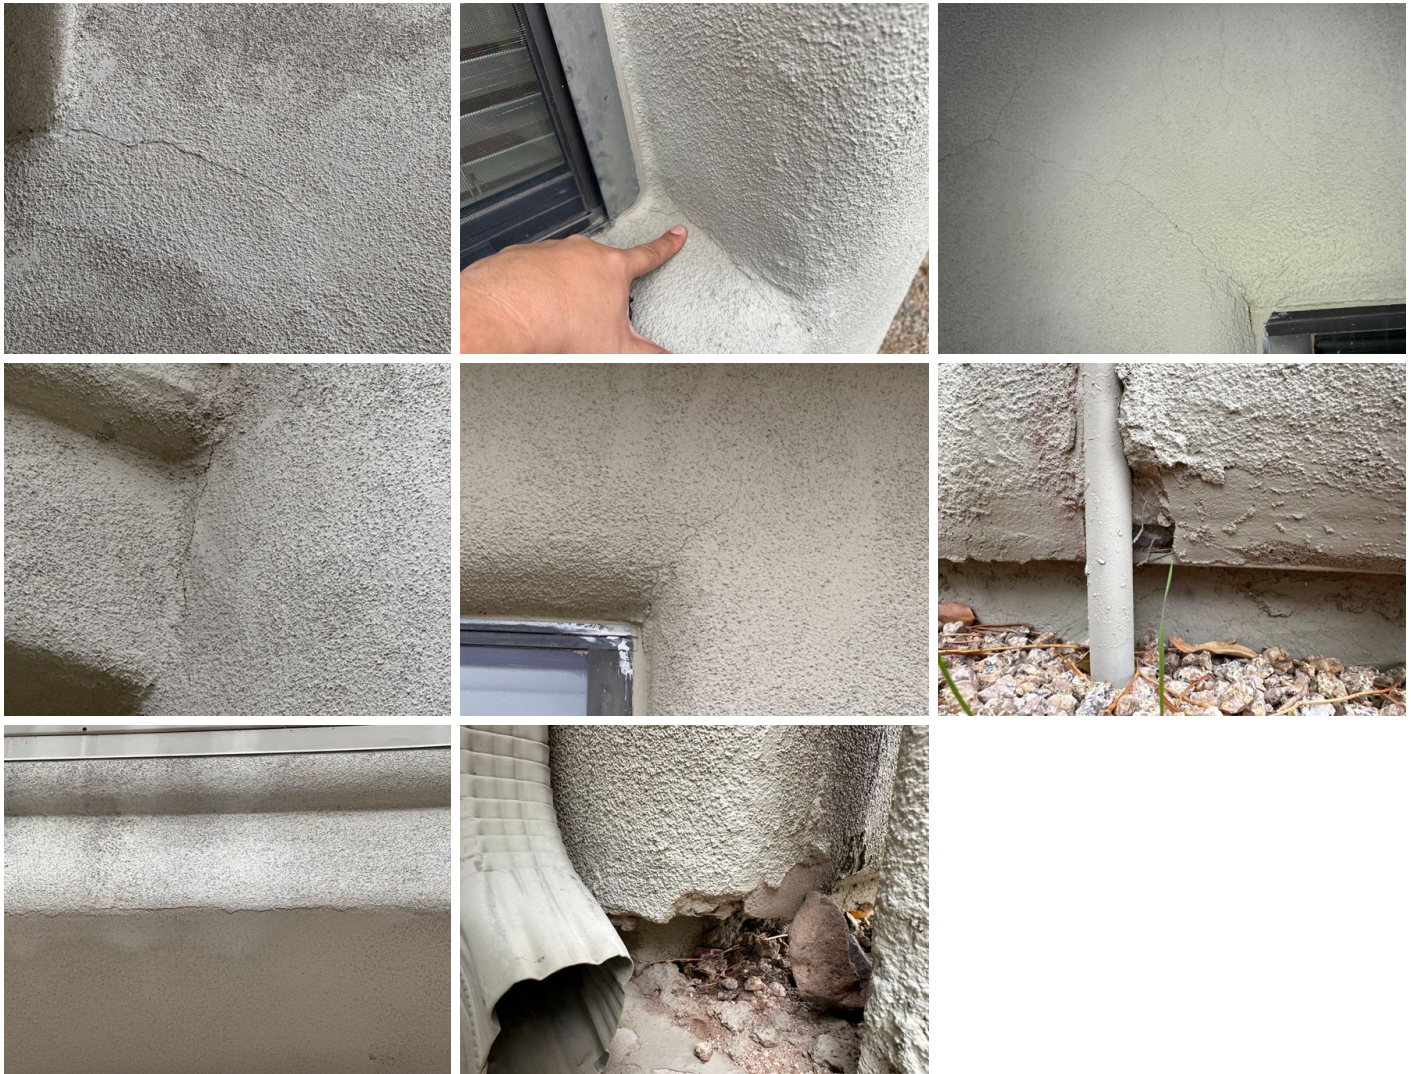
**Cladding/Siding, Flashing & Trim: Stucco Cracks, Chips and Openings**

Stucco cracks, chips and openings were observed in some areas. Cracking is often a result of the natural curing process however can also be an indication of settling or movement. Stucco cracks are typically be sealed when they reach the point where water could penetrate.

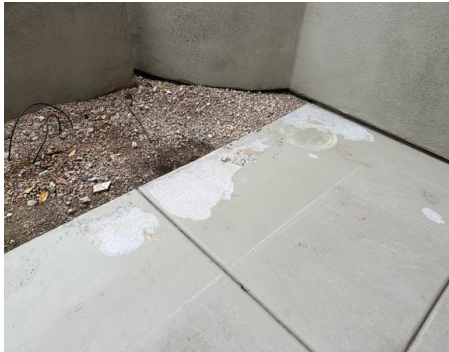
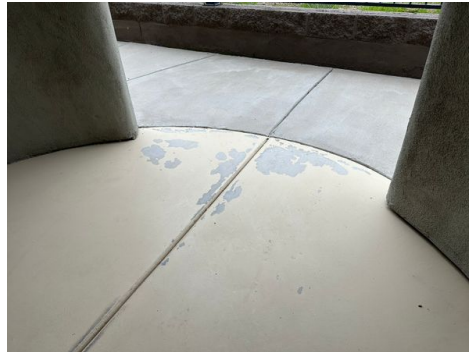
### Porch/Patio, Deck, Balcony, Stoops/Steps, Railings & Areaways: Concrete surface damage

Minor concrete surface damage was observed. The concrete slab is otherwise still usable.

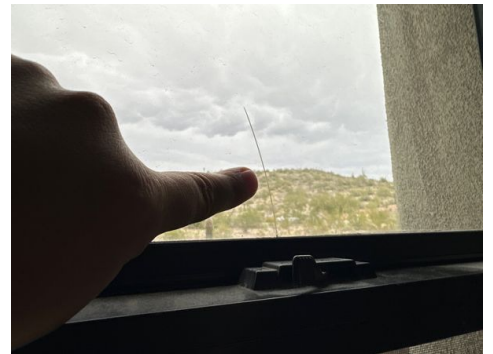
#### DAMAGED GLAZING

Cracked/damaged window glazing was observed. A licensed window repair and installation professional should be consulted for service.

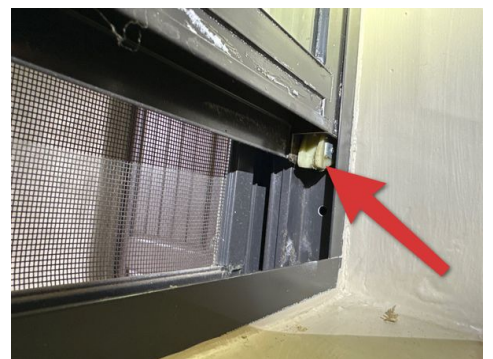
### 3.7.2 Windows

The single-hung window counter-balance mechanism is detached. This will often prevent a window from remaining open unassisted and/or will prevent a window from fully closing. A window repair professional should be consulted for service/repair.

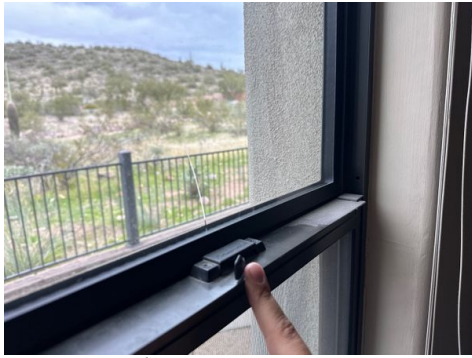
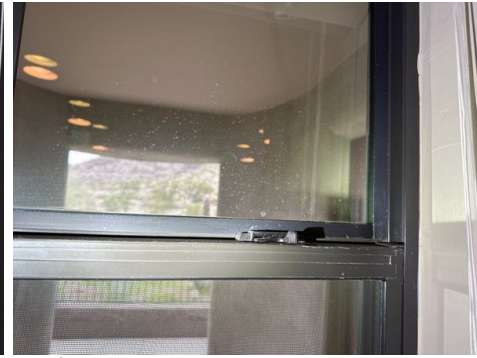
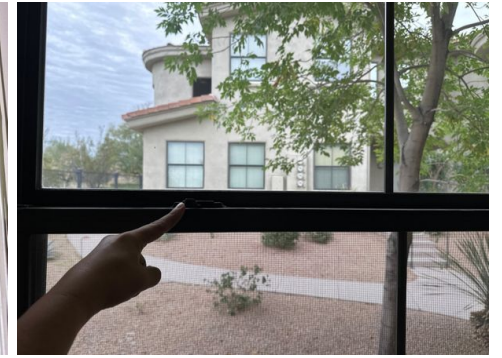
Some of the windows were difficult to lock after opening. A window repair professional can be consulted for adjustment.

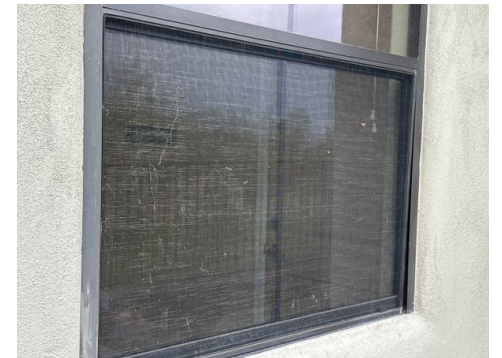
Window screens are damaged/weathered in areas and can be replaced as needed.

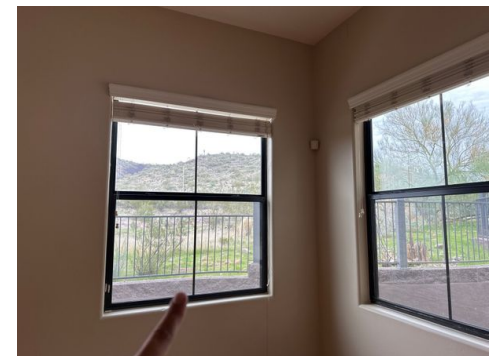
3.7.5 Windows

I was not physically able to open the window with normal testing. I recommend consulting a window repair professional for service.

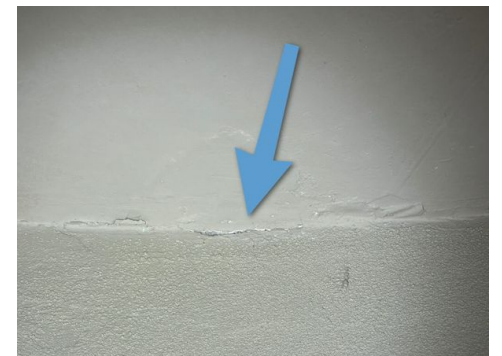
Separation between stucco and exterior drywall was observed. The intersection can be resealed as needed.

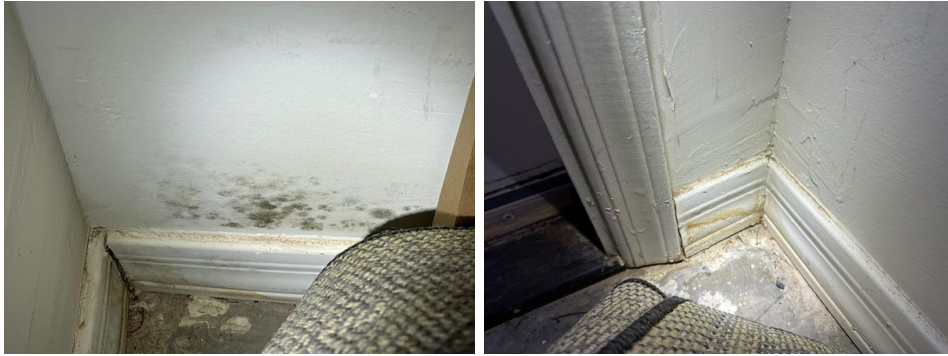
3.11.1 Exterior Storage Closet

**WATER STAINS/DAMAGE**

Water stains/damage with areas of dark discoloration were observed in the exterior storage closet. No elevated moisture was detected at the time of the inspection. It appears as though a degree of roof leaking and/or plumbing leaking has occurred. The other side of this wall is a separate unit. I recommend inquiry with the seller regarding leak history and consulting a licensed professional to replace damaged materials.

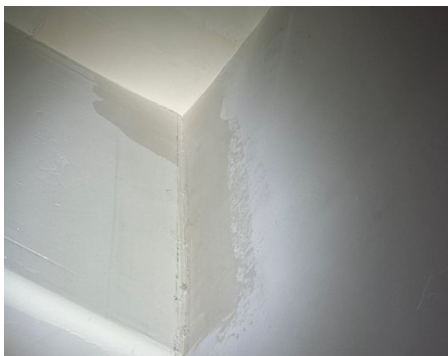
### Walls, Ceiling & Firewall Separation : Evidence of repair

Drywall appears to have been repaired or replaced in the garage. I recommend inquiry with the seller regarding the reason for/nature of the repair.

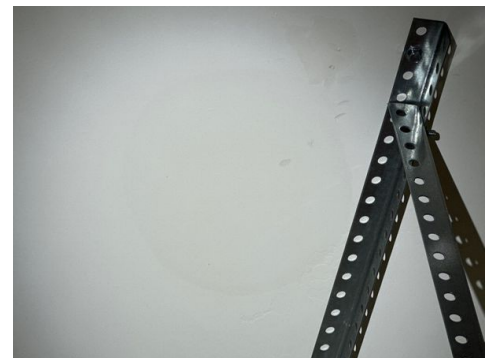
4.1.2 Walls, Ceiling & Firewall Separation

**WATER STAINS (FROM ROOF LEAK)**

A water stain was observed in the garage. Observed conditions that can lead to leaking have been noted in the roof section. I recommend consulting a drywall repair professional for service and monitoring after roof service is complete.

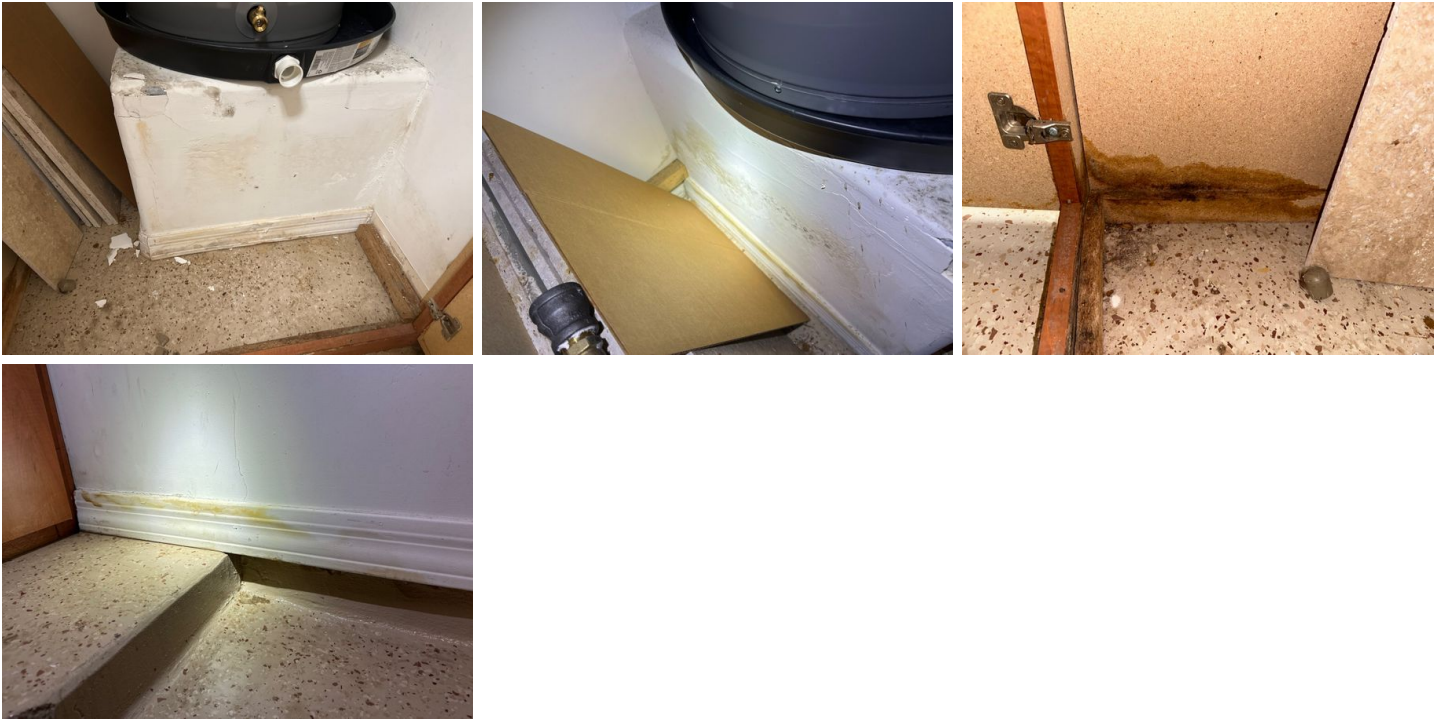
4.1.3 Walls, Ceiling & Firewall Separation

**WATER STAINS/DAMAGE NEAR WATER HEATER**

Evidence of leaking was observed near the water heater. No elevated moisture was detected at the time of the inspection and material feels generally solid. Please note that I am not able to determine the extent of the condition due to the water heater/limited visibility. A drywall repair professional should be consulted for service/repair.

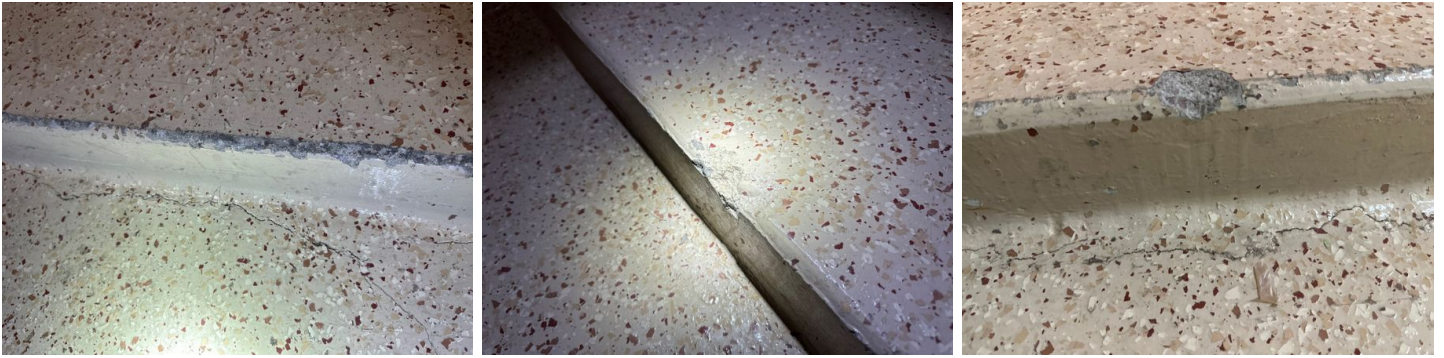
#### 4.2.1 Floor

#### **CONCRETE SLAB CRACKS/CHIPS**

The garage concrete floor/slab is cracked in some areas. A concrete/foundation repair professional should be consulted to review/service.

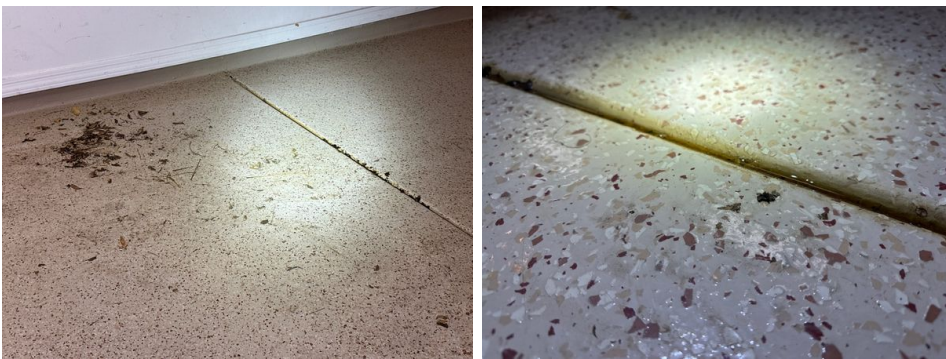
4.2.2 Floor

A small amount of water was observed in the garage. This could be due to recent rain coming in through the garage door. I recommend monitoring this and adding weatherstripping where needed.

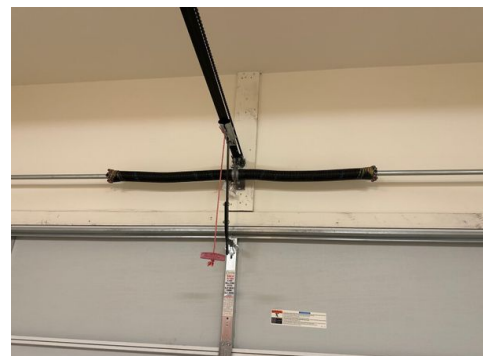
4.3.1 Garage Overhead Door(s)

The garage overhead door torsion spring did not hold the door partially (half-way or more) open. This may indicate it is not wound tight enough. I recommend consulting a garage door repair professional to assess and service/tighten as necessary.

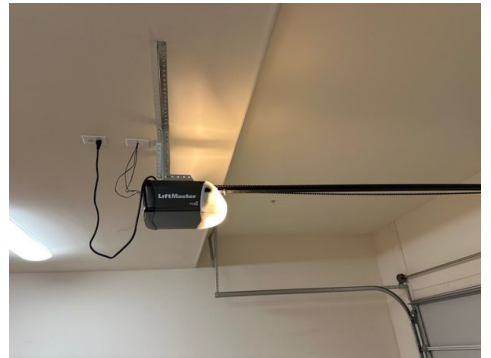
## 4.4.1 Garage Door Opener(s) &amp; Safety Functions

The garage door operator did not reverse operation when the overhead door was met with a reasonable amount of resistance. This could cause bodily injury and/or personal property damage. I recommend consulting a garage door repair professional to adjust the travel setting.

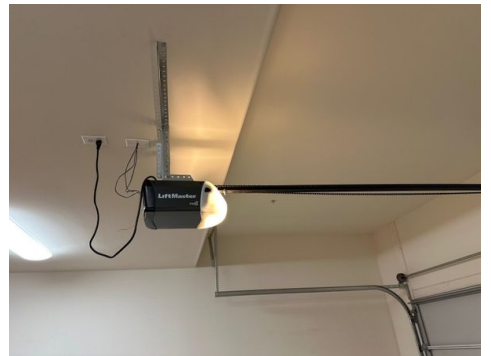
**Maintenance/Improvement Items****MODERATELY NOISY**

The garage overhead door operator and/or door could be considered moderately noisy when opening and closing. A garage door technician could be consulted for service if needed.

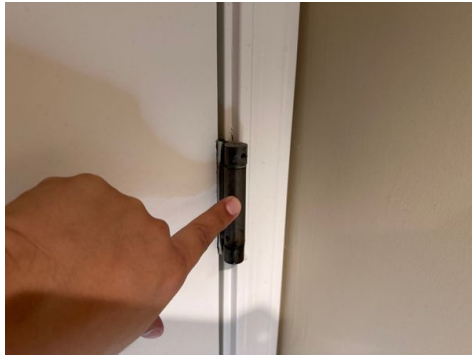
## 4.5.2 Fire Door (to interior)

**Safety Items****ADJUST/REPLACE HINGES**

The occupant door does not fully close (and latch) without assistance. Self-closing/spring-loaded hinges are not functional or have been loosened. This limits the firewall separation between the garage and interior as the door could be left open. I recommend tightening or replacing the self-closing/spring-loaded hinges. A door repair professional can be consulted for service.

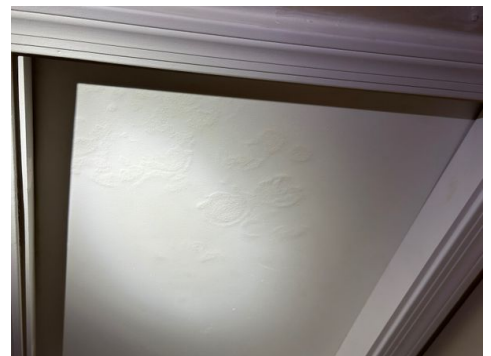
Minor swelling was observed at the laundry room access panel. No elevated moisture was detected. I recommend consulting a qualified professional to replace panel if desired.

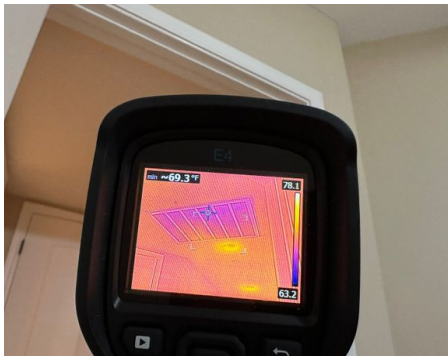
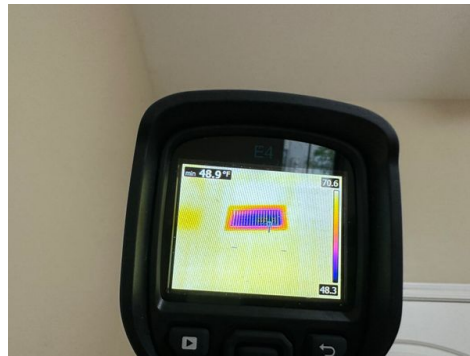
**Central Cooling System(s): Temperature Differential**

The difference in temperature between the cooling system return and registers was approximately **20** degrees. Please note this was measured using an infrared thermometer/camera. The actual air temperature could vary. Additional factors that can influence the temperature differential are not measured by these tools.

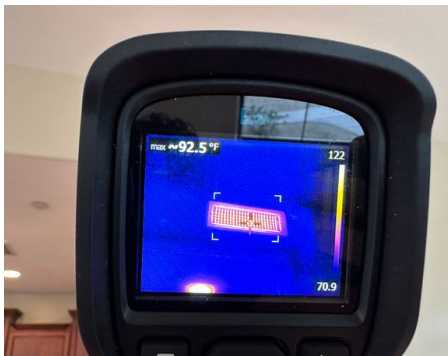
**Heating System(s): Functional heat pump**

The heat pump system was tested in heat mode and warmed air to an acceptable temperature.

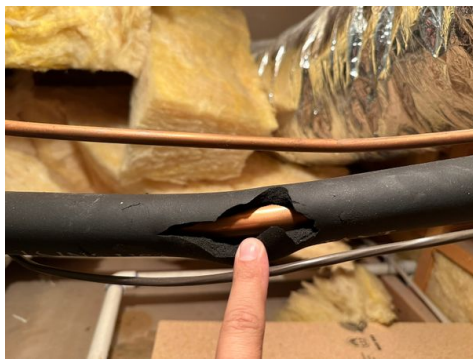
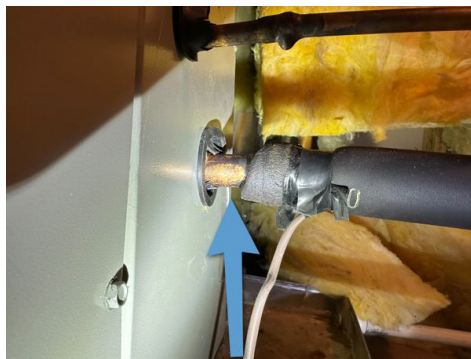
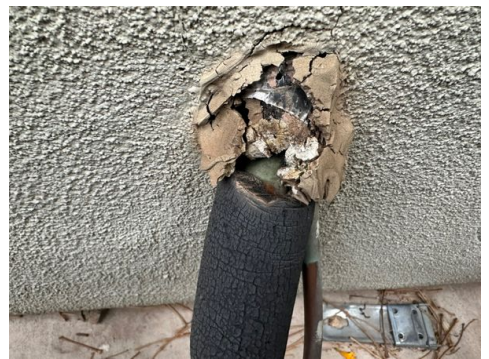
**DAMAGED/MISSING INSULATION**

Insulation for the cooling system refrigerant line(s) is damaged, open or missing. This can lead to excessive condensation and dripping. I recommend consulting a qualified HVAC repair professional for service.

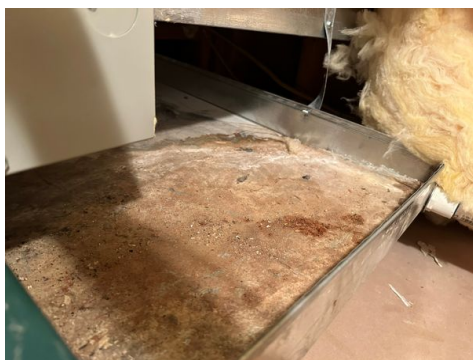
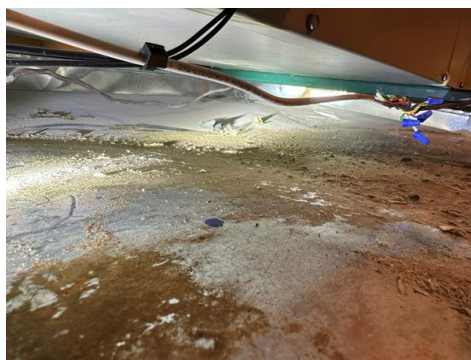
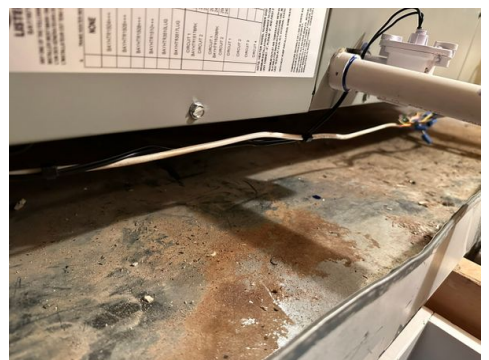
6.1.2 Central Cooling System(s)

Staining was observed in the air handler drip pan. Condensate will drip from the air handler into the drip pan below if the primary condensate drain becomes obstructed. I recommend inquiry with the seller regarding prior/recent HVAC service to help determine if these conditions are old. An HVAC professional should be consulted to clear the drain if necessary.

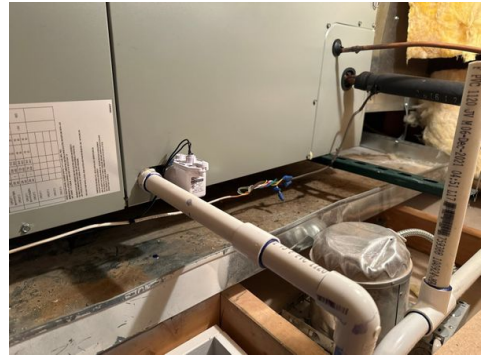
## 6.1.3 Central Cooling System(s)

It appears as though a sizable amount of water would need to collect in the air handler drip pan before it will be able to drain through the pipe. It is generally advisable to arrange the pan and pipe to collect as little water as possible and maximize drainage out of the attic area. I recommend consulting an HVAC professional for assessment/service.

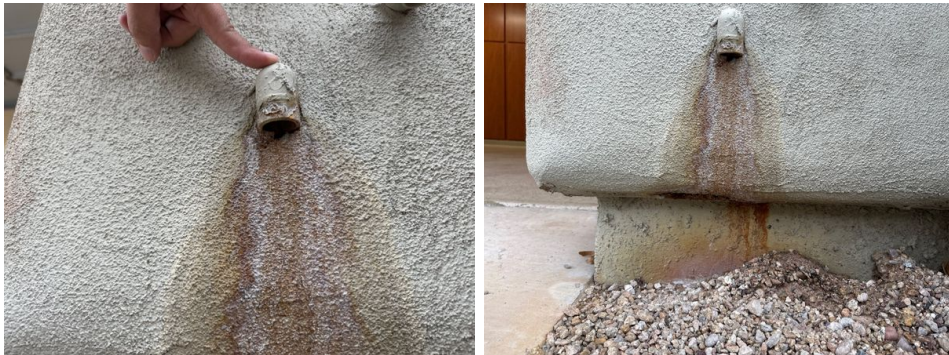
## 6.1.4 Central Cooling System(s)

The HVAC condensation line is partially behind the stucco. Stucco is stained which is a sign of moisture intrusion. I recommend consulting a qualified professional for repair.

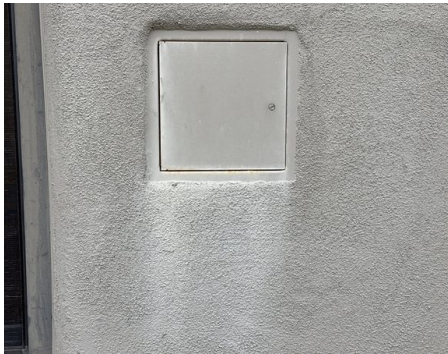
### Water Supply & Distribution System: Water Stains

Evidence of (prior) leaking in the form of water staining was observed at the sprinkler system access panel. No active leaking was observed. The staining could have been from when the system was serviced. I recommend consulting a plumber to assess/service as it is not evident that service has been performed.

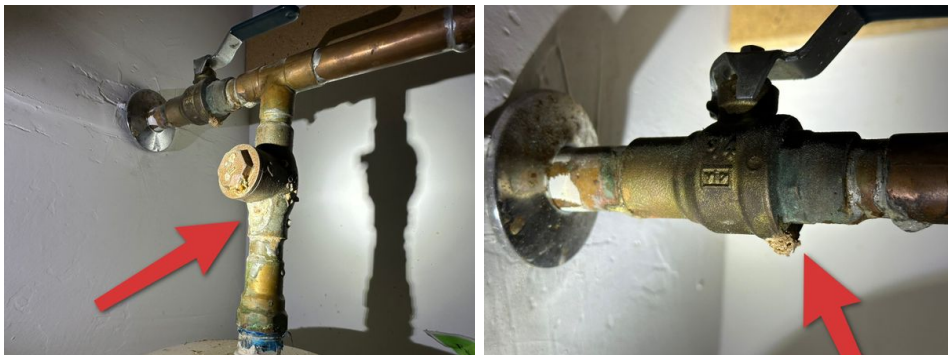
Corrosive build-up was observed at the water heater fittings. Corrosion can lead to water restriction as well as material damage resulting in leaking. I recommend consulting a licensed plumber for service.

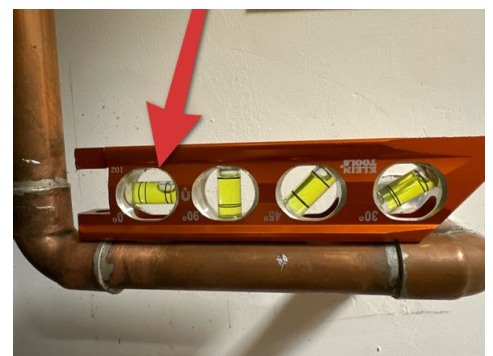
### 7.4.2 Hot Water Systems

#### TPR DISCHARGE PIPE SLOPE

A length of the water heater temperature/pressure relief valve discharge pipe slopes uphill. This pipe is required to slope in a manner in which all water can drain with gravity. Water held against the valve could lead to calcification and/or corrosion which could render the valve inoperable. I recommend consulting a licensed plumber to correct the condition.

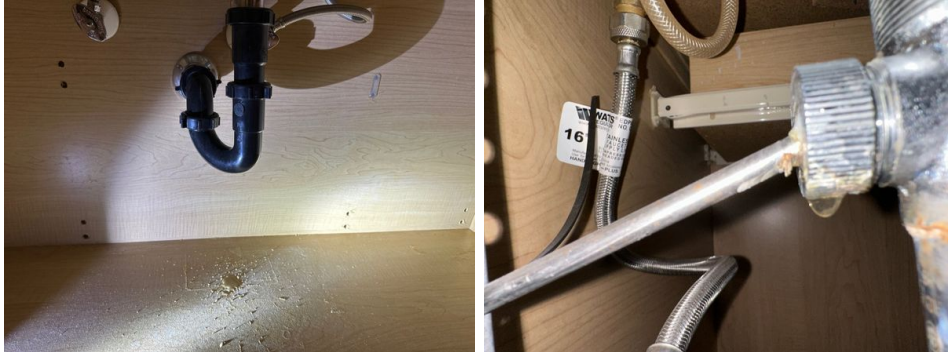
7.8.1 Sinks & Faucets

**DRAIN LEAK**

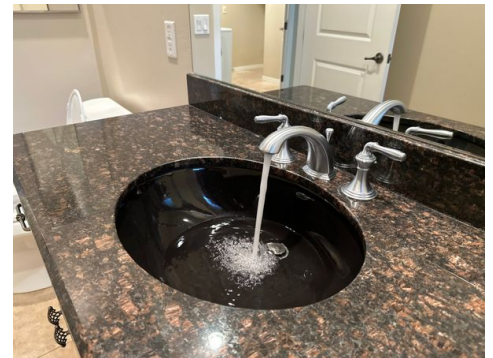
7.8.2 Sinks & Faucets

**SLOW DRAINAGE**

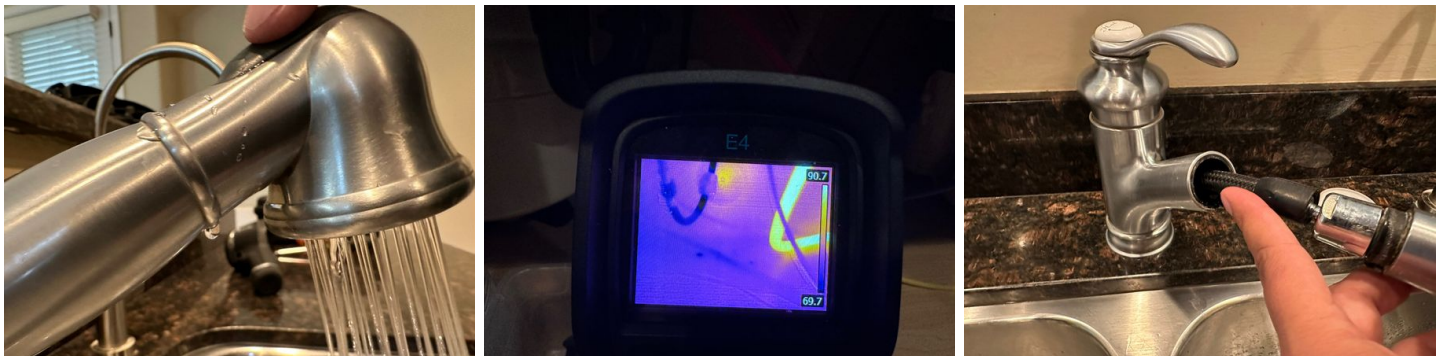
7.8.3 Sinks & Faucets

**LEAKING FAUCET**

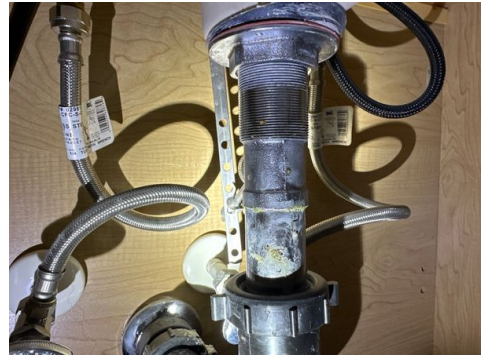
## 7.8.4 Sinks &amp; Faucets

Corrosion was observed at the drain tail piece(s). Corrosion can lead to water restriction as well as damage/leaking. I recommend consulting a qualified professional/plumber for replacement.

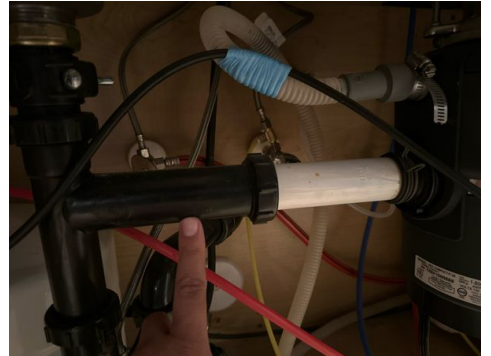
## 7.8.5 Sinks &amp; Faucets

The sink drain slopes slightly uphill after the P-trap. This portion of the pipe will fill with water and can increase the likelihood of a blockage. I recommend service/correction by a qualified plumber.

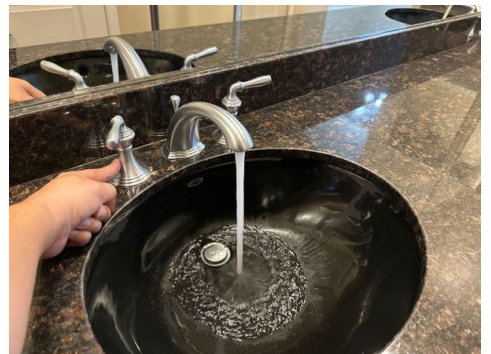
## 7.8.6 Sinks &amp; Faucets

Some (at least one) of the faucet handles are loose/not secured. A qualified professional/plumber can be consulted to secure handles as needed.

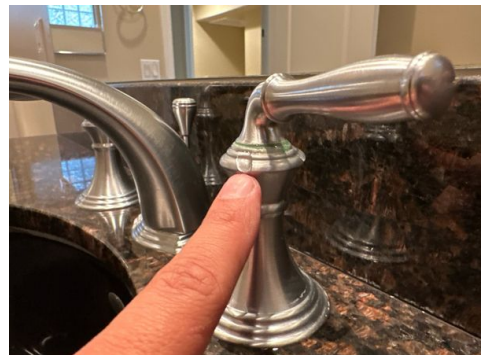
## 7.8.7 Sinks &amp; Faucets

Leaking from the faucet handle(s) was observed during testing. I recommend consulting a licensed professional/plumber for repair.

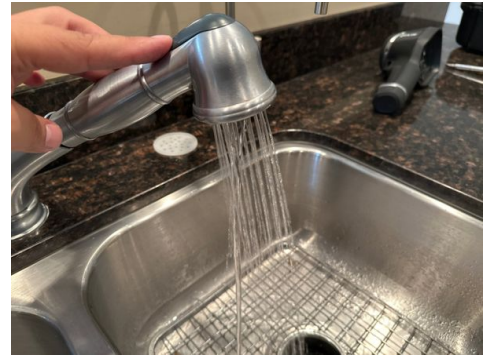
## 7.8.8 Sinks &amp; Faucets

The sink extendable sprayer pattern does not change when different buttons are pressed. A plumber can be consulted for service or replacement if needed.

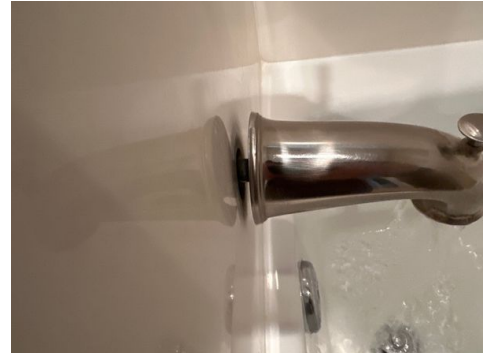
7.9.1 Bathtubs & Showers

There is a gap between the tub spout and shower surround that could allow moisture intrusion into the wall cavity. I recommend consulting a licensed plumber to repair.

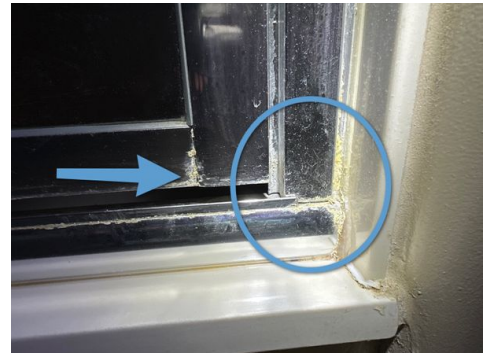
7.9.3 Bathtubs & Showers

A degree of corrosion/damage was observed in the lower corners of the shower door/wall. A licensed contractor can be consulted for service or replacement if needed.

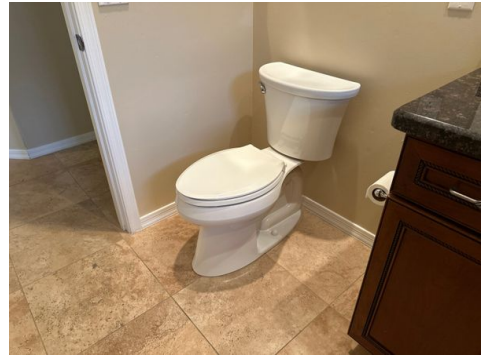
7.10.1 Toilets

The toilet is loose/able to be rocked or shifted. Toilets should remain tightly secured to floors to avoid displacement of the seal. I recommend consulting a licensed plumber for service.

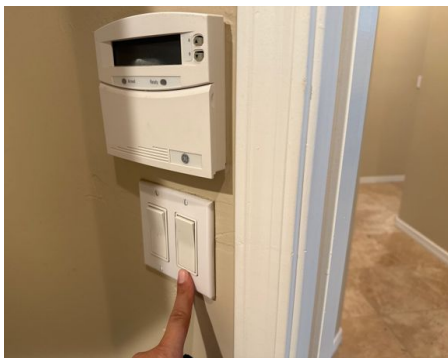
**Light Fixtures, Ceiling fans and Switches : Switch function**

I was not able to determine the function or operation of some switches. The switches may be disconnected. I recommend inquiry with the seller as needed regarding functionality.

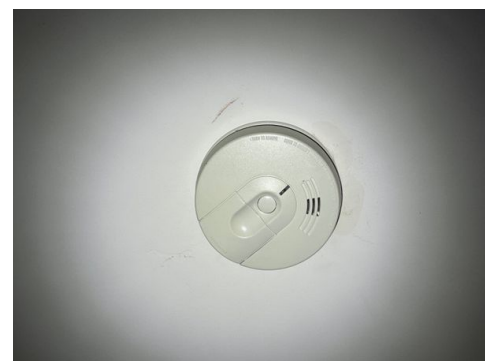
Some smoke detectors appear as though they could be older than approximately 10 years. It is generally recommended that smoke detectors be replaced at ten year intervals or less. I recommend replacement where necessary by a qualified professional/electrician.

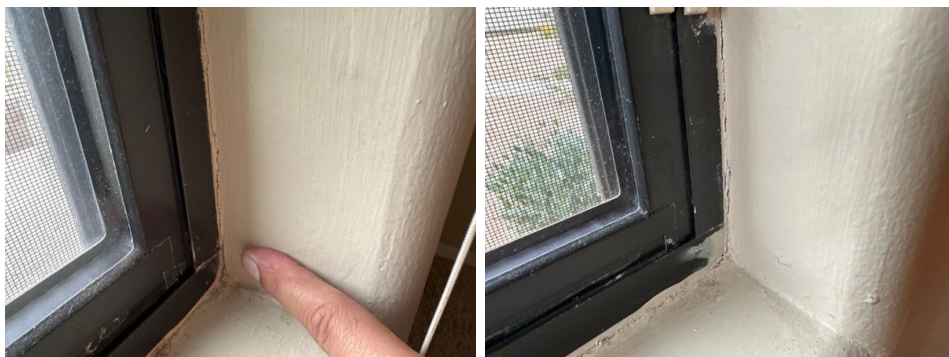
Gaps/separated caulking was observed at the interior side of some windows. This is a common condition that develops with time. Gaps can be re-sealed as needed.

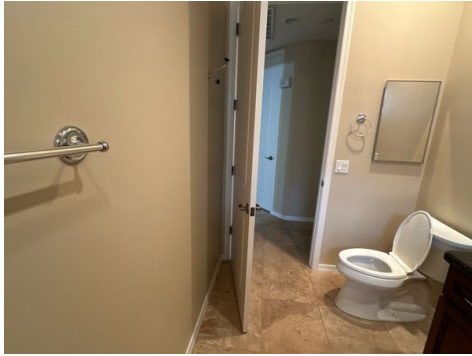
### 9.1.2 Walls & Ceilings

Door stops are missing in some areas. Door stops can help prevent damage to interior finish by preventing impact with door handles.

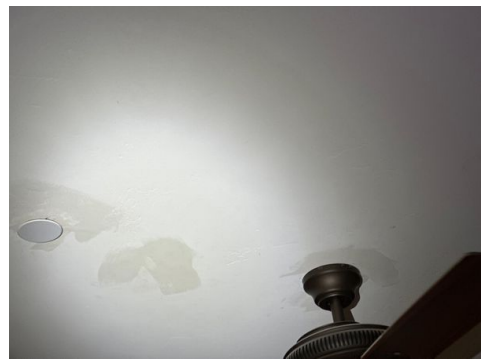
The drywall repair might be considered complete however is still easily visible.

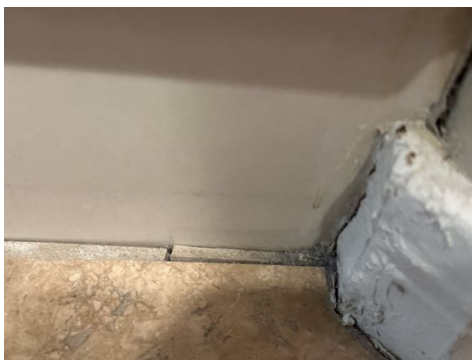
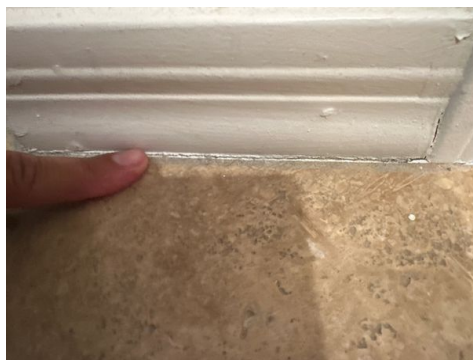
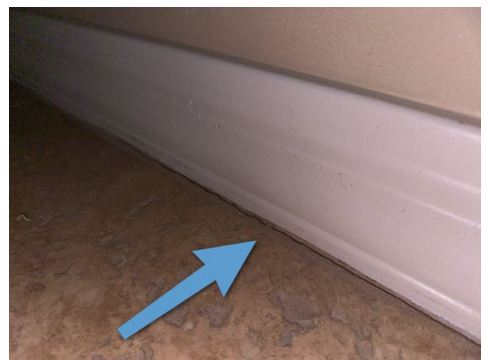
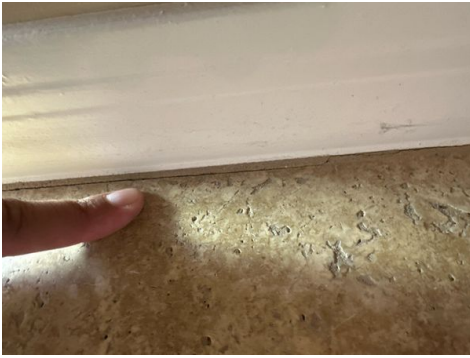
9.2.1 Floors

Areas of cracked and/or missing tile floor grout were observed. A tile flooring professional can be consulted to reapply grout or caulk where missing.

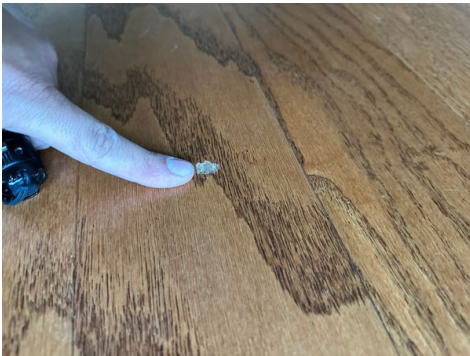
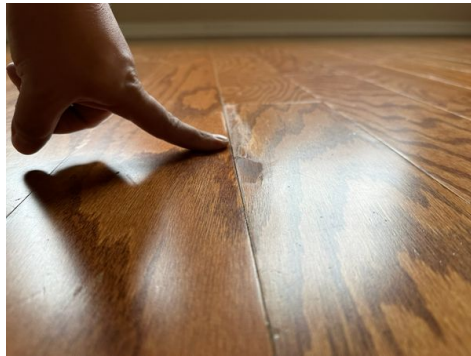
Damaged laminate flooring material was observed. These materials can be replaced if needed by a flooring repair and installation professional.

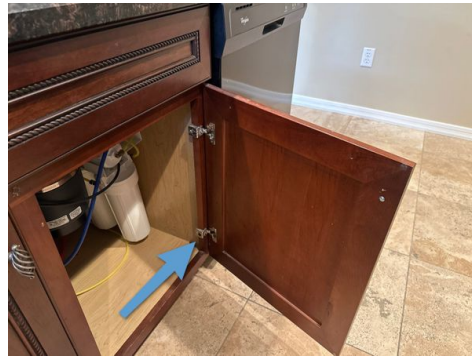
9.4.1 Countertops & Cabinets

Loose cabinet door hinge(s) were observed. Some hardware may be able to be tightened while hardware in other areas may require replacement.

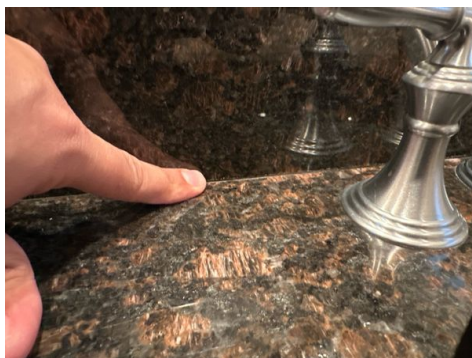
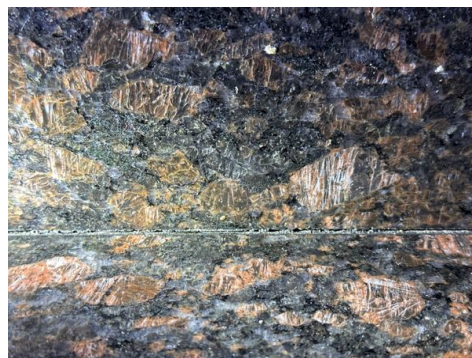
9.4.2 Countertops & Cabinets

I recommend resealing between countertops and backsplash where needed to help prevent water intrusion behind these finish materials/areas.

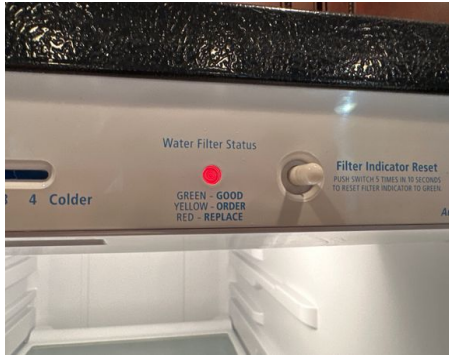
### Refrigerator : Replace water filter

The "replace water filter" LED was illuminated at the refrigerator control.

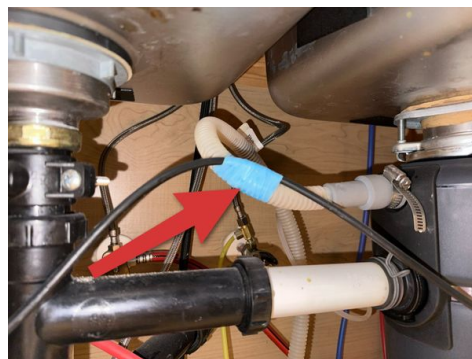
The dishwasher drain is not secured in a manner that provides a high loop. A high loop will help to prevent waste water from draining from your sink to your dishwasher and will help keep water from settling in the hose after draining. I recommend securing the hose high under the sink between the dishwasher and sink drain or garbage disposal connection (as pictured).

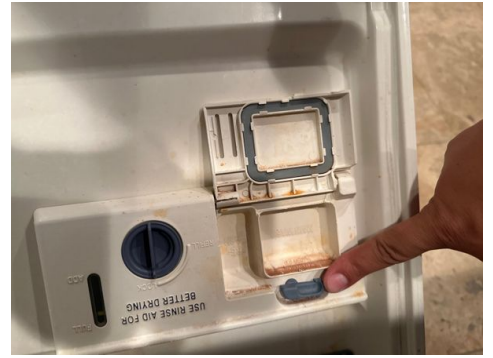
### 10.1.2 Dishwasher

The dishwasher detergent cap does not latch closed and stays open. A qualified appliance repair professional could be consulted to service if needed.

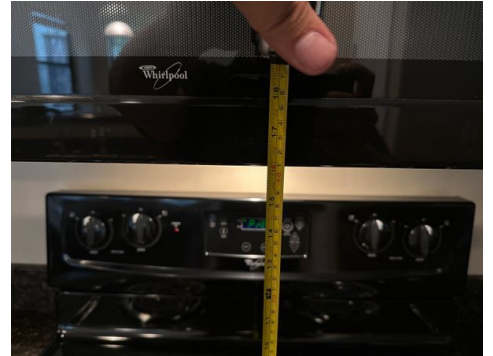
#### 10.5.1 Built-in Microwave

Clearance between the bottom of the microwave and the cooktop appears low. The manufacturer of the microwave would likely dictate what the minimum clearance requirements is. Low clearance could make cooking more difficult. I recommend verifying requirements with the manufacture if possible and observing available clearance to help determine if it will be adequate/sufficient for cooking.
