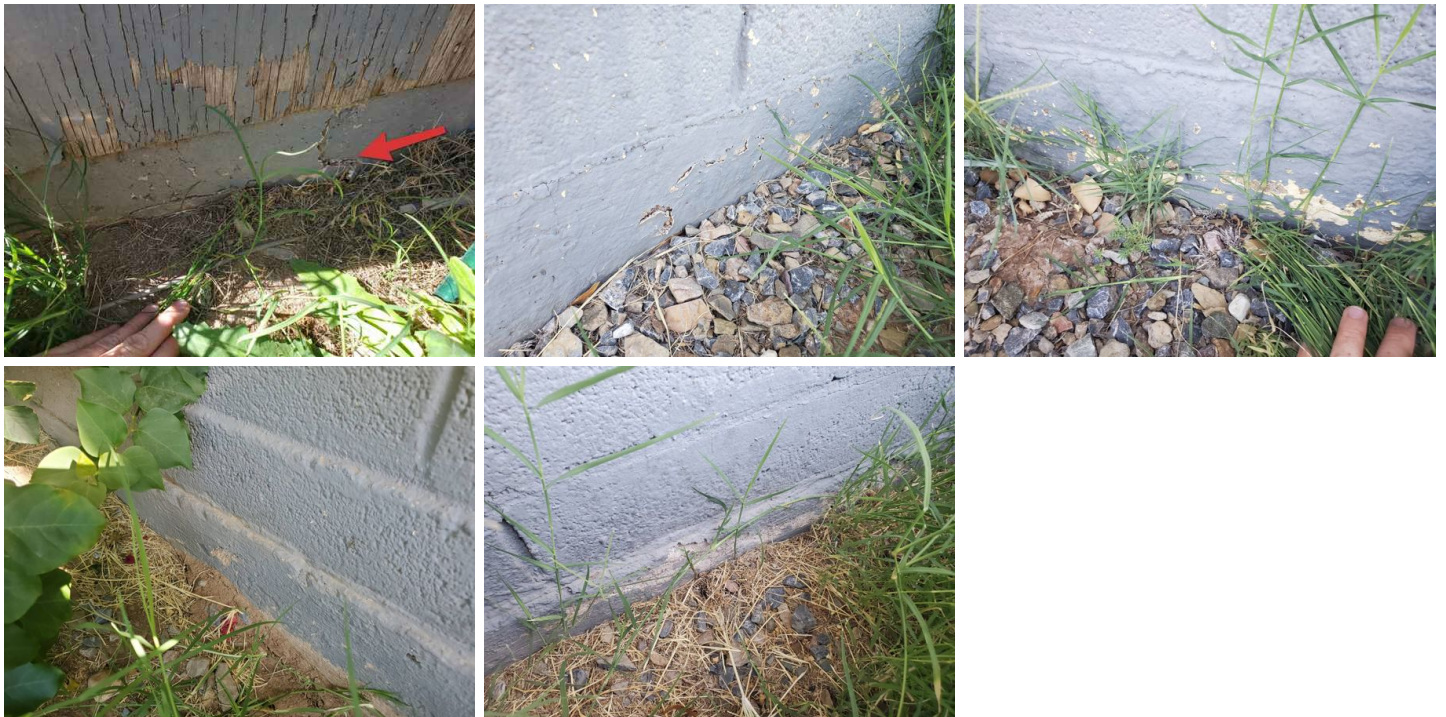
2.1.1 Foundation

SPALLING AND CRACKING CONDITIONS

Cracks/fractures as well as spalling concrete conditions were observed. These are sometimes indications that rain water is not sufficiently draining away from the home. I recommend the affected areas be assessed and repaired by a licensed concrete/foundation repair professional. I recommend monitoring the foundation as well as drainage conditions around the foundation. Drainage conditions should be corrected anywhere water collects close to/against the foundation after rain.

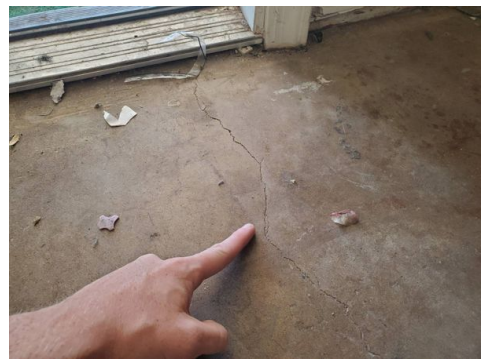
2.2.1 Floor Structure

CRACKED SLAB

The exposed concrete floor slab is cracked/damaged. No excessive cracking or vertical displacement was observed. A licensed concrete repair professional should be consulted for service.

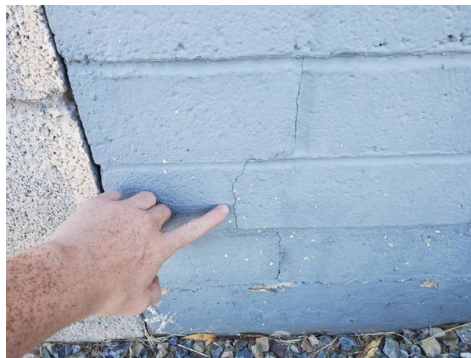
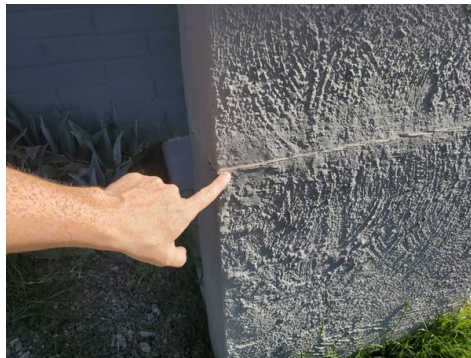
2.3.1 Wall Structure **STEP CRACKING**

Step cracking was observed at masonry exterior walls. Cracking penetrates through masonry units in some areas. I recommend consulting a licensed contractor to assess and repair/seal where necessary.

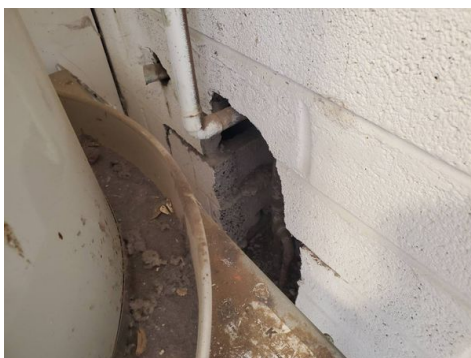
2.3.2 Wall Structure **REMOVED MASONRY**

Sections of the masonry block wall have been removed in some areas. I recommend consulting a licensed contractor to replace where missing.

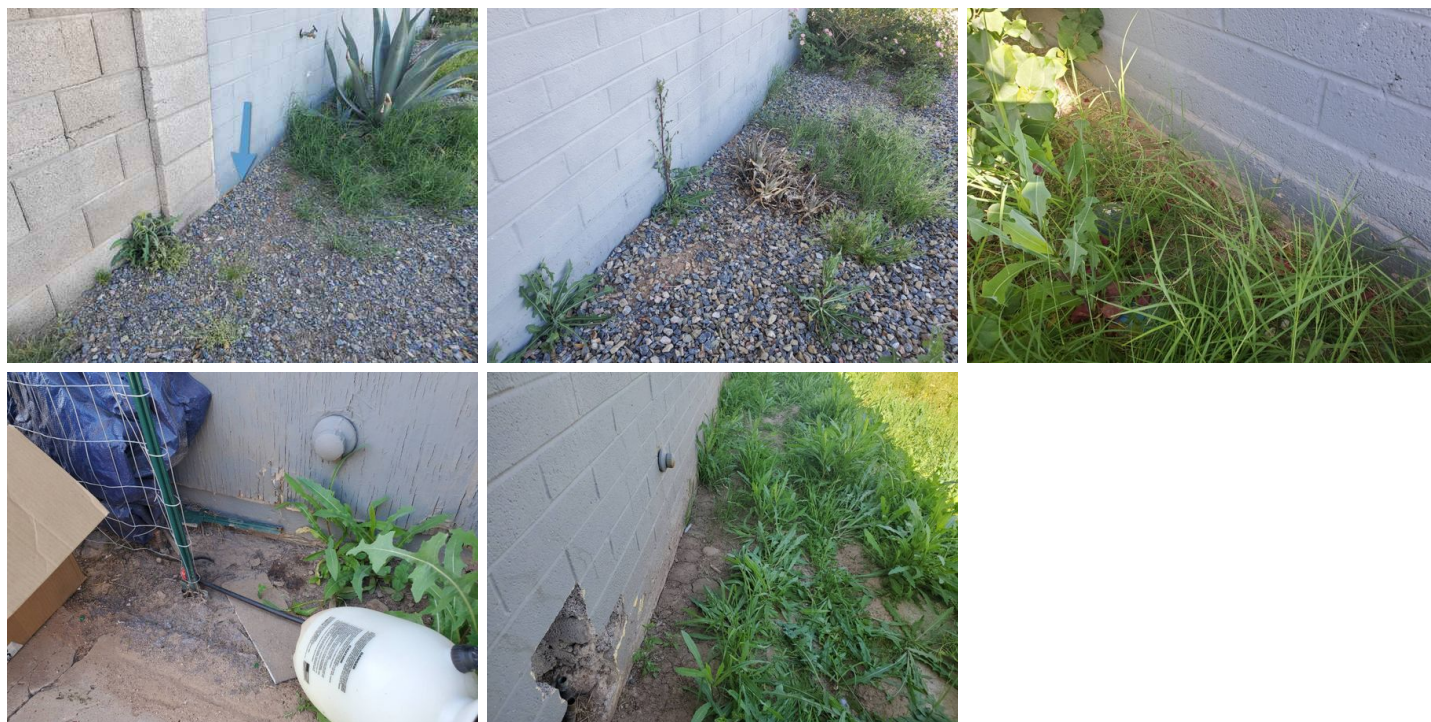
3.2.1 Vegetation, Grading, Drainage & Retaining Walls

IMPROPER GRADE/SLOPE

Exterior grade is flat and/or negatively sloped in some areas. A slope of approximately **1 inch per foot away** from the foundation is recommended for at least the first few feet so that proper drainage can be maintained. I recommend grading conditions be corrected where necessary by a qualified grading or landscape professional.

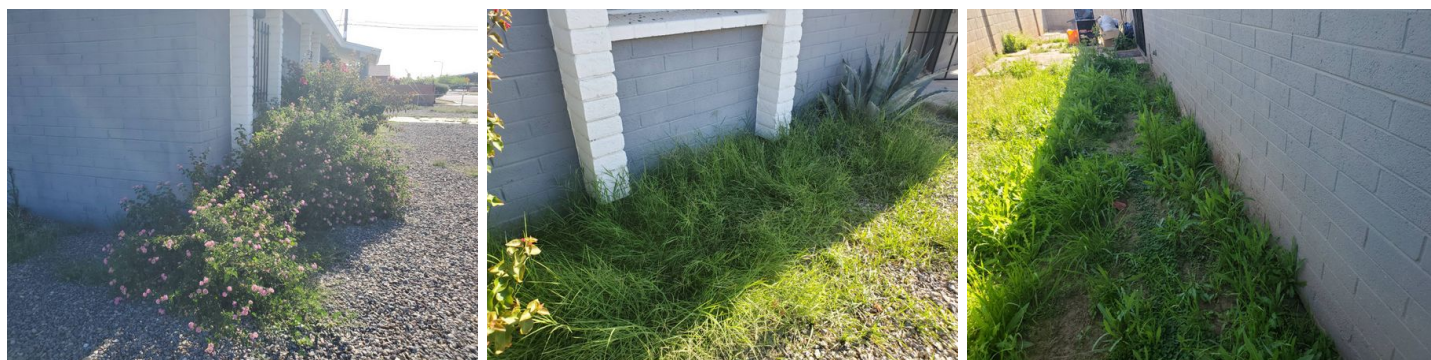
3.2.2 Vegetation, Grading, Drainage & Retaining Walls

VEGETATION CONTACTING HOME

Vegetation is contacting and obstructing visibility of exterior walls in some areas. It is recommended that vegetation be trimmed away from exterior walls so that visibility may be maintained as well as to limit exterior siding/paint damage and moisture issues. I recommend trimming or removing where necessary.

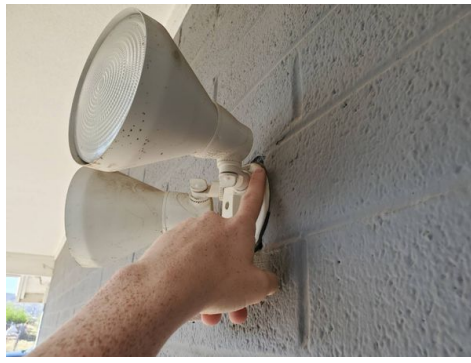
3.3.1 Cladding/Siding, Flashing & Trim

UNSEALED EXTERIOR LIGHT(S)

Some exterior light fixtures are loose and/or the enclosures are not sealed against the exterior wall. These exterior wall openings can allow pest and/or moisture intrusion. I recommend securing and sealing around all the exterior lights. A qualified handy person could be consulted for service if needed.

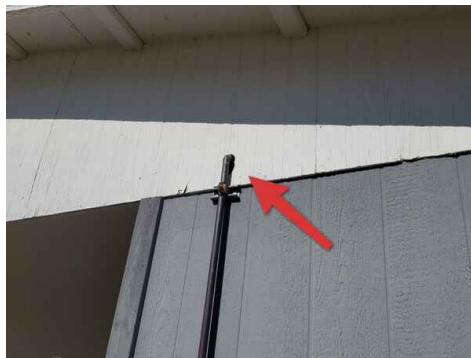
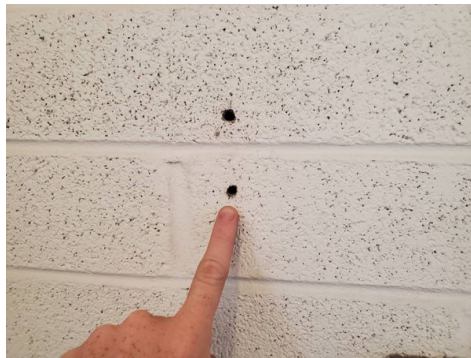
Exterior wall penetration(s) are not sufficiently sealed in some areas. Openings/penetrations should be sealed with approved exterior caulk/sealant to prevent pest and moisture intrusion.

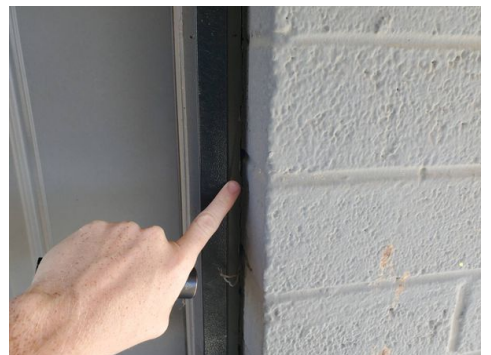
3.3.3 Cladding/Siding, Flashing & Trim

CRACKED/MISSING EXTERIOR CAULK

Cracked, separated and/or missing exterior caulk was observed. I recommend sealing/re-sealing where needed to prevent moisture intrusion.

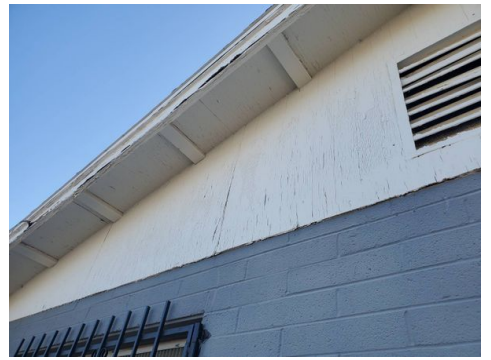
3.3.4 Cladding/Siding, Flashing & Trim

WEATHERED PANEL SIDING & TRIM

Siding & trim installed appears weathered/damaged in areas. Exposure to water and/or UV would typically cause further damage so maintaining paint and controlling rainwater will be necessary. I recommend further assessment/service by a qualified exterior siding professional.

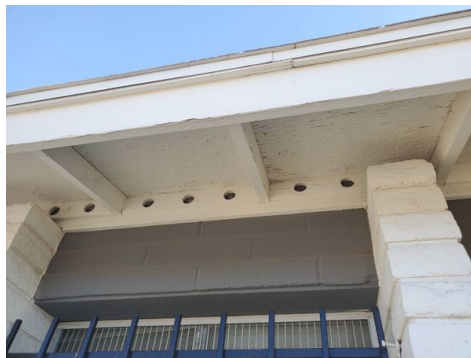
FLAKING/CRACKING EXTERIOR PAINT

Exterior paint is flaking, cracking and generally weathered in appearance in some areas. Loose paint should typically be scraped and exposed areas repainted. An exterior painter can be consulted for service if needed.

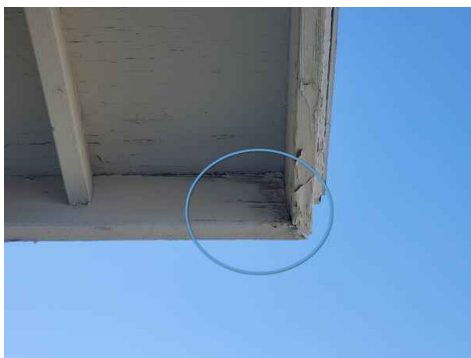
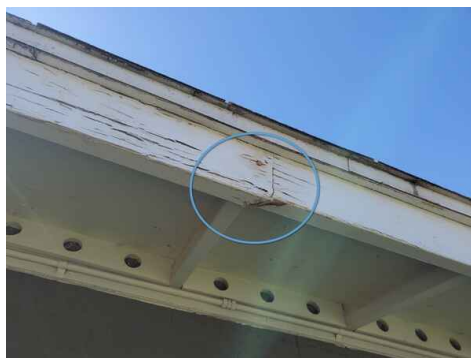
WATER STAINS

Water stains were observed at some roof eaves/overhang locations. The conditions could be due to wind driven rain or potentially a degree of roof leaking. Observed conditions that can contribute to leaking have been documented in the roof section. Stains can typically be resealed and repainted. I recommend monitoring for indications of worsened stains that can indicate roof leaks.

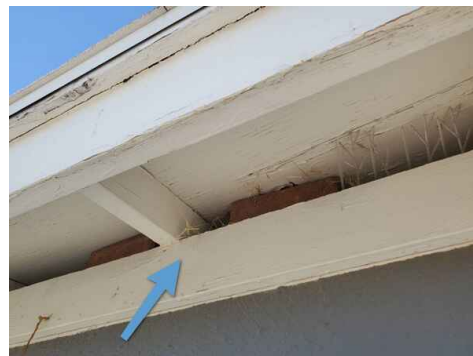
BIRD NESTING

Bird nesting debris was observed at the roof overhang. There were no live birds present in the area at the time of the inspection.

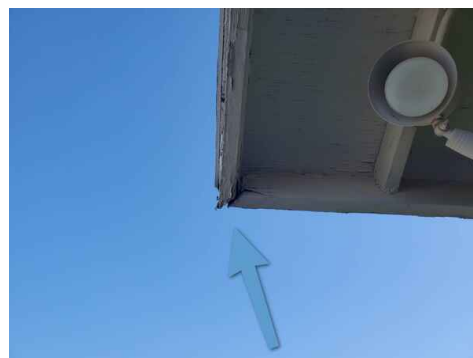
3.5.3 Eaves, Soffits & Fascia **SEPARATED FASCIA**

Roof eave fascia is separated in some areas. I recommend adding or replacing fascia nails plates as needed.

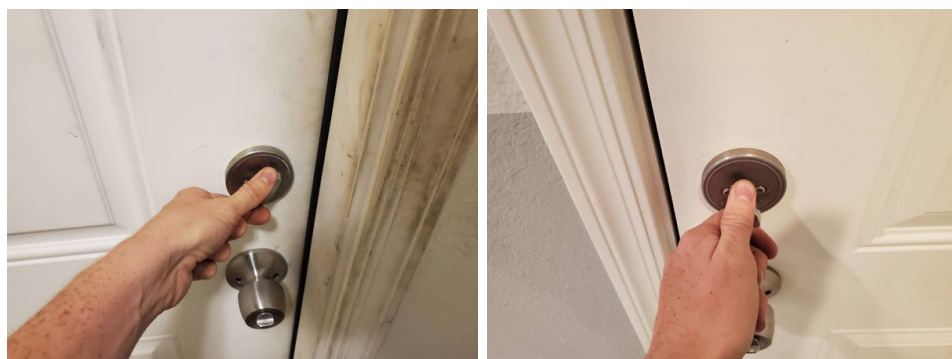
3.6.1 Exterior Entry Doors **DEADBOLT NOT ALIGNED**

The deadbolt is not properly aligned and will not easily engage. A door repair professional can be consulted for service.

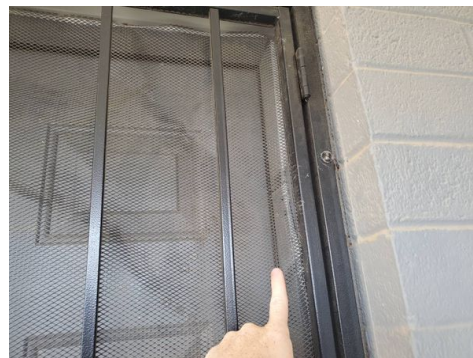
DAMAGED SECURITY DOOR

The security door screen is damaged/torn. A qualified door repair professional could be consulted to replace if needed.

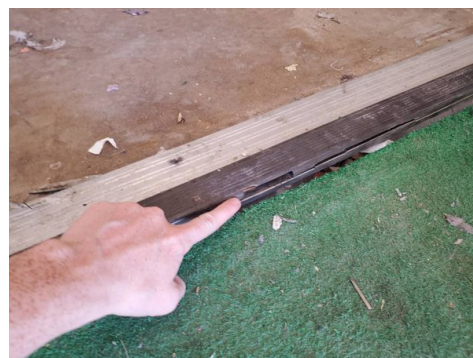
DAMAGED THRESHOLD

The utility closet door threshold is damaged and can be replaced by a qualified professional

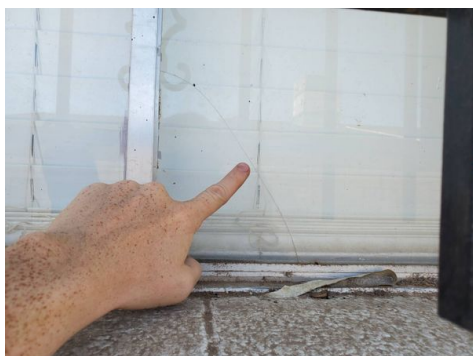
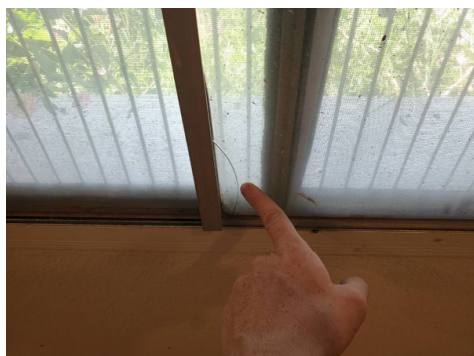
DAMAGED GLAZING

Cracked/damaged window glazing was observed. A licensed window repair and installation professional should be consulted for service.

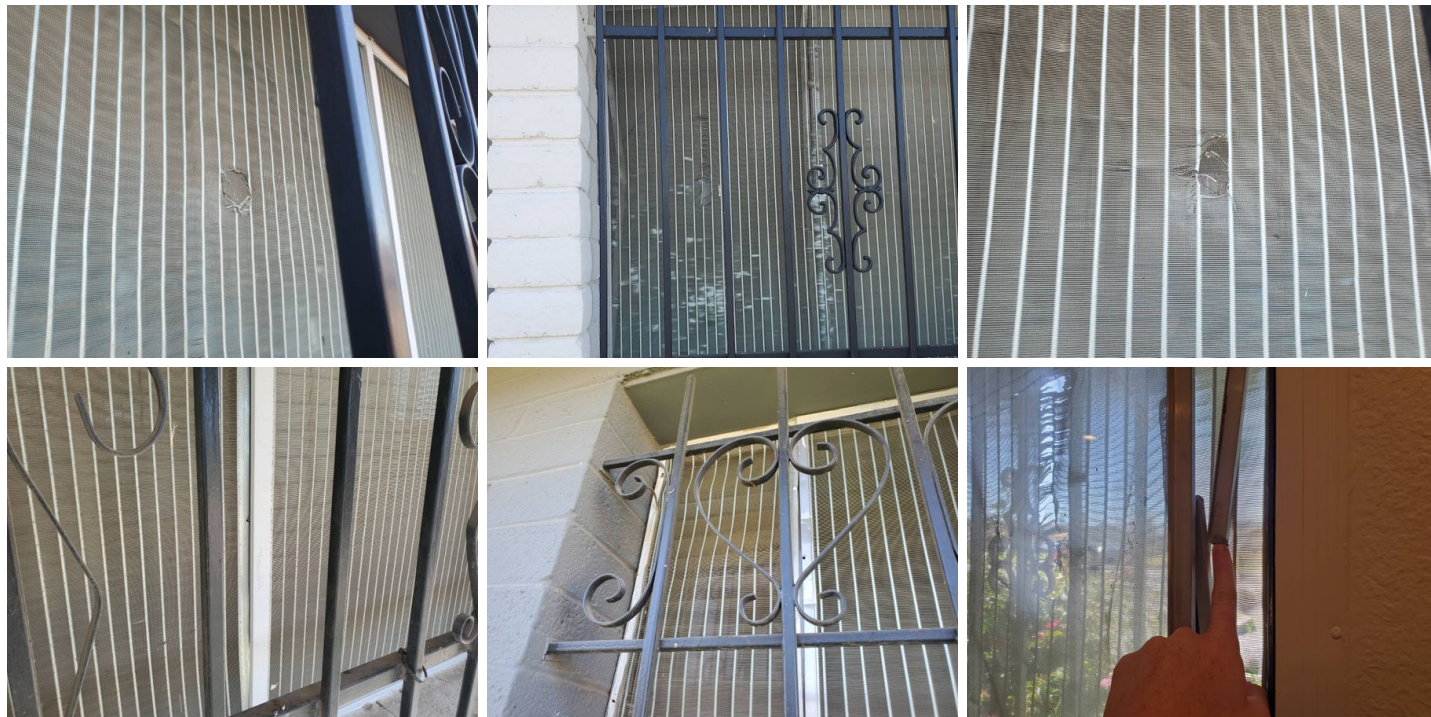
DAMAGED WINDOW SCREENS

Some of the window screens are damaged. A qualified window repair professional or handy person could be consulted to re-screen or replace as needed.

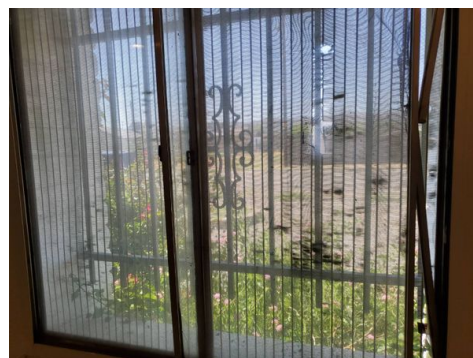
Some windows could be considered moderately difficult to open and close. A window repair professional can be consulted to service or adjust as needed for easier operation.

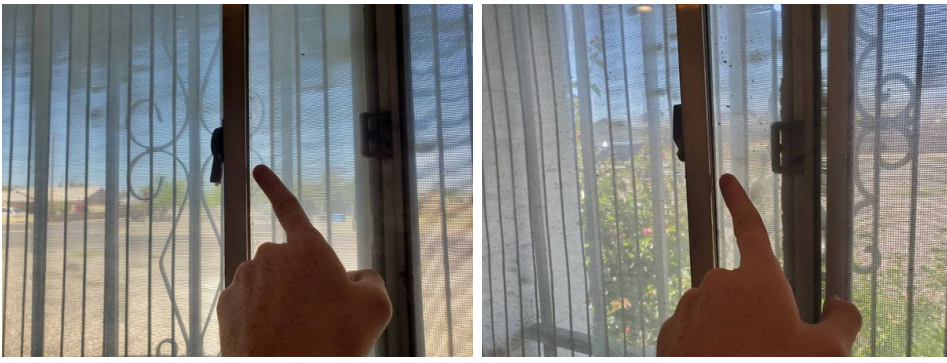
**LOOSE GLAZING**

Window glazing (glass) is loose and is able to moved within the sash. I recommend consulting a window repair professional for service.

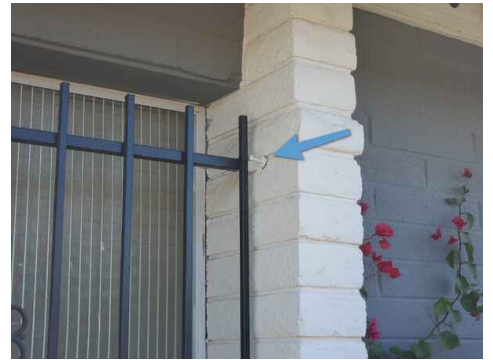
3.7.5 Windows

LOOSE SECURITY BAR HARDWARE

Fasteners to secure the window security bars are loose and can be further secured by qualified professional.

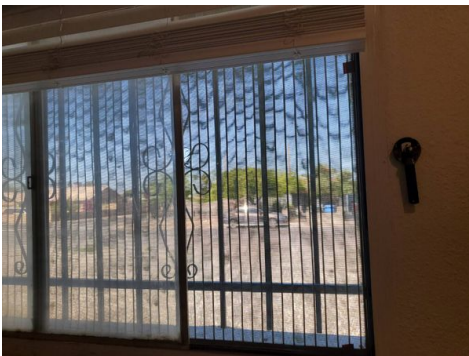
I was unable to open bedroom window security bars. These security bars should be openable from the inside to ensure emergency egress is established. Additionally, I was unable to close the family room window security bar after opening. I recommend consulting a licensed window repair professional for service.

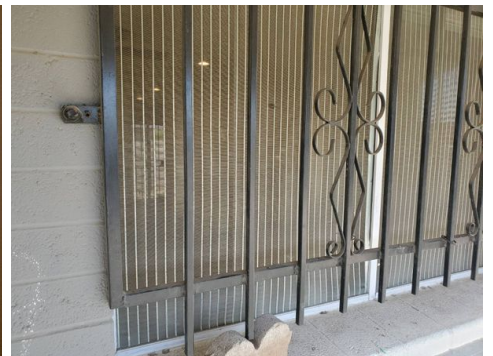
3.7.6 Windows

UNABLE TO OPEN/CLOSE SECURITY BARS

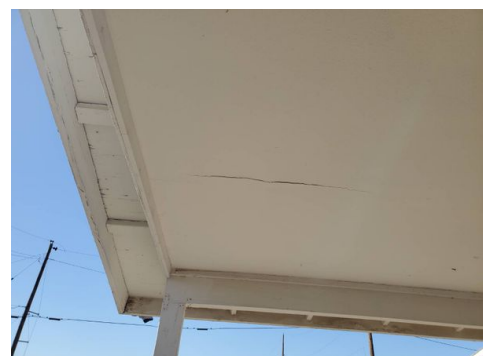
3.8.1 Porch/Patio, Deck, Balcony, Stoops/Steps, Railings & Areaways

EXTERIOR DRYWALL CEILING (SEPARATION)

Loose drywall tape and/or visible tape seams were observed at the exterior drywall ceiling. A drywall repair professional can be consulted for service as needed.

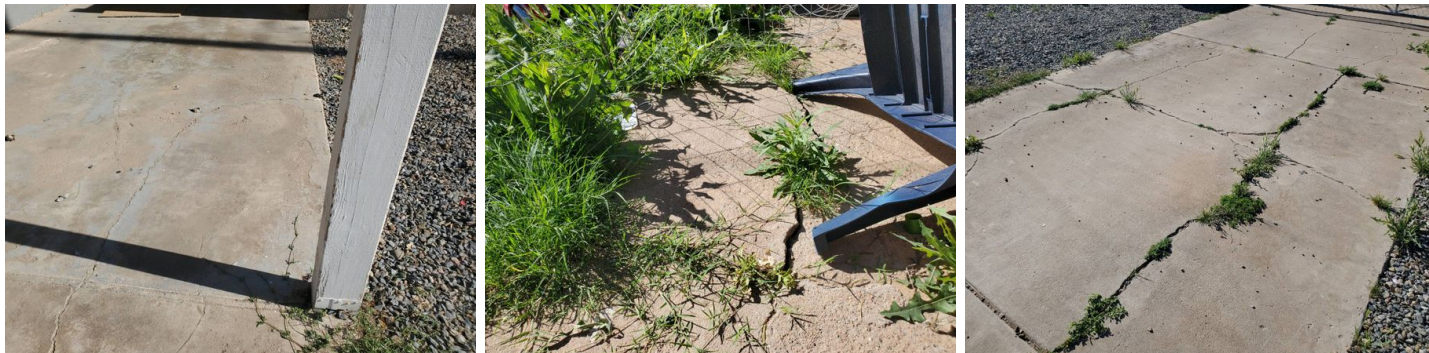
3.8.2 Porch/Patio, Deck, Balcony, Stoops/Steps, Railings & Areaways

CRACKED/DAMAGED SLAB

The exterior concrete slab and driveway is cracked/damaged. I recommend consulting a qualified professional for service/repair.

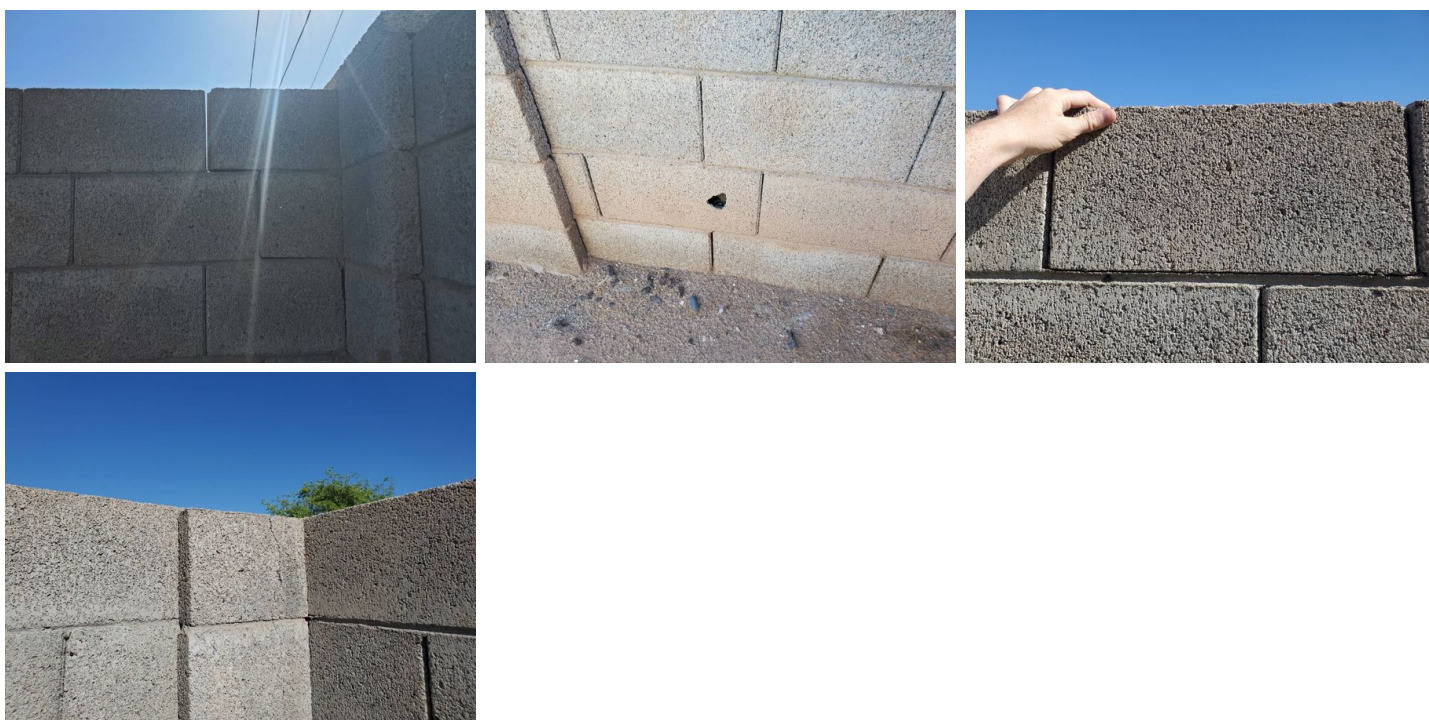
3.9.1 Fence

BLOCK FENCE CONDITIONS

Conditions observed at the perimeter masonry block fence included: Step cracking/displaced masonry, cracked/damaged blocks, loose blocks, and missing block caps. A qualified masonry fence repair professional can be consulted for service.

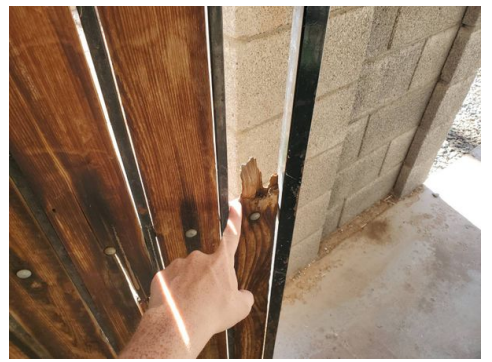
3.10.1 Gates

WEATHERED/DAMAGED GATE PLANKS

Gate planks are weathered, splitting and/or damaged due to exposure to moisture and UV. Some planks could be salvageable/able to be painted and resealed while others may require replacement. A qualified handy person or gate repair professional could be consulted for service if needed.

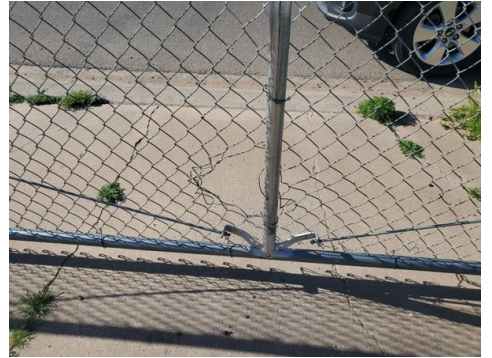
3.10.2 Gates

DAMAGED CHAIN LINK GATE

The driveway chain link gate is damaged and slightly difficult to open and close. A qualified professional can be consulted for service/replacement.

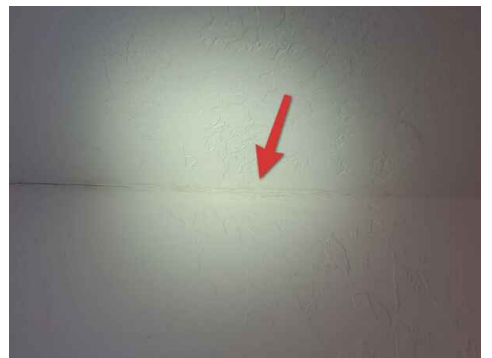
3.11.1 Utility Closet

WATER STAINS

Water stains were observed in the exterior utility closet. It appears as though a degree of roof leaking has previously occurred. I recommend inquiry with the seller regarding leak history and consulting a licensed professional to replace damaged materials. Please note, conditions that could lead to roof leaks have been documented in this report.

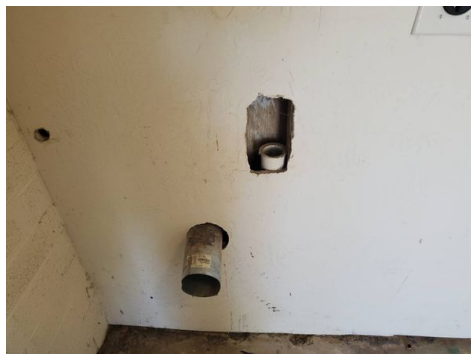
Unsealed/open drywall was observed in some areas in the exterior utility closet. A licensed professional can be consulted for repair as needed.

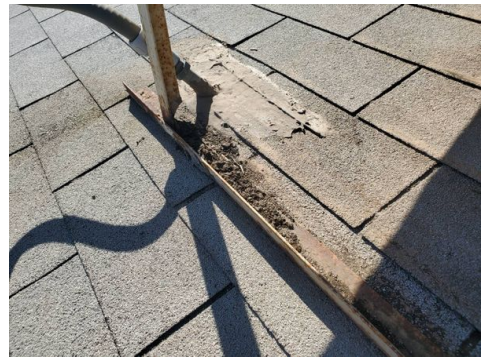
4.1.1 Roof Coverings **DEBRIS ON ROOF**

Dust/debris accumulation was observed on the roof. Debris accumulation can lead to limited drainage and water intrusion. I recommend debris be removed by a qualified professional/roofer.

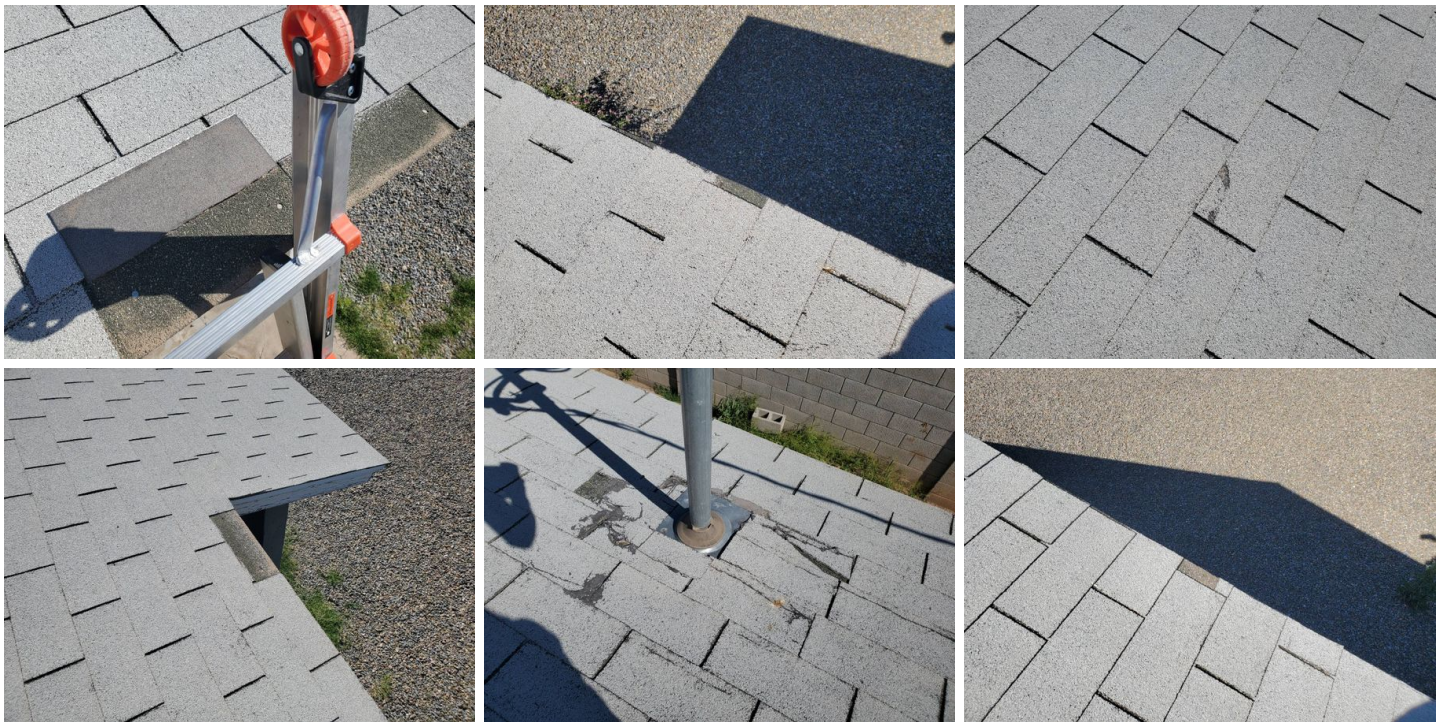
4.1.2 Roof Coverings **DAMAGED/WORN ASPHALT SHINGLES**

Physical damage/granule loss was observed at some of the asphalt shingles. Additionally, some shingles are loose/missing. I recommend consulting a qualified roof repair professional for service.

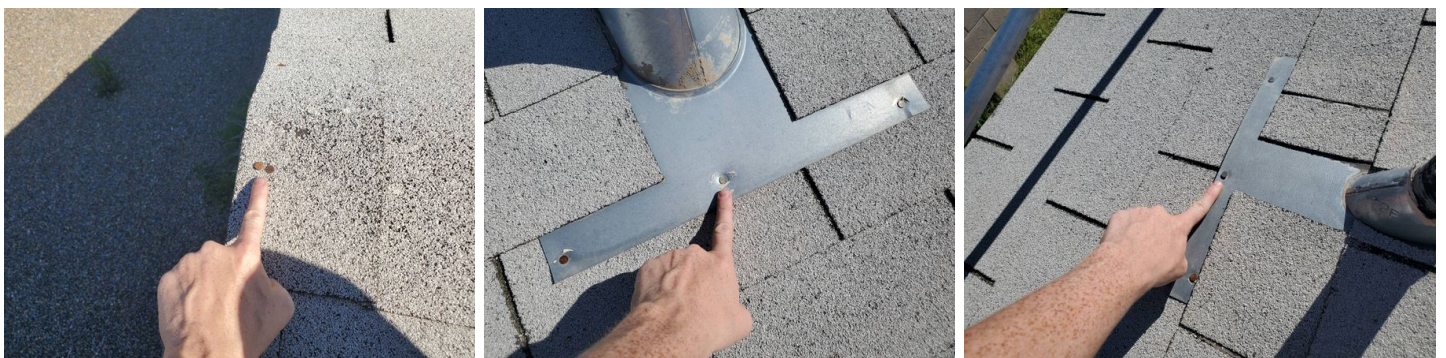
4.1.3 Roof Coverings **EXPOSED/UNSEALED FASTENERS**

Exposed/unsealed fasteners that penetrate the roof covering can (potentially) lead to water intrusion. I recommend having these fasteners sealed by a qualified roofer.

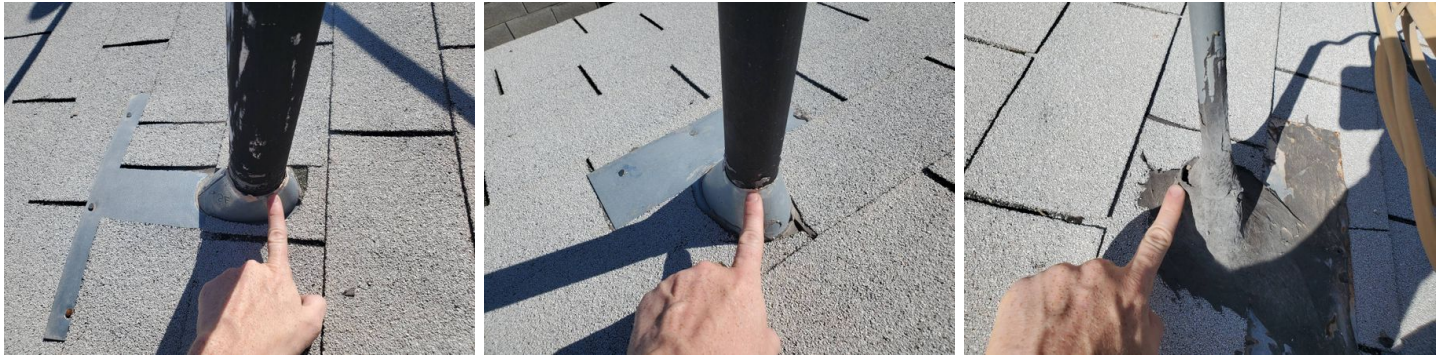
4.2.1 Flashings

CRACKED/OPEN COLLARS

Flashing collars are open/not fully sealed in some areas. This can lead to leaking into the attic. I recommend consulting qualified roof repair professional for service.

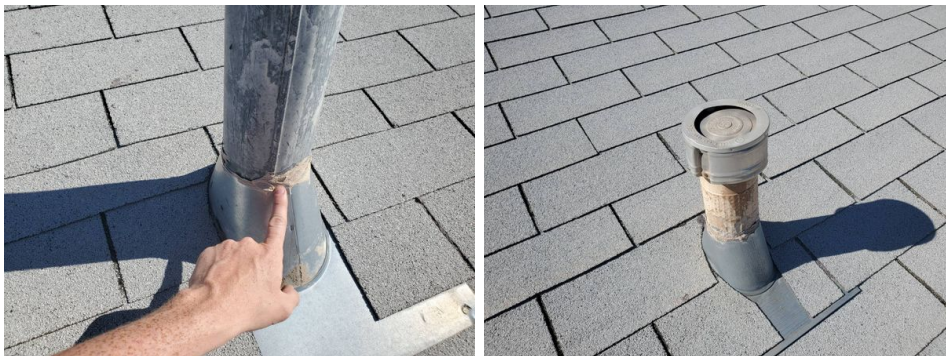
4.2.2 Flashings

MISSING B-VENT FLASHING COLLAR(S)

There are no flashing collar(s) installed for B-vent(s). Storm collars help maintain a watertight seal around the flashing opening. A licensed roofer should be consulted to assess/install collars.

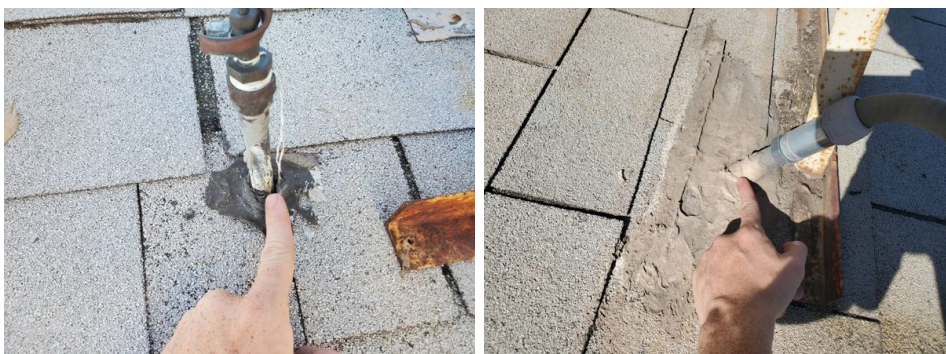
4.3.1 Skylights, Chimneys & Roof Penetrations

MISSING FLASHING

At least one roof penetration is not flashed. The penetration(s) are sealed only with roof cement. Roof cement is not considered to be a permanent water barrier. Permanent flashing should be installed where possible. I recommend consulting a qualified roofer to assess/install flashing if/where possible.

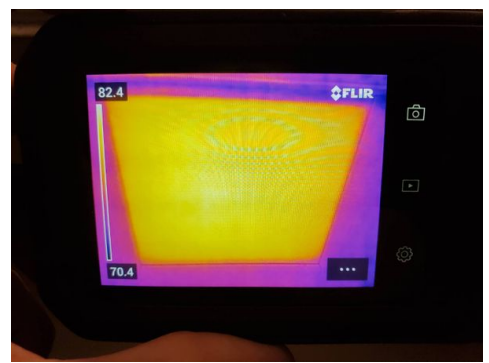
4.5.1 Attic Access

Insulation is missing or has been removed above the attic access. I recommend installing insulation to help with thermal efficiency in the room/area.

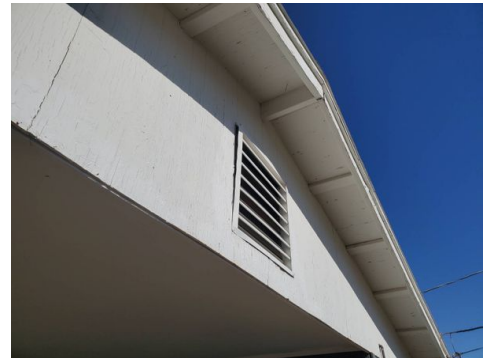
4.7.1 Roof/Attic Ventilation

LOOSE GABLE VENT

The attic gable vent is loose from the attachment to the exterior wall. I recommend consulting a licensed professional to re-secure.

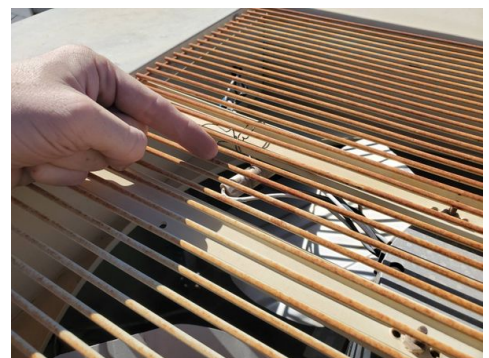
5.1.1 Central Cooling System(s)

Electrical conductors are partially exposed for the cooling system condenser fan. This is a fairly common condition that typically indicates the fan has been replaced. Electrical conductors that are continuously exposed to UV will break down (insulation will become brittle). I recommend consulting a licensed HVAC professional for service.

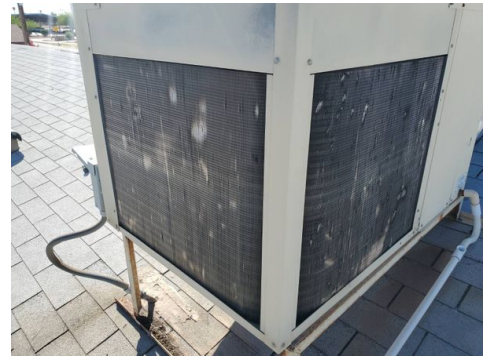
Some of the condenser fins are dented or damaged. These fins can sometimes be combed for added efficiency/performance. I recommend evaluation and service if needed by a qualified HVAC professional.

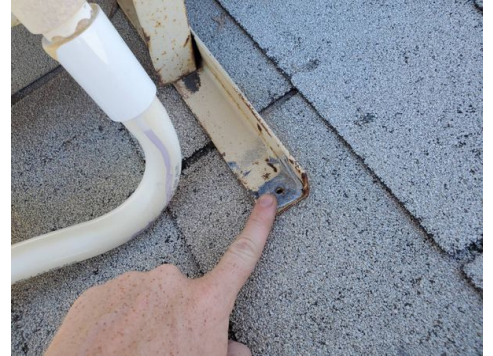
5.1.4 Central Cooling System(s)

MISSING MOUNTING BRACKET FASTENERS

Fasteners to secure the roof mounted heating and cooling unit bracket to the roof are missing. I recommend consulting a qualified contractor to add and replace hardware as necessary.

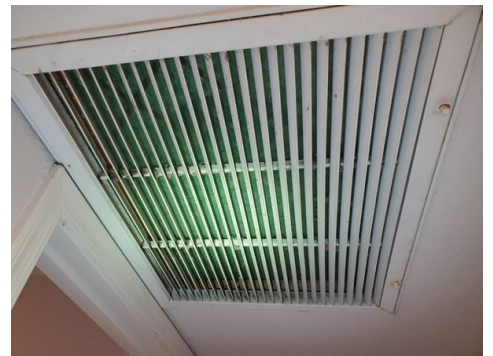
5.4.1 Distribution System

REPLACE FILTER(S)

The air filter(s) are dark/dirty and should be replaced so proper air flow may be established and to prevent dirt/dust accumulation within the system.

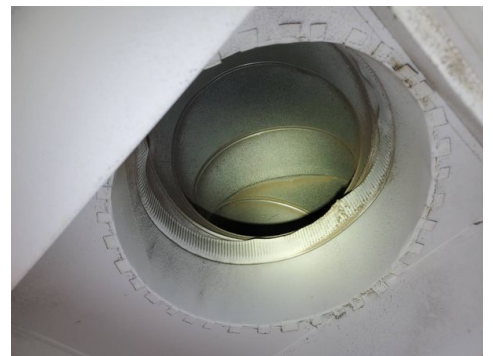
5.4.2 Distribution System

Dust accumulation was observed inside the AC return vent. This could indicate a need to have the distribution system cleaned. A qualified duct cleaning professional could be consulted for service.

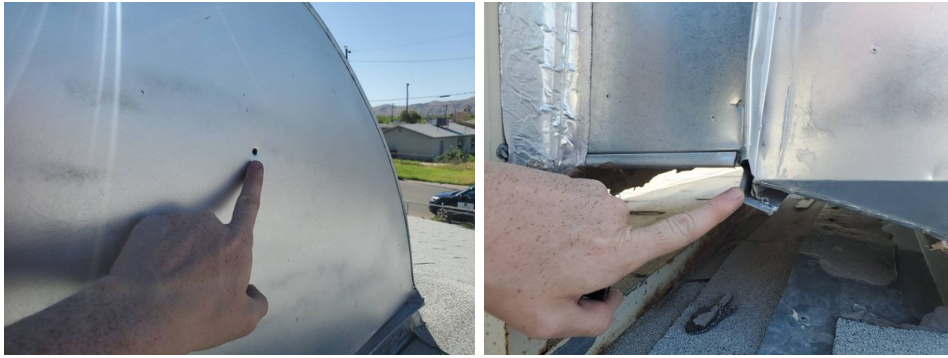
5.4.3 Distribution System

Openings have been created in the HVAC duct for test probes however, have not been resealed. I recommend re-sealing these openings.

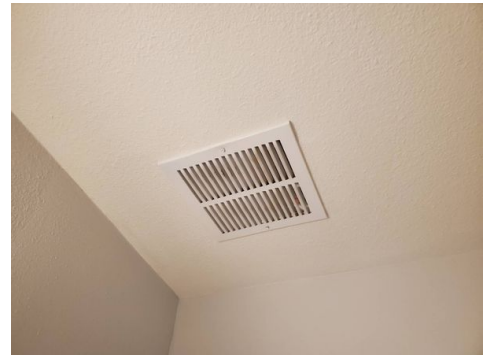
5.7.1 Interior Venting Systems (Fans)

The ventilation fan is or could be considered noisy while in use. The fan may be able to be serviced for quieter operation or may need to be replaced. A qualified professional/electrician can be consulted for service.

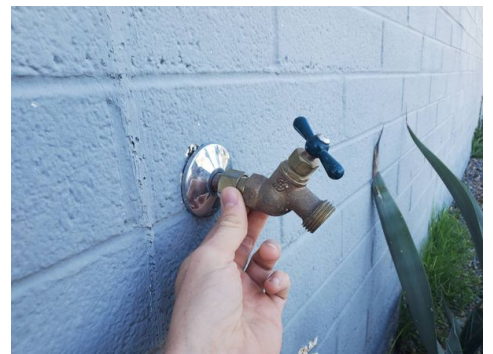
6.1.1 Water Supply & Distribution System

LOOSE DISTRIBUTION PIPING

Plumbing distribution piping is loose/not secured. Distribution piping should remain secured to prevent movement and loosening of connections. A qualified professional/plumber can be consulted for service.

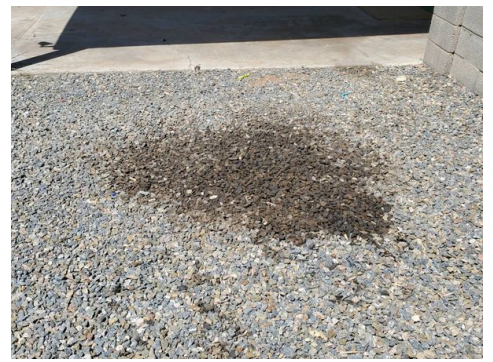
Soil in the front yard was saturated with moisture. This can sometimes indicate an underground plumbing leak. I recommend observing prior to close to ensure this location remains dry and consulting a qualified plumber for service if moisture still remains.

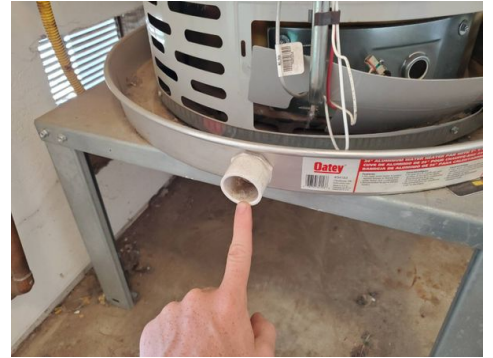
6.4.1 Hot Water Systems

The drip pan for the water heater is not plumbed to the exterior, a floor drain or similar location. Water could still be allowed to damage nearby finish material in the event of a leak. A qualified plumber should be consulted to plumb the pan to a suitable location.

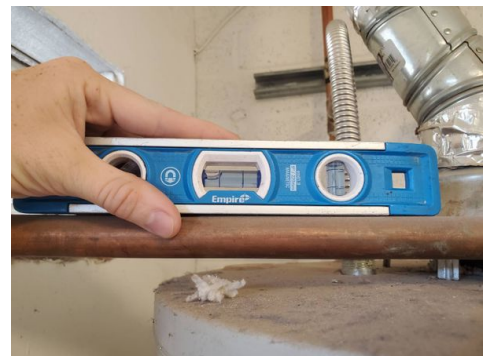
6.4.2 Hot Water Systems

A length of the water heater temperature/pressure relief valve discharge pipe slopes uphill. This pipe is required to slope in a manner in which all water can drain with gravity. Water held against the valve could lead to calcification and/or corrosion which could render the valve inoperable. I recommend consulting a licensed plumber to correct the condition.

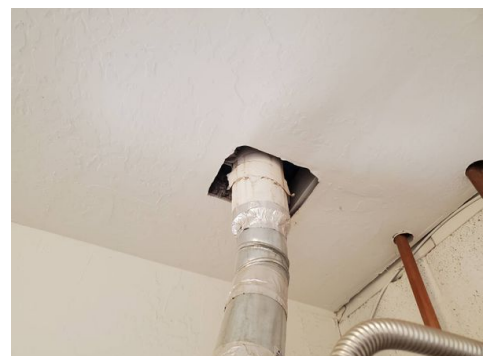
A length of the water heater flue appears as though it may be transite pipe. Transite was commonly installed when this home was built and sometimes contains asbestos. This material can be tested for asbestos as needed by a qualified asbestos/abatement professional.

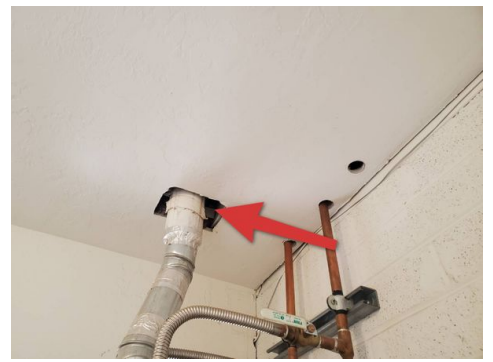
It appears there is no insulation shield installed around the water heater gas vent in the attic. An insulation shield would typically be installed to provide clearance from attic insulation. I recommend consulting a licensed plumber to install an insulation shield as necessary.

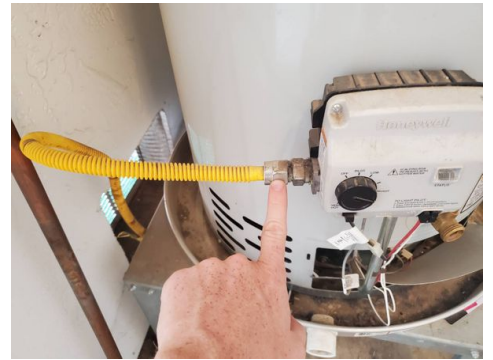
6.5.1 Fuel Storage & Distribution Systems
NO SEDIMENT TRAP

There is no sediment trap installed for the gas fired water heater. Sediment traps can typically help to prolong the serviceable gas equipment. A plumber should be consulted to install a sediment trap.

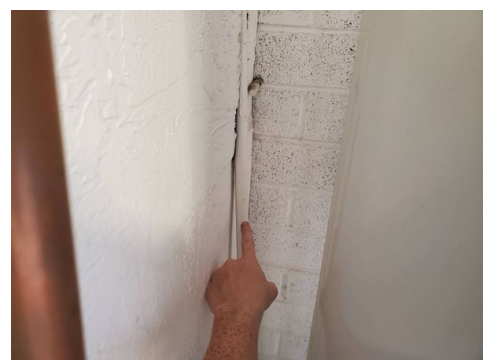
6.5.2 Fuel Storage & Distribution Systems
LOOSE GAS PIPING

Water heater gas distribution piping is loose and should be further secured. A qualified plumber can be consulted for service.

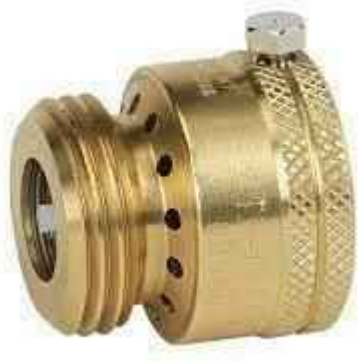
A connected hose without a vacuum breaker may draw contaminated water into the clean/potable water supply. I recommend installing vacuum breakers where missing/before connecting hoses.

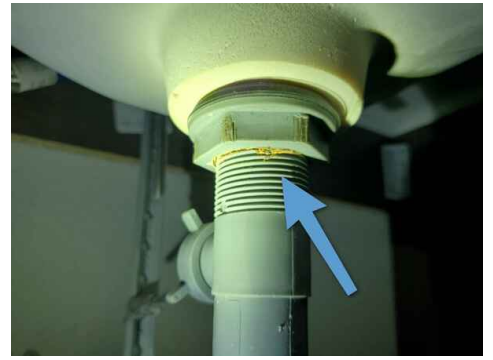
6.8.1 Sinks & Faucets
EVIDENCE OF LEAKING

Evidence of leaking was observed. It is not evident that these leaks were serviced or repaired. Minor leaking can sometimes self seal however sinks should still be serviced/fittings should be tightened to prevent future leaking.

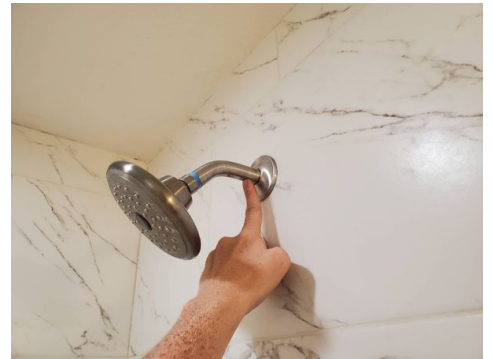
6.9.1 Bathtubs & Showers
LOOSE SHOWER ARM

The shower arm is loose at the attachment within the wall and should be secured to prevent movement/loosening. A qualified professional/plumber can be consulted for service.

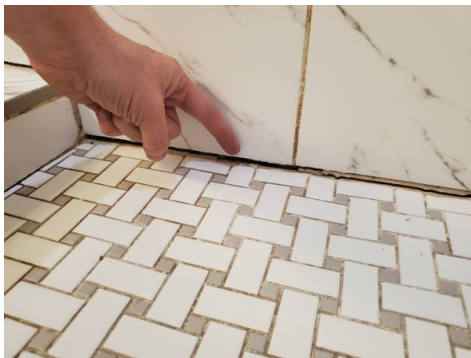
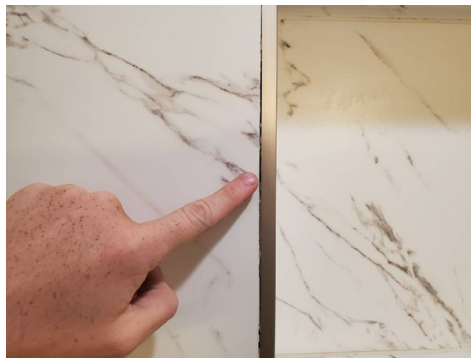
Cracked and missing grout was observed. I recommend resealing as and when necessary to help prevent moisture intrusion behind tile.

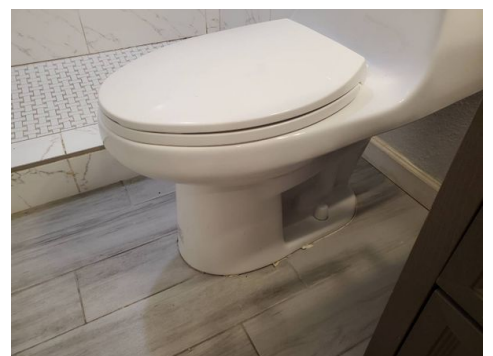
6.10.1 Toilets
LOOSE TOILET

The toilet is loose/able to be rocked or shifted. Toilets should remain tightly secured to floors to avoid displacement of the seal. I recommend consulting a licensed plumber for service.

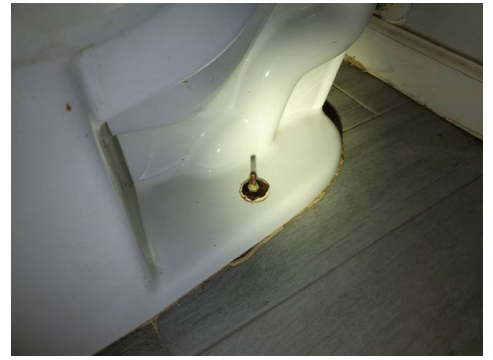
6.10.2 Toilets

RUSTY CLOSET BOLTS (LEAKING SEALS)

The toilet closet bolts appear rusted. Rust at closet bolts could indicate a compromise and the wax seal resulting in leaking. I recommend consulting a licensed plumber for service.

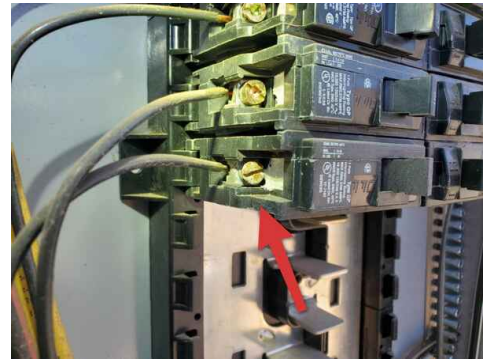
7.3.1 Branch Circuit Conductors & Over-Current Devices

RUST ON TERMINALS

Rust was observed at circuit breaker terminals. Rust could lead to a loose/weak electrical connection which could result in excessive heat/resistance. I recommend consulting a licensed electrician to review/service.

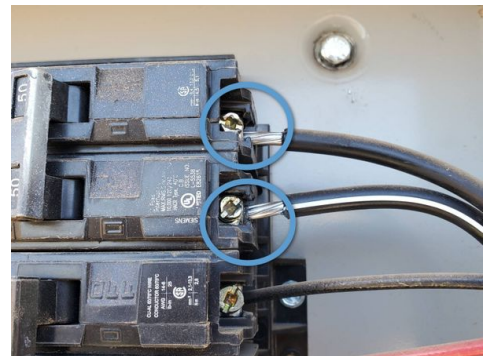
7.3.2 Branch Circuit Conductors & Over-Current Devices

Electrical conductor insulation was excessively trimmed at the circuit breaker termination. Circuit breakers (manufacturers) typically recommend a specific amount of insulation be removed prior to termination. A licensed electrician should be consulted for service/correction.

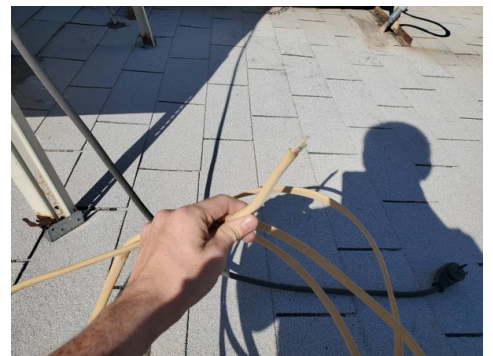
7.4.1 Conduit & Wiring

Exposed electrical wiring/wiring that is not connected to electrical devices was observed. This is a safety concern as exposed wiring can lead to accidental shock/injury. Recommend service/correction by a licensed electrician.

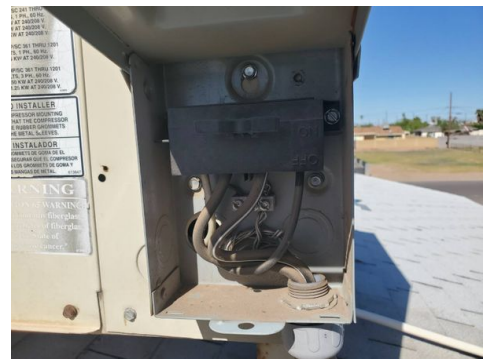
7.5.1 Service Disconnects

MISSING EXTERIOR COVER

The exterior cover is missing for the air conditioner service disconnect. I recommend consulting a qualified electrician to replace the cover or the entire disconnect if necessary.
