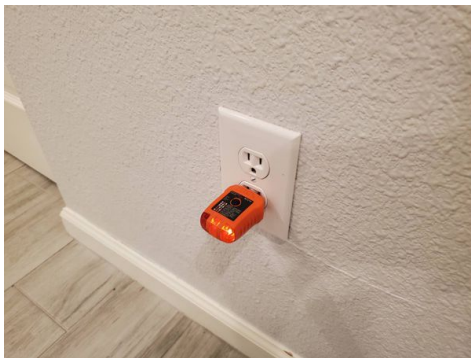
Some of the receptacles are loose and easily moved within their enclosures or enclosures are loose in walls. I recommend securing where needed. An electrician can be consulted for service.

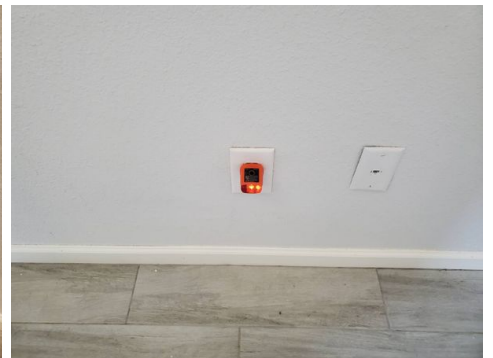
7.6.1 Receptacles & GFCI Devices

LOOSE RECEPTACLE(S)

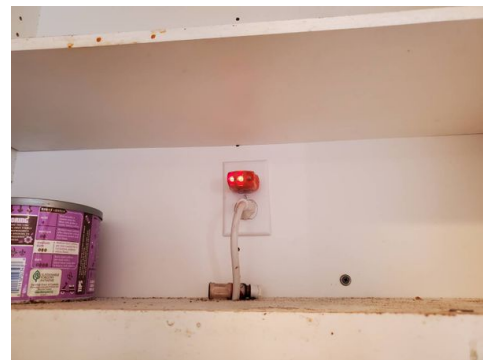
7.6.2 Receptacles & GFCI Devices

Receptacles are wired with reversed polarity (the hot and neutral conductors are reversed). I recommend consulting a qualified electrician to correct the wiring.

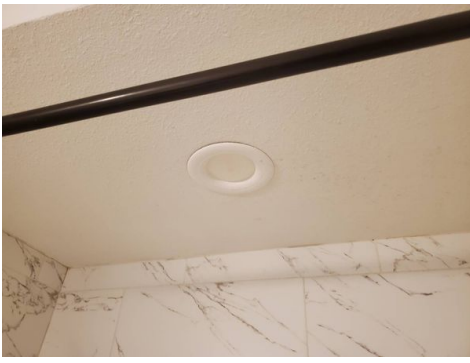
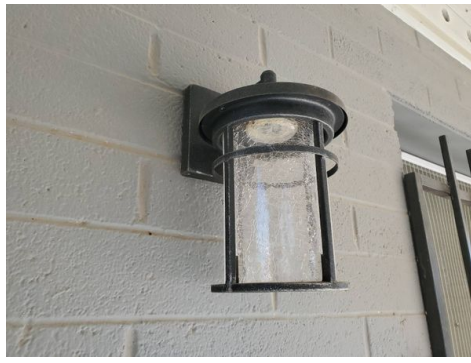
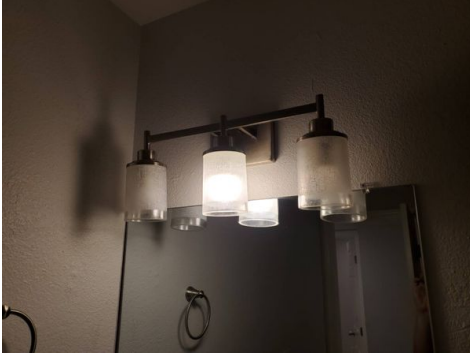
Some of the lights did not respond when tested. I recommend requesting all missing and burnt-out bulbs be replaced so lights may be retested at final walk-through.

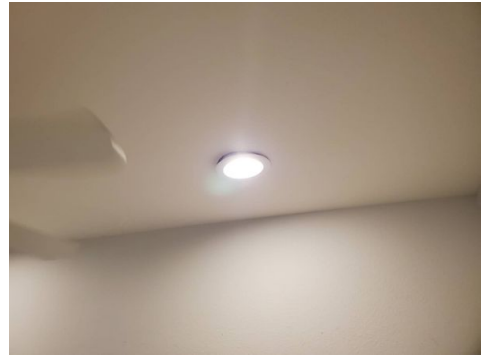
LOOSE RECESSED LIGHT

The recessed light is loose/not flush with the ceiling. A qualified handy person or electrician to be consulted to secure as needed.

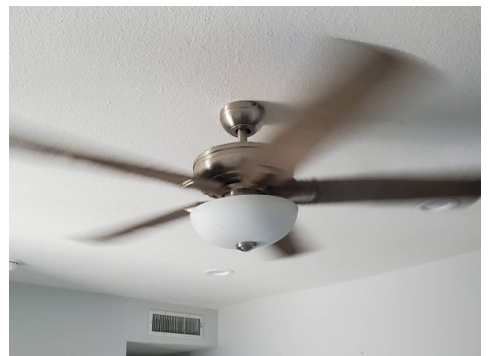
7.7.3 Light Fixtures, Ceiling fans and Switches

The ceiling fan light did not respond to the wall switch, and there are no chains installed. It appears as though a remote is needed to operate the fan and light. I recommend inquiry with the seller regarding the availability of a remote and testing within the inspection period if needed.

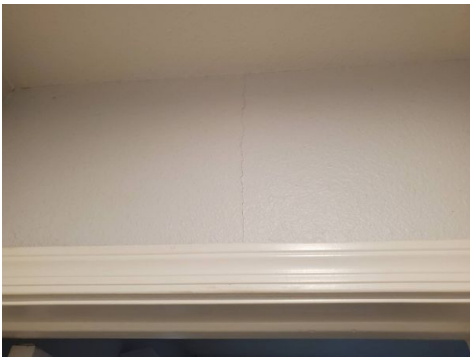
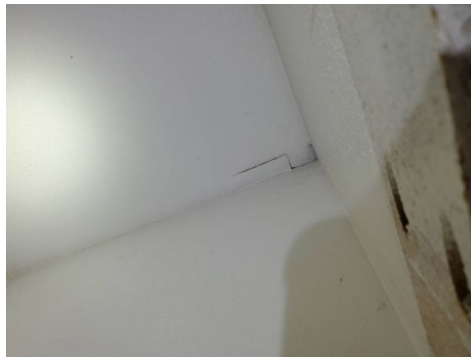
Interior drywall cracks and/or separated tape seams were observed. Drywall can crack for various reasons including settling/movement and curing of framing. A drywall repair professional can be consulted for service.

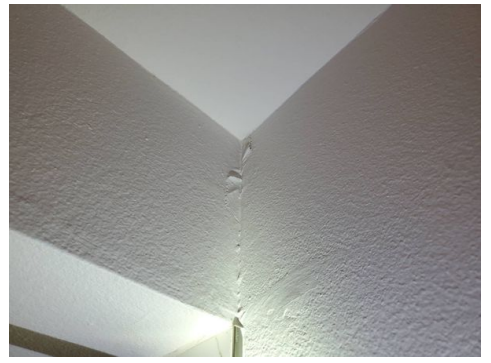
8.1.1 Walls & Ceilings

DRYWALL CRACKS/TAPE SEAMS

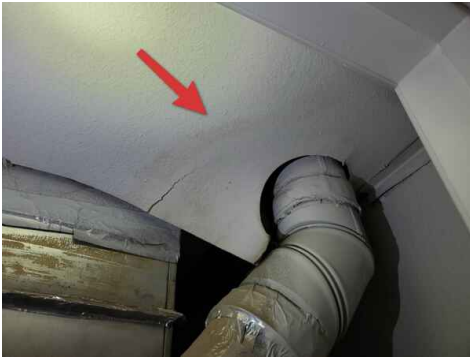
WATER STAINS (POTENTIAL ROOF LEAKS)

Water stains and/or discoloration was observed at the drywall ceiling in some areas. I recommend inquiry with the seller regarding leak history. Observed conditions on the roof that could lead to leaking have been documented. A roofer should be consulted to review above. A drywall repair professional or similar can be consulted for service in the room.

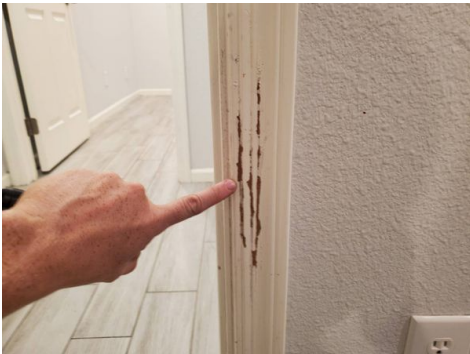
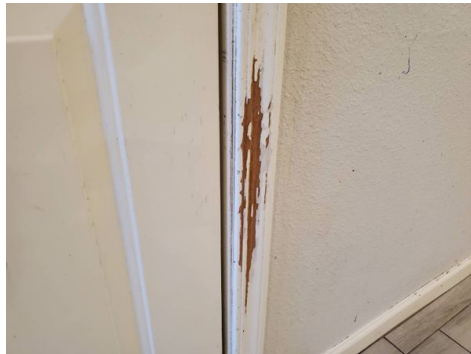
POSSIBLE PET DAMAGE

Possible pet damage/scraped and scratched paint, wood and/or drywall was observed.

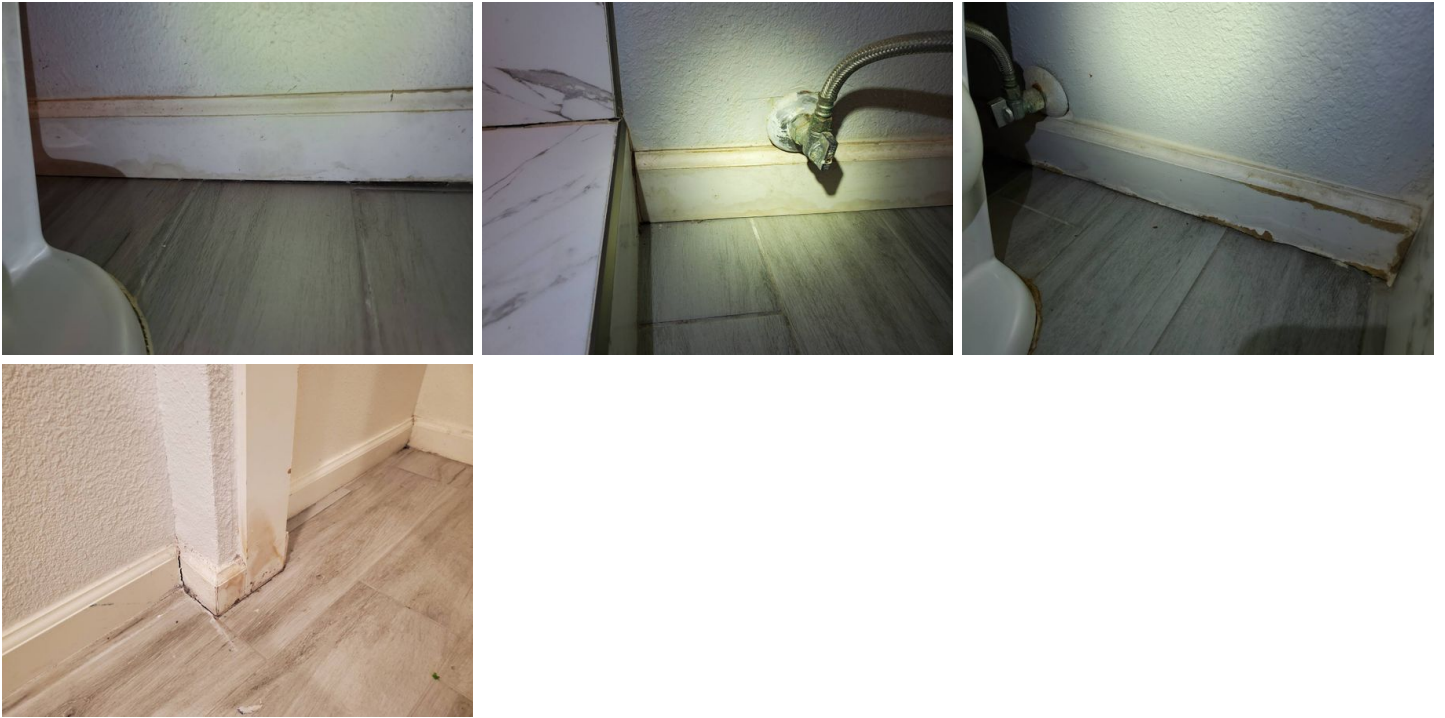
BASEBOARD WATER DAMAGE

Water stained/damaged baseboards observed. No elevated moisture was detected at the time of the inspection. I recommend baseboards be replaced as needed by a qualified interior finish professional.

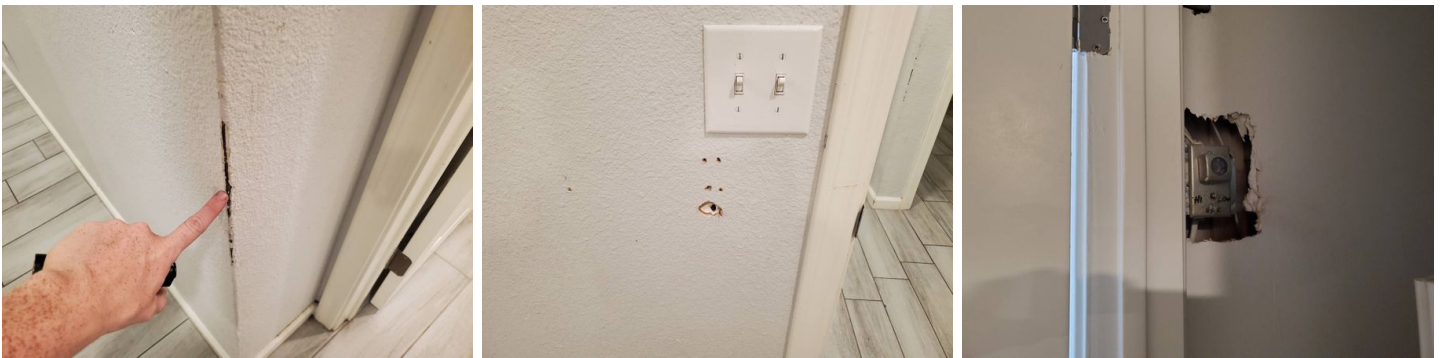
8.1.5 Walls & Ceilings

DAMAGED/OPEN DRYWALL

Damaged, dented, and/or open drywall was observed. A drywall repair professional can be consulted for service.

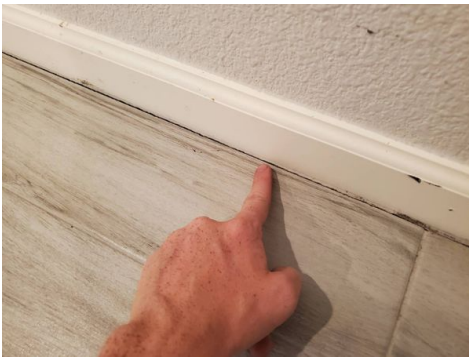
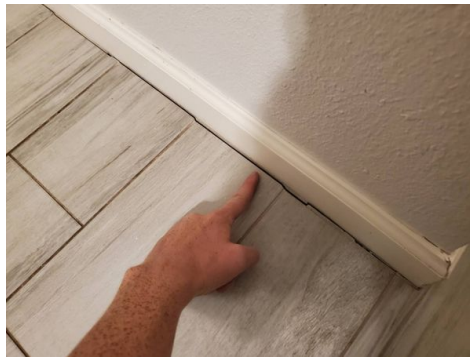
Areas of cracked and/or missing tile floor grout were observed. A tile flooring professional can be consulted to reapply grout or caulk where missing.

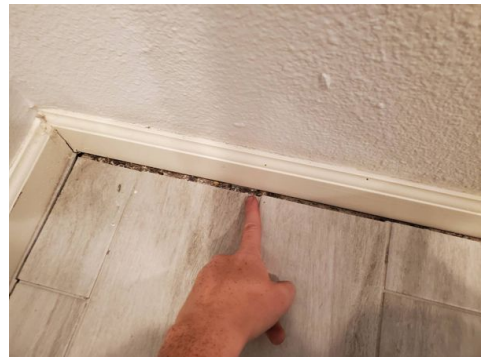
8.2.1 Floors

CRACKED/MISSING GROUT

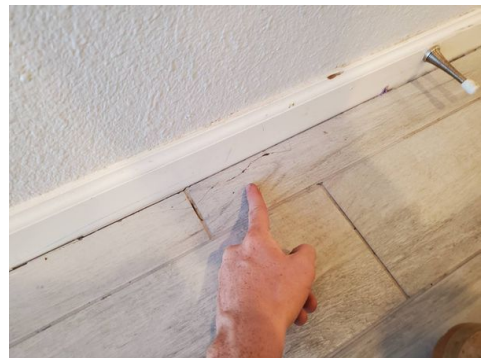
8.2.2 Floors

CRACKED/CHIPPED TILE

Cracked and chipped interior floor tile observed. Floor tile can sometimes be serviced/repaired. A tile floor repair and installation professional can be consulted for service

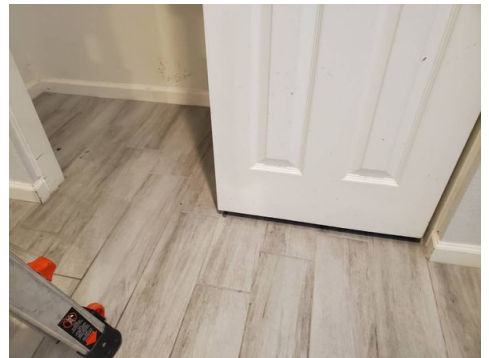
8.3.1 Interior Doors & Closets

There are no closet door floor guides installed. Floor guides will help prevent the sliding doors from moving back and forth and potentially coming out of the track. A qualified door repair professional could be consulted to install if needed.

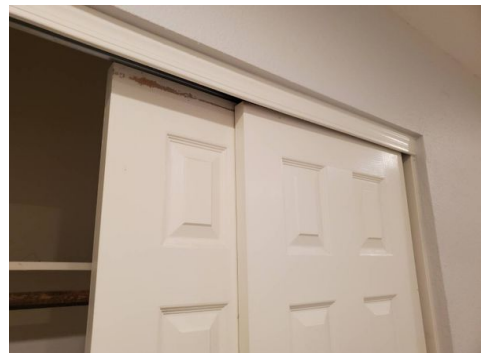
8.3.2 Interior Doors & Closets

Sliding closet doors could be considered difficult to open and close. I recommend service if needed by a qualified handy person or door technician.

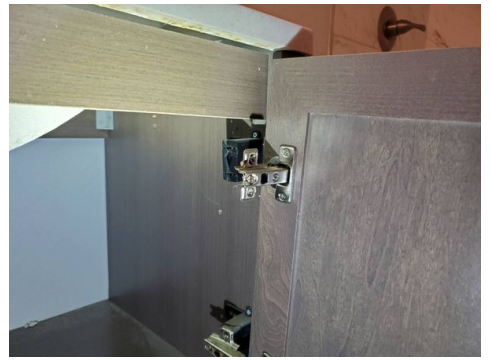
8.4.1 Countertops & Cabinets

LOOSE HINGE(S)

Loose/damaged cabinet door hinge(s) were observed. Some hardware may be able to be tightened while hardware in other areas may require replacement.

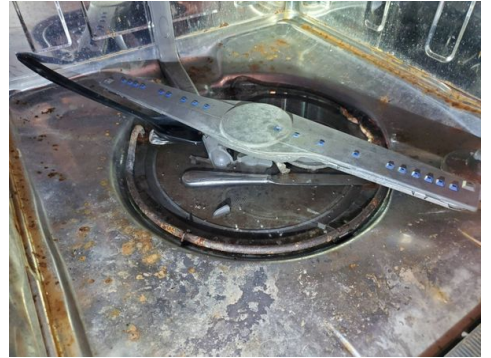
9.1.1 Dishwasher

Standing water was present in the dishwasher at the time of the inspection. I recommend evaluation and service (or replacement if needed) by a qualified appliance repair professional.

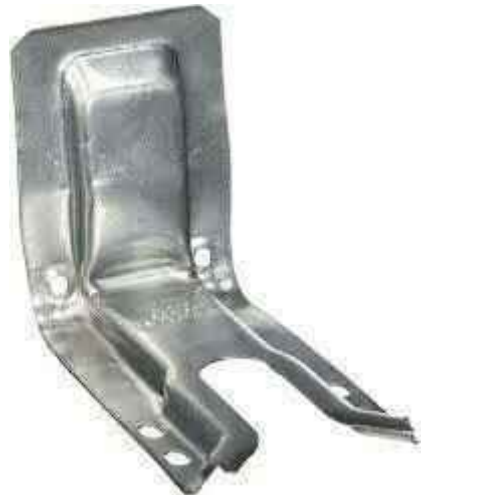
9.3.1 Range/Oven and Cooktop

MISSING ANTI-TIP DEVICE

There is no anti-tip device installed to secure the oven to the floor. This is a potential safety concern. I recommend consulting a qualified professional to install anti-tip device.

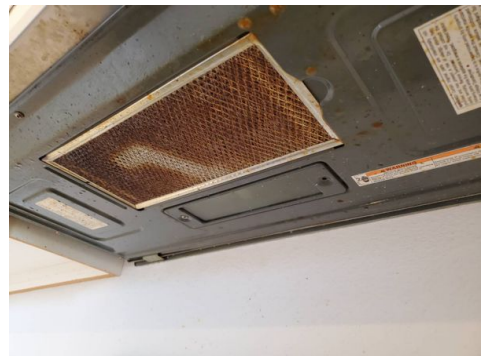
9.5.1 Built-in Microwave

The microwave light was not functional/did not respond when tested.

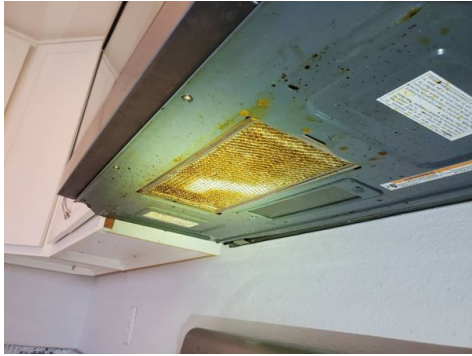
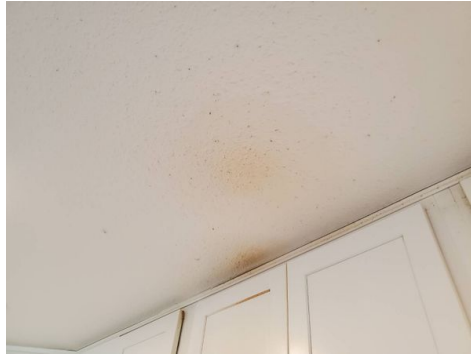
9.5.2 Built-in Microwave
DIRTY GREASE FILTER

The microwave grease filter is noticeably dirty. Additionally, grease stains were observed at the drywall ceiling above the microwave vent. I recommend cleaning or replacing the grease filter.
