RESIDENTIAL HOME INSPECTION REPORT

532 N Hassayampa Dr
Prescott, AZ 86303

MARCH 1, 2024

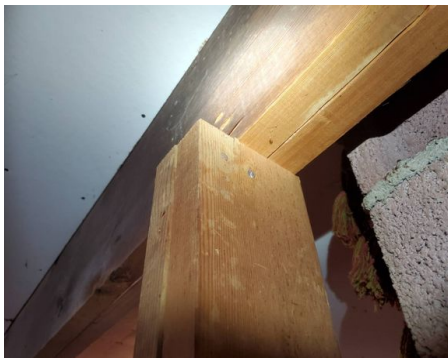
Columns & Beams : Toenailed connections

Some of the connections between columns and beams are toenailed. The installation of metal straps or similar components is typically preferred. A licensed contractor can be consulted to add hardware as needed.

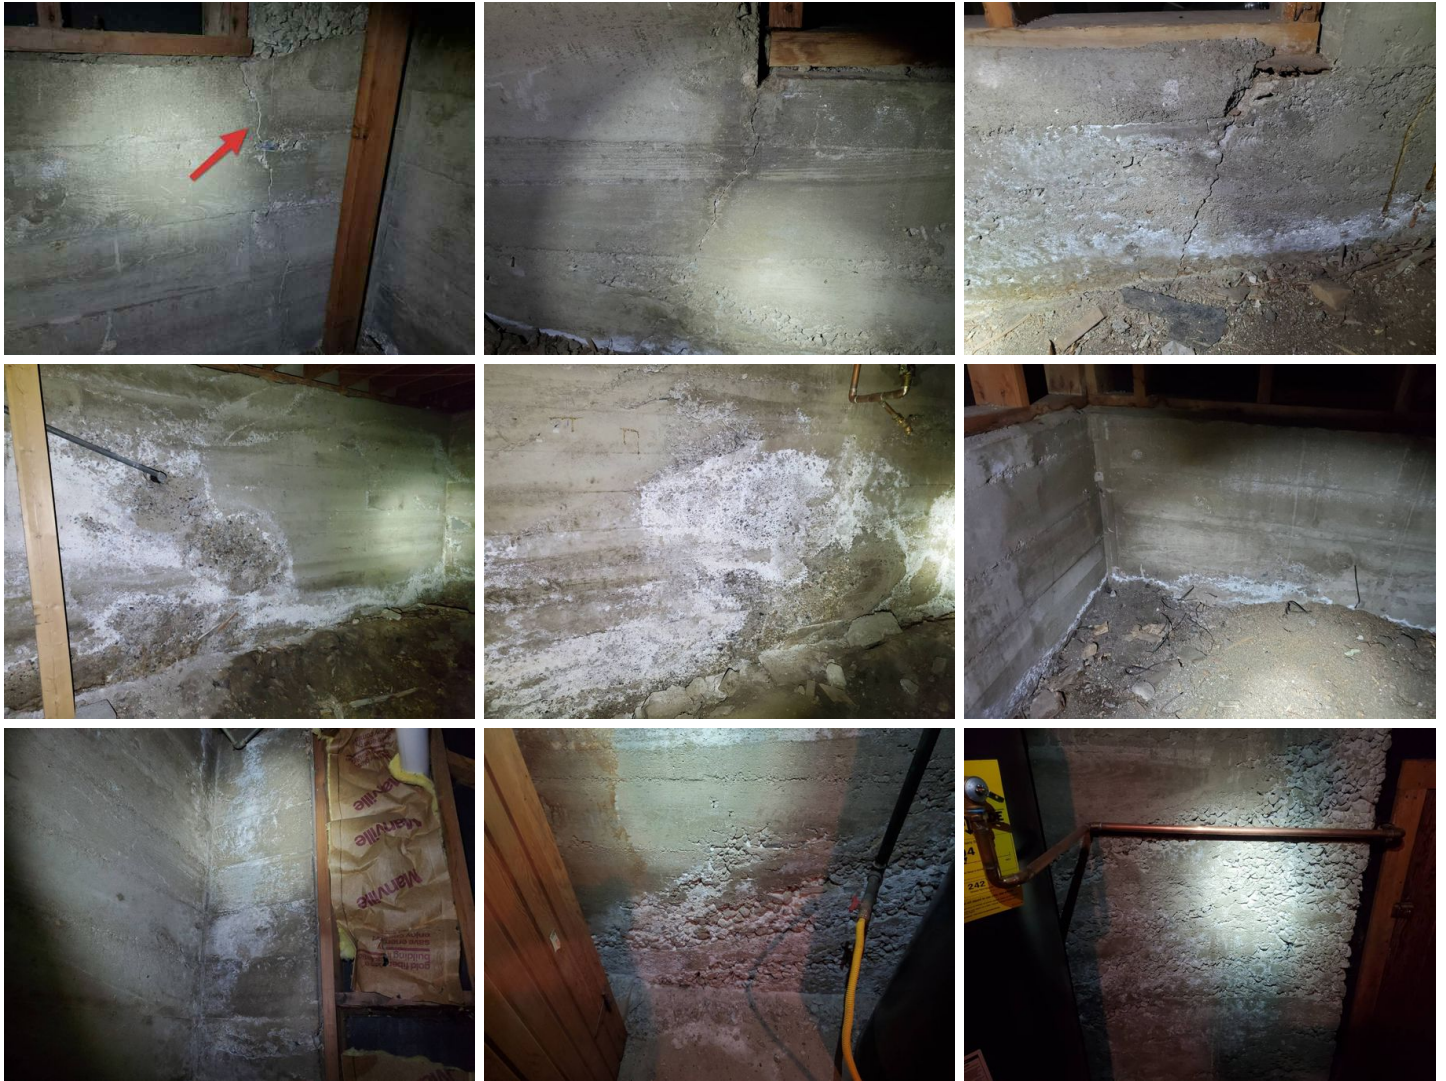
2.1.1 Foundation

FOUNDATION CONDITIONS

Conditions observed at exposed foundation concrete walls included: Vertical fractures with a varying degree of separation, exposed aggregate (Missing finish coat), and efflorescence/water stains. Soil was also damp near some sections of the foundation walls inside the basement. Cracks can indicate a degree of settlement and could allow for water intrusion. Additionally, efflorescence/water stains can indicate improper site drainage. I recommend consulting a licensed foundation/concrete repair professional for service. Additionally, I recommend correcting grading/drainage conditions around the home where necessary.

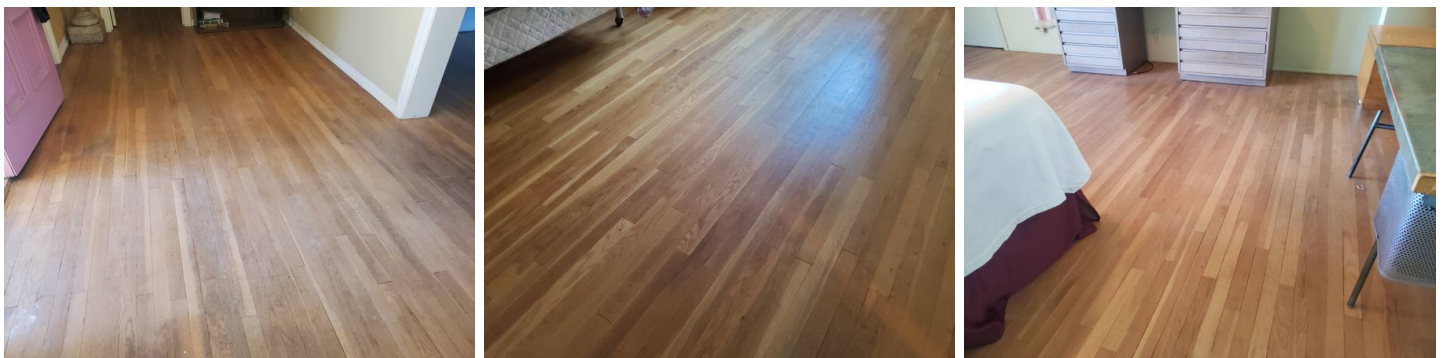
2.2.1 Floor Structure

Squeaking or popping sounds can be felt while walking on some second-story floor areas. Fasteners and framing can often be secured to remedy the condition. A licensed contractor can be consulted for service as needed.

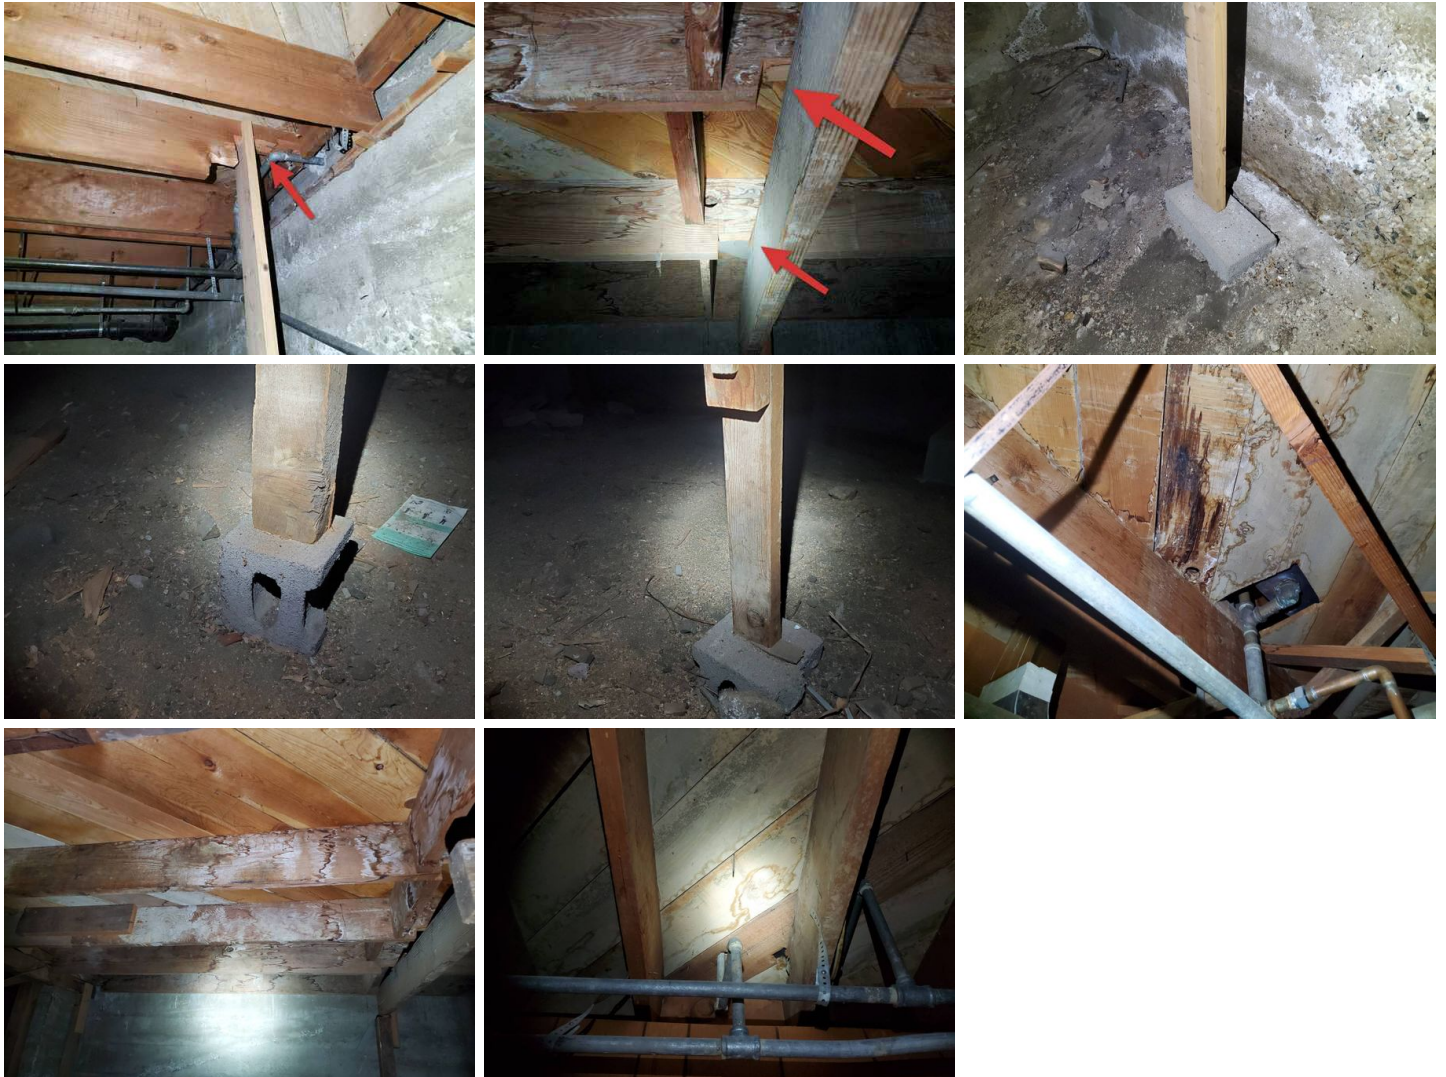
2.2.2 Floor Structure

FLOOR FRAMING CONDITIONS

Basement floor joists are excessively/improperly cut/notched in some areas. Furthermore, water stained/damaged floor joists/subflooring was observed. Lastly, some joists are supported by wooden posts which do not have a concrete footing installed/are resting on concrete blocks. I recommend consulting a licensed contractor to further assess/provide service options.

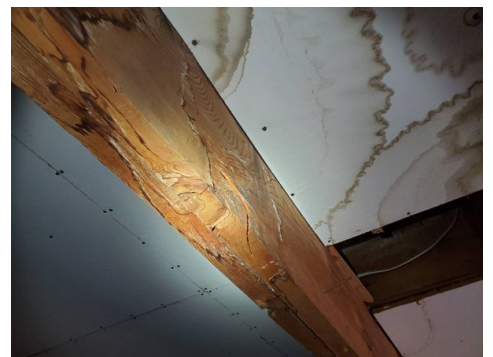
2.5.1 Columns & Beams

CRACKED BEAM

Water stains as well as cracking of a downstairs beam was observed. No major damage was detected. A licensed contractor can be consulted to further assess.

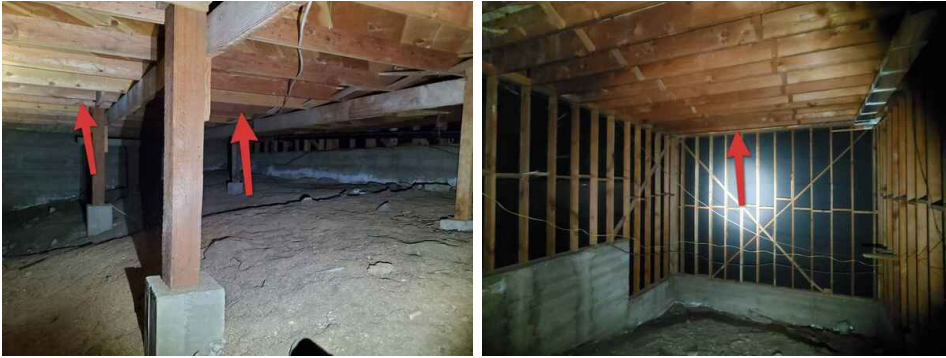
2.7.1 Basement/Crawlspace

MISSING FLOOR INSULATION

Underfloor insulation and vapor barrier material is missing in some areas in the crawlspace/basement. I recommend installation of insulation/vapor barrier where missing by a qualified insulation installation professional.

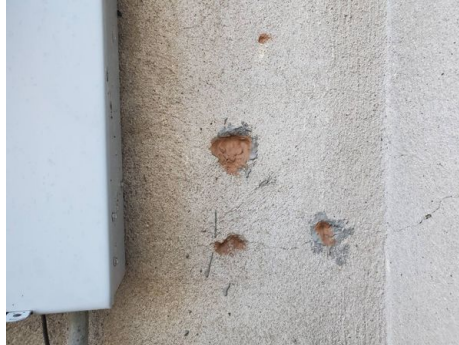
Stucco repairs or patched areas
are visible in some locations.

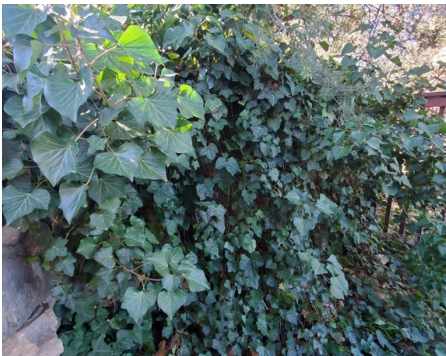
Vegetation, Grading, Drainage & Retaining Walls: Limited retaining wall visibility

Visibility of the condition of the front yard retaining wall is limited due to vegetation growth.

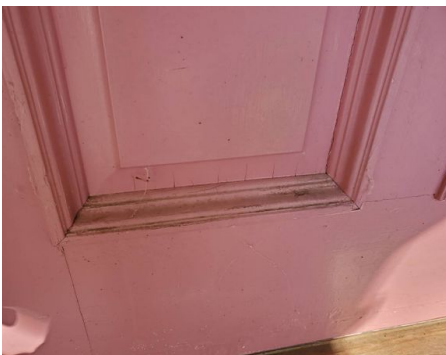
Exterior Entry Doors: Cosmetic conditions

Cosmetic conditions such as small dents, chipped/flaking paint, cracks and chipped wood were observed. These conditions did not affect the performance or serviceability of the door(s) when observed and tested.

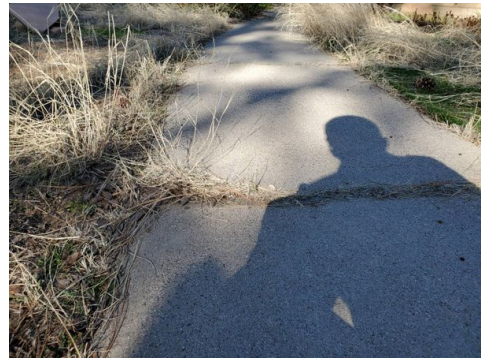
The uneven walkway/transition *could* be a trip concern. I recommend caution when walking in the area. A qualified hardscape repair professional could be consulted for service if needed.

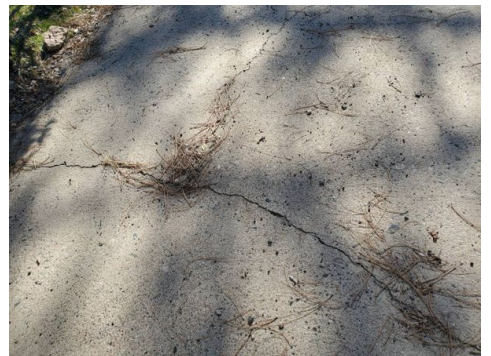
**CRACKED/CHIPPED
DRIVEWAY**

Cracked and chipped concrete was observed at the driveway. The condition could worsen with water penetration. A concrete repair professional can be consulted for service/to seal as needed.

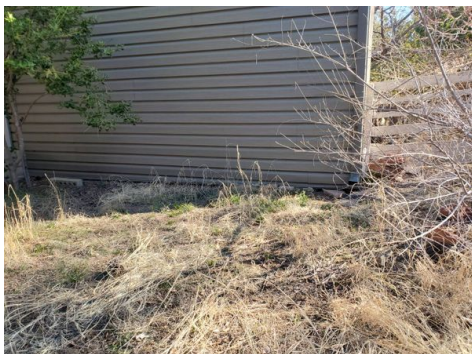
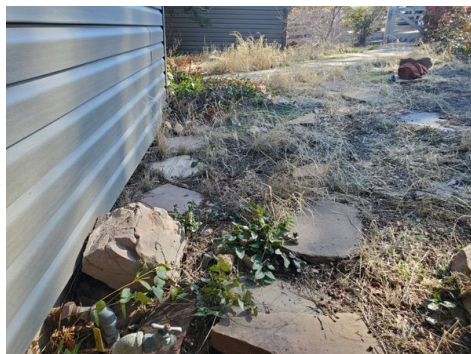
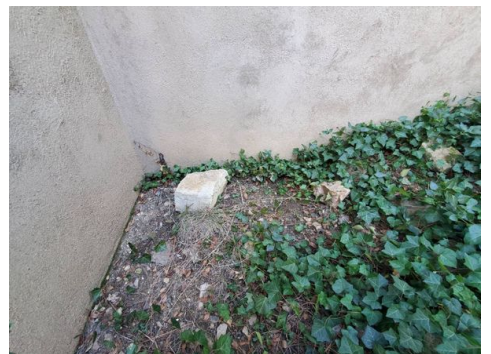
IMPROPER GRADE/SLOPE

Exterior grade is flat and/or negatively sloped in some areas. A slope of approximately **1 inch per foot away** from the foundation is recommended for at least the first few feet so that proper drainage can be maintained. I recommend grading conditions be corrected where necessary by a qualified grading or landscape professional.

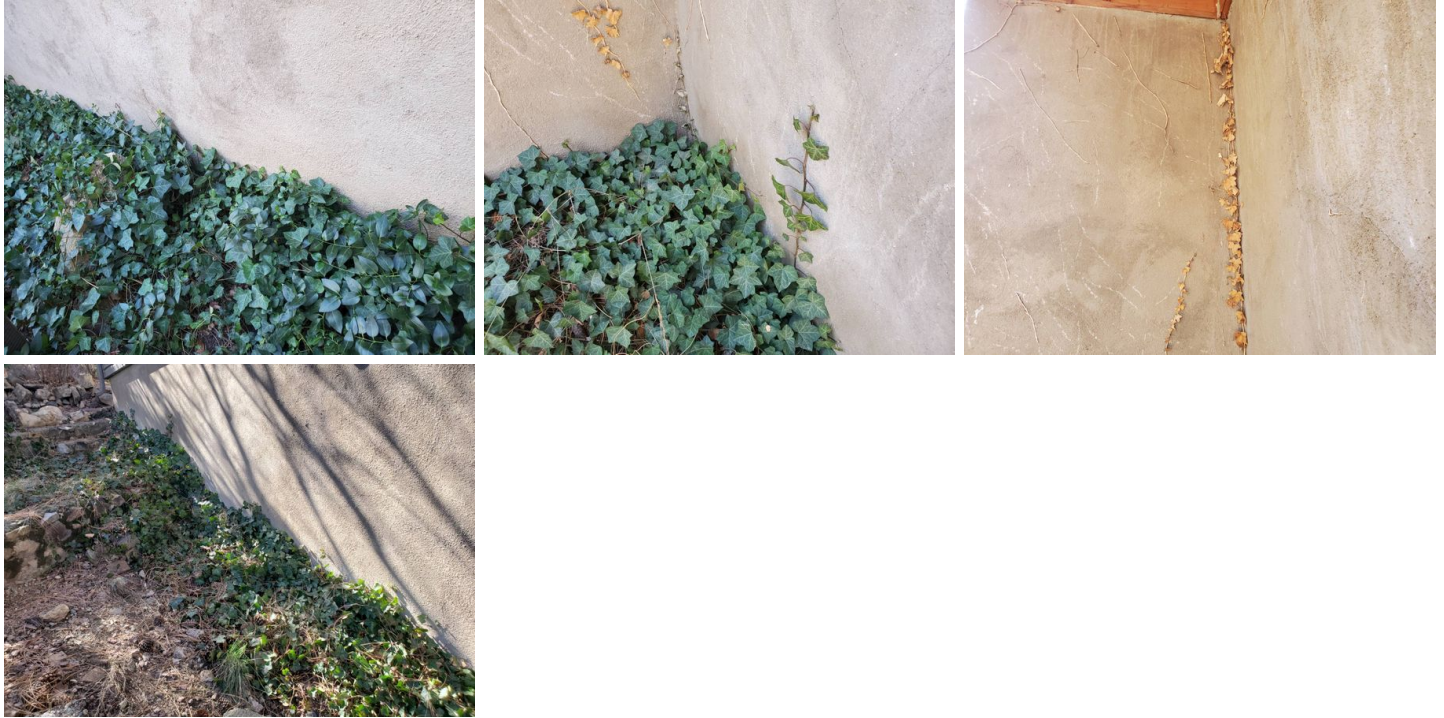
Vegetation is contacting and obstructing visibility of exterior walls in some areas. It is recommended that vegetation be trimmed away from exterior walls so that visibility may be maintained as well as to limit exterior siding/paint damage and moisture issues. I recommend trimming or removing where necessary.

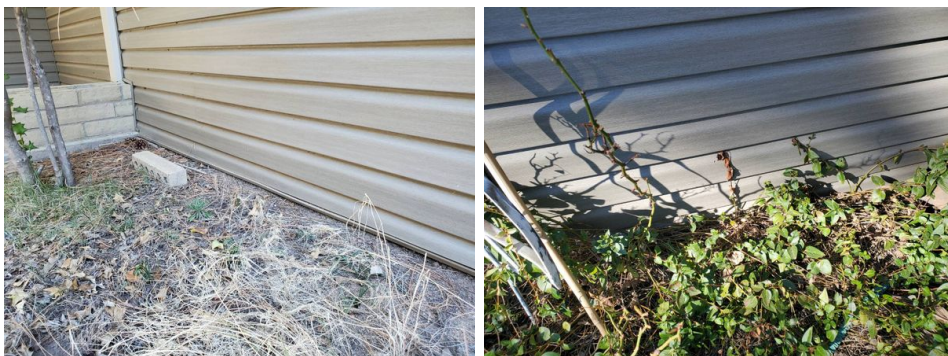
Exterior grade is high and contacting exterior siding and/or covering the foundation in some areas. It is important that grade not contact siding to prevent water damage, to help prevent pest intrusion as well as to monitor foundation conditions. I recommend grade be lowered where necessary leaving an appropriate slope away from the foundation (at least 1 inch per foot for the first few feet). A landscape or grading professional should be contacted for service if needed.

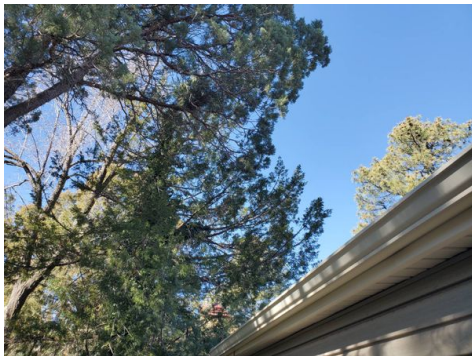
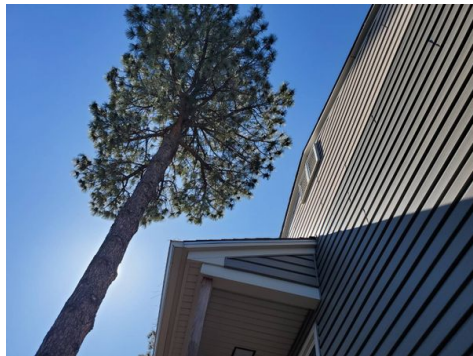
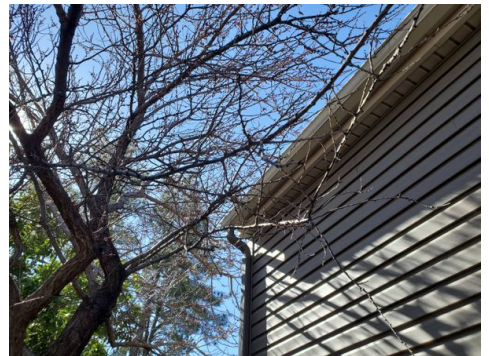
TREE(S) OVERHANGING ROOF

Tree(s) contacting and/or overhanging a roof can lead to roof covering damage, vegetation accumulation on the roof and limited drainage. I recommend trimming as necessary. A licensed arborist can be consulted for service for larger trees.

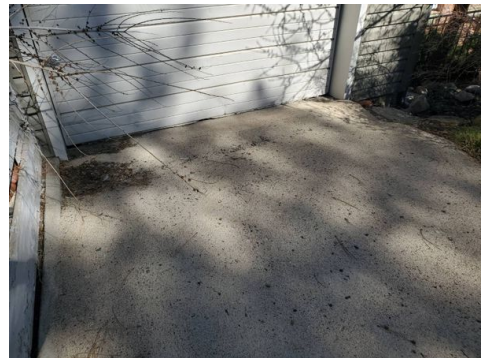
IMPROPER HARDSCAPE SLOPE

Hardscape materials are flat or negatively sloped toward the garage, however a raised area of the hardscape is present in front of the garage door to limit water entry. I recommend monitoring water drainage in this area to ensure it adequately drains away from the garage. I recommend consulting a licensed contractor/hardscape professional for service/correction if necessary.

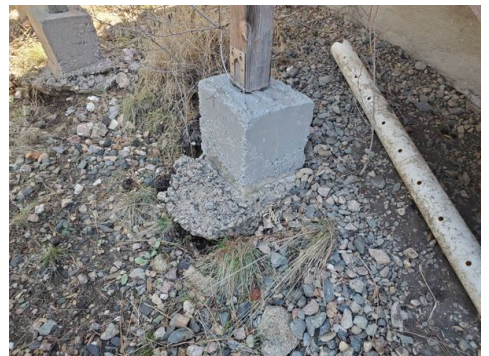
ERODED SOIL (BELOW FOOTINGS)

Soil is has eroded and/or is missing below the staircase pier footings. This could lead to breaking of the concrete/settling. I recommend having soil replaced where it is low and missing.

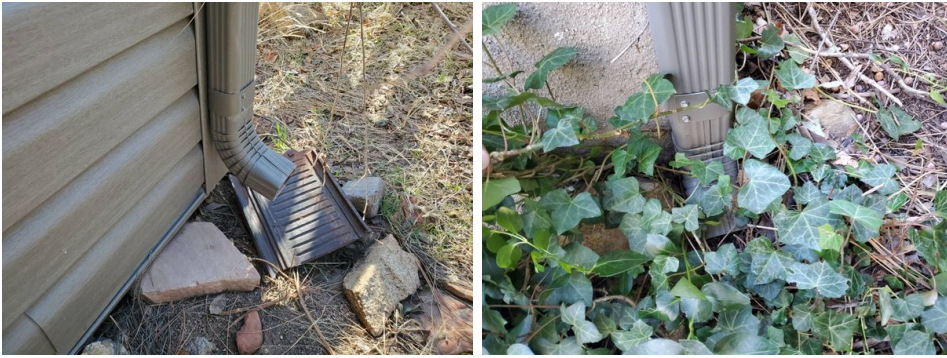
Gutter downspout(s) terminate next to the structure. It is recommended gutters discharge a few feet away from the structure. A qualified professional can be consulted to extend downspouts where needed.

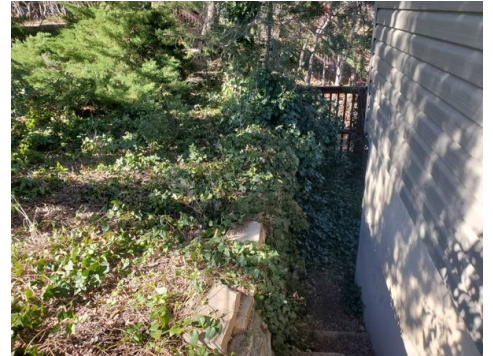
3.2.8 Vegetation, Grading, Drainage & Retaining Walls

A guard rail has not been installed around the front yard retaining wall. A guard rail should be installed to limit falling hazards.

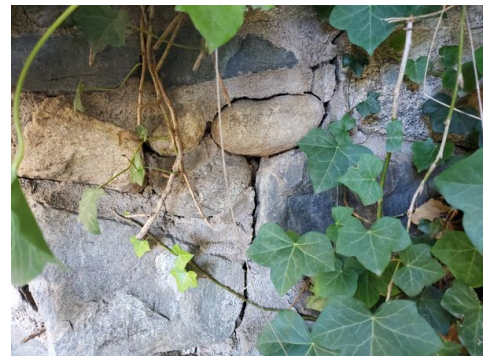
3.2.9 Vegetation, Grading, Drainage & Retaining Walls

Cracks in mortar were observed at the visible sections of the front yard retaining wall. I recommend consulting a licensed professional to further evaluate/service.

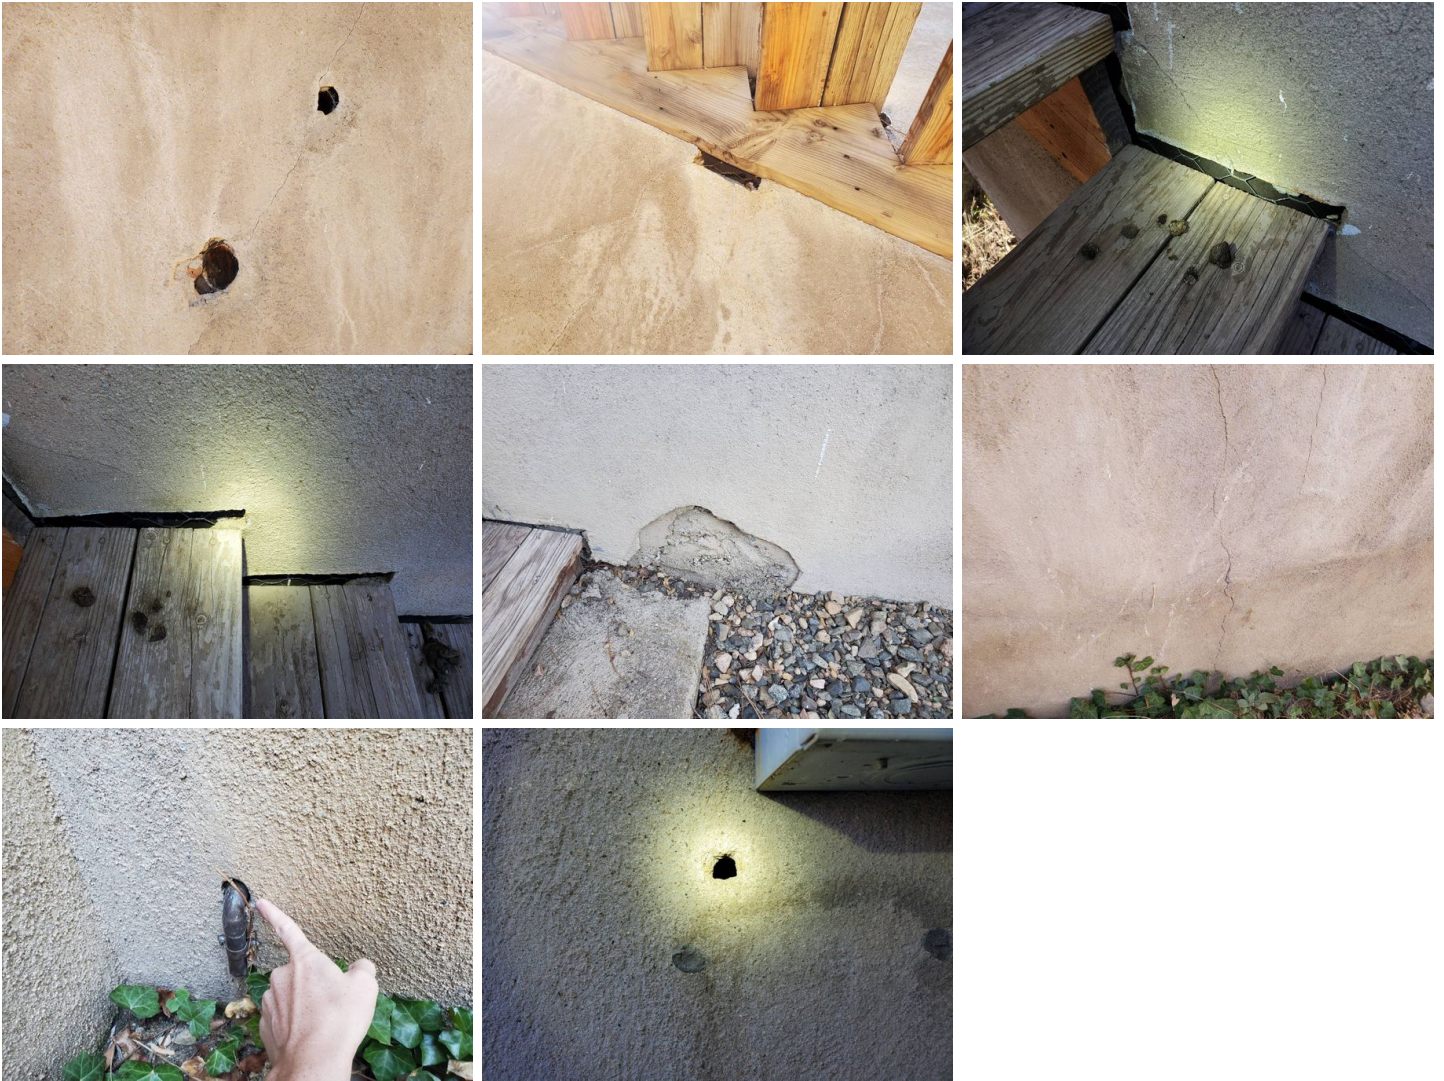
3.3.1 Cladding/Siding, Flashing & Trim

Stucco cracks/chips, unsealed penetrations, and areas of missing stucco were observed. Cracking is often a result of the natural curing process however can also be an indication of settling or movement. Stucco cracks are typically be sealed when they reach the point where water could penetrate. A siding repair professional should be consulted for service if needed.

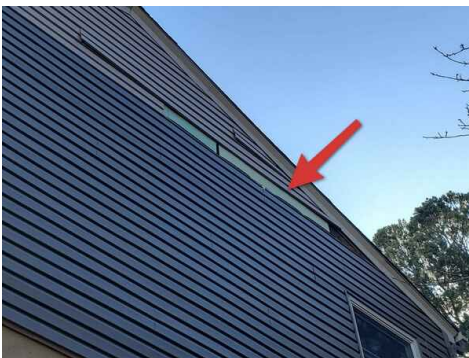
Vinyl siding is loose/missing in some areas. Additionally, small unsealed holes were observed in siding. I recommend consulting a licensed siding repair professional for service.

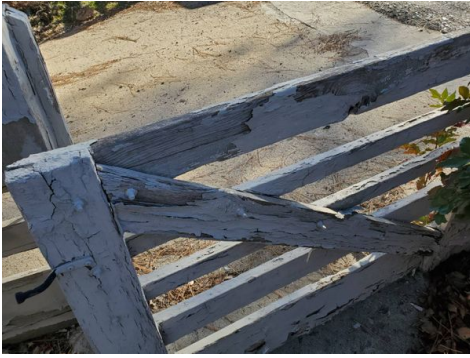
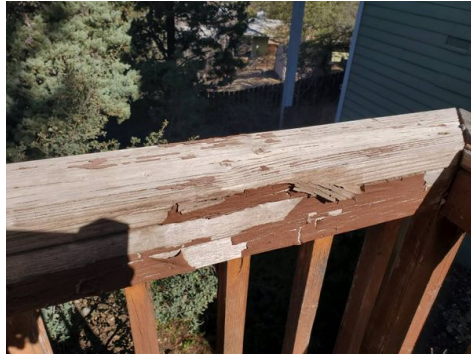
FLAKING/CRACKING EXTERIOR PAINT

Exterior paint is flaking and/or cracking in some areas. Loose paint should typically be scraped and exposed areas repainted. An exterior painter can be consulted for service if needed.

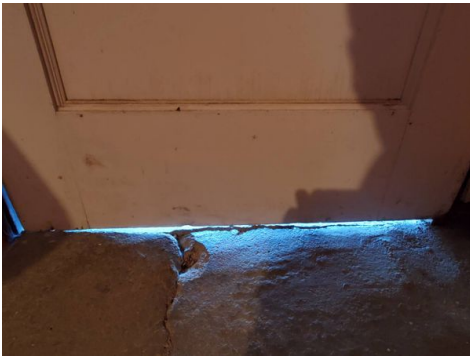
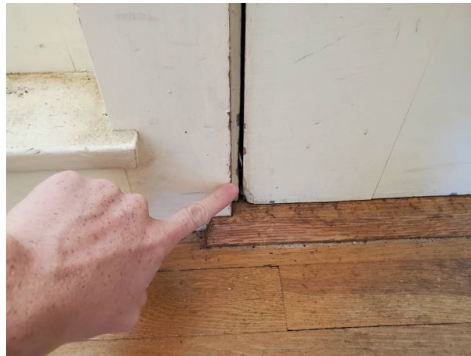
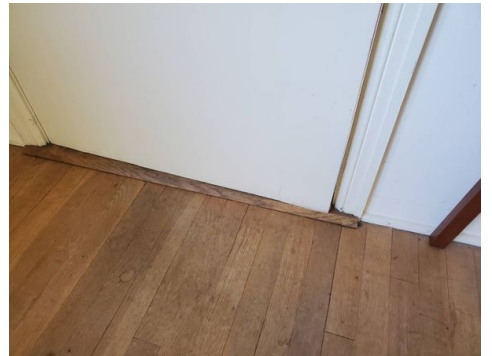
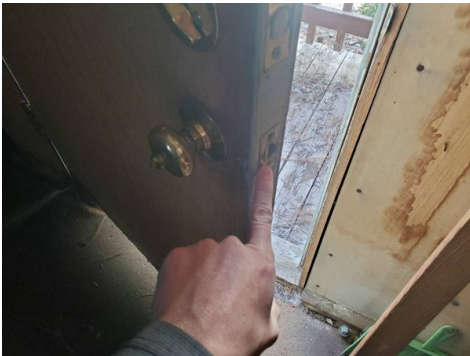
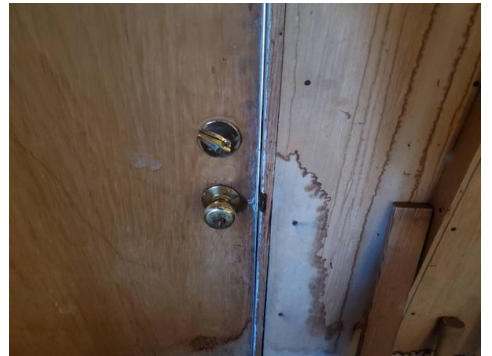
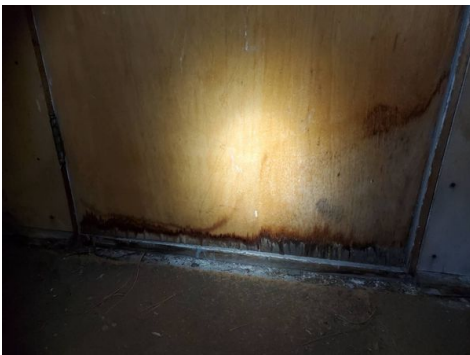
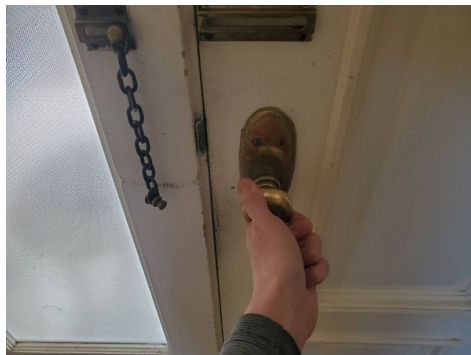
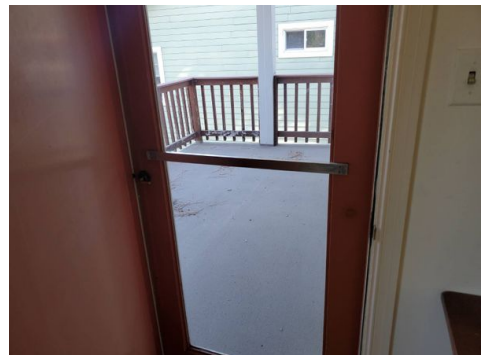
EXTERIOR DOOR CONDITIONS

Exterior door conditions observed included: Doors not sealed when closed, water damage, doors that rub against the threshold, latches that stick or are difficult to engage, cracked jambs, and missing safety glazing labels for door glazing. I recommend consulting a licensed door repair professional for service.

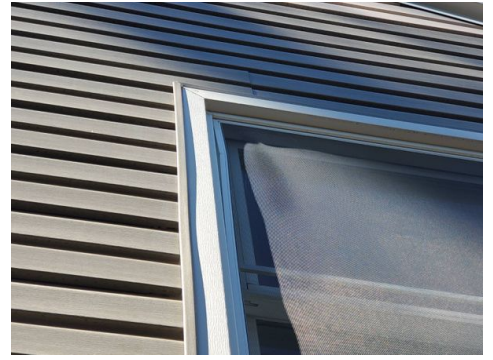
Some of the window screen frames are bent and no longer securely sit in place. A qualified handy person or window repair professional could be consulted to replace if needed.

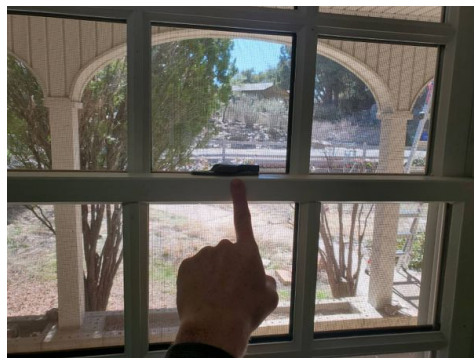
Kitchen

Some of the windows were difficult to lock after opening. A window repair professional can be consulted for adjustment.

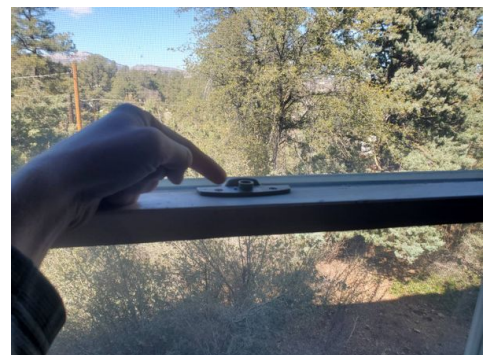
DOWNSTAIRS

The window lock component is missing. A window repair professional could be consulted to replace the lock.

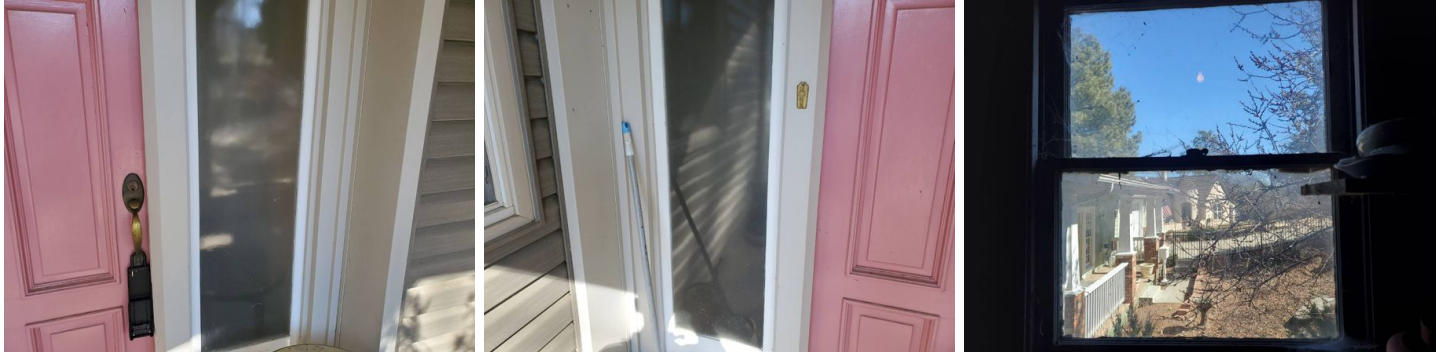
I was not able to locate a safety glazing label to ensure that tempered glass is installed. Safety/tempered glazing would be required in this location. I recommend consulting a window repair and installation professional to further assess.

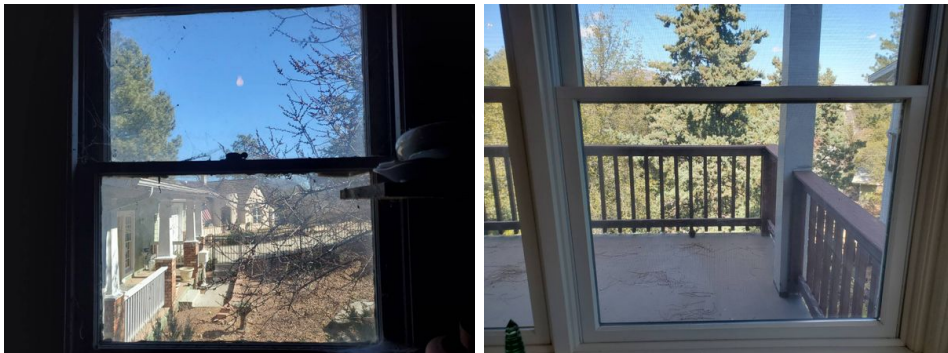
3.7.5 Windows

I was not physically able to open the window with normal testing. I recommend consulting a window repair professional for service.

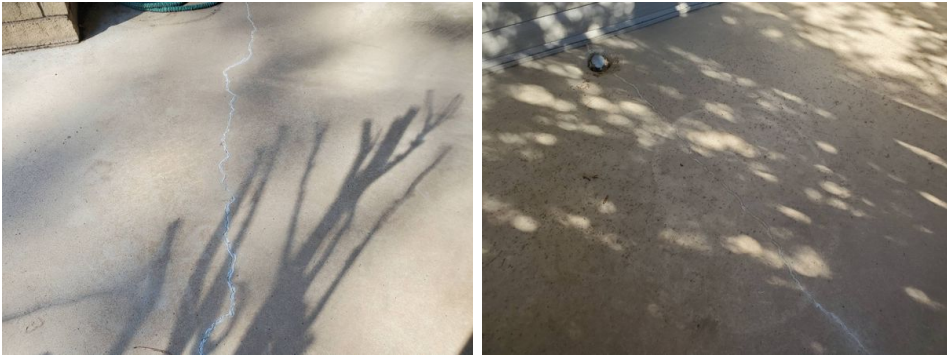
3.8.1 Porch/Patio, Deck, Balcony, Stoops/Steps, Railings & Areaways

The exterior concrete slab is cracked/damaged and has been previously repaired in some areas. I recommend consulting a qualified professional for additional service/repair.

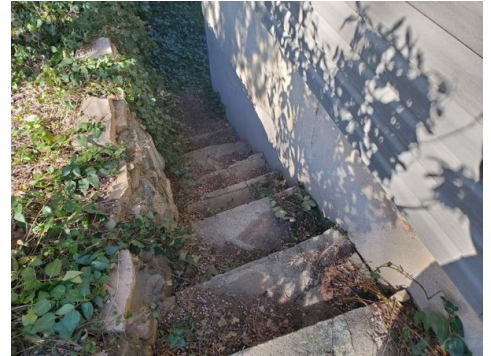
NO HANDRAIL

There is no handrail installed. Exterior stairs with four or more riser should have a handrail installed. I recommend consulting a licensed contractor for installation.

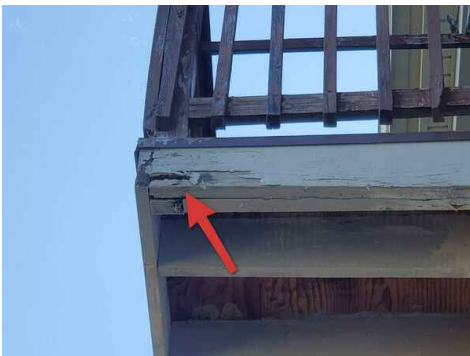
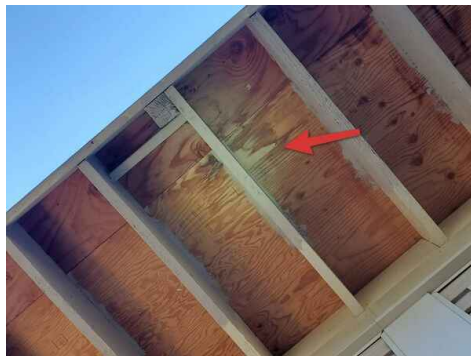
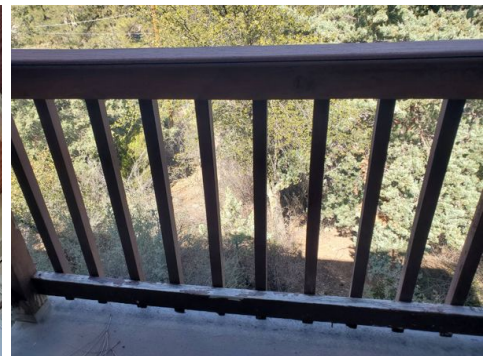
BALCONY CONDITIONS

Water stains/damage was observed at balcony framing. Additionally, guardrail baluster spacing exceeded more than 4". Guardrail spacing should not exceed 4" to limit children from passing through. I recommend consulting a licensed contractor to further assess.

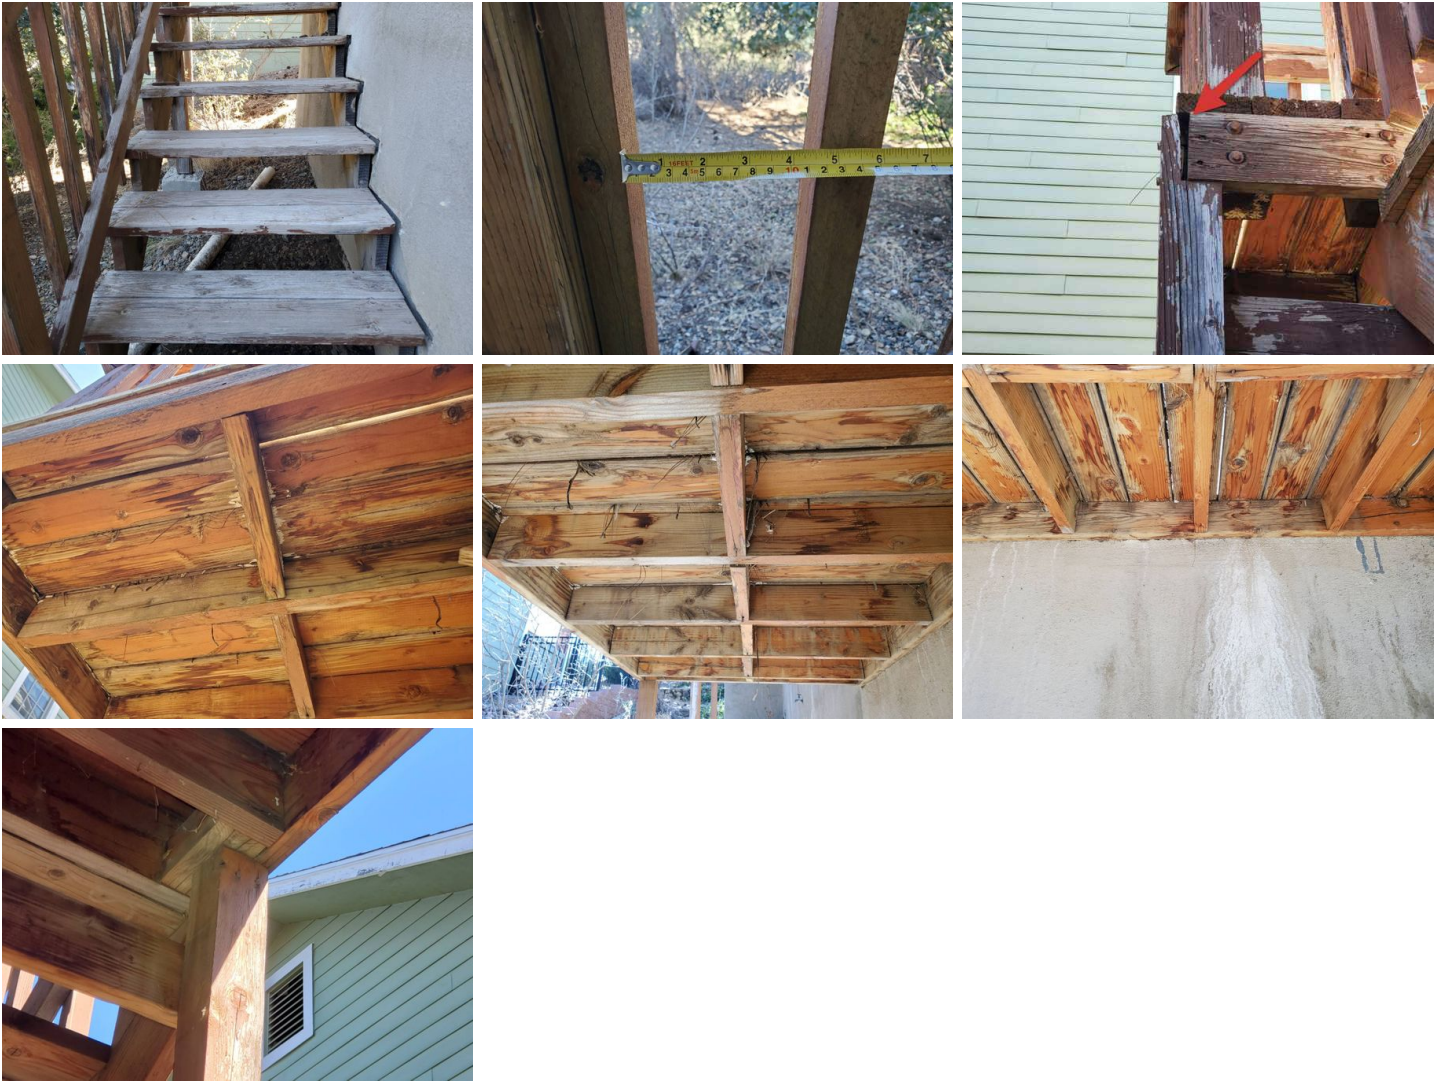
Staircase conditions observed included: Open staircase risers, baluster spacing exceeding 4", separated framing components, water stains/damage, slightly wobbly guard railing, and toenailed framing connections. I recommend consulting a licensed contractor to further assess/service.

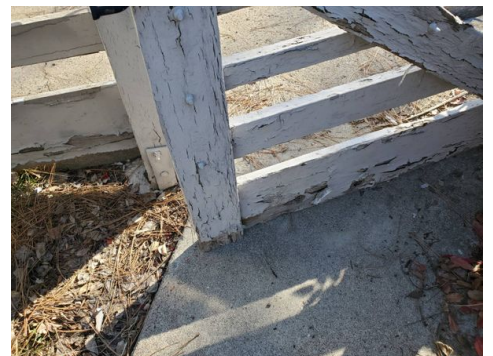
3.10.1 Gates

The exterior gate rubs the ground/walkway when opening and closing. A qualified handy person could be consulted to adjust if needed.

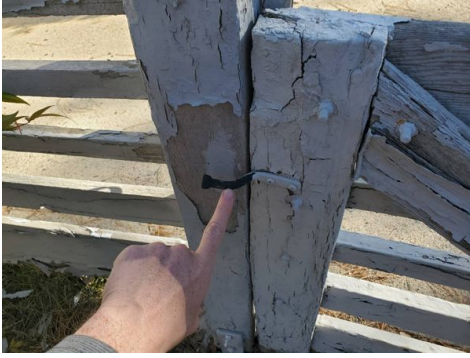
MISSING LATCH HARDWARE

Latching hardware for the gate is missing. I recommend consulting a qualified professional for replacement.

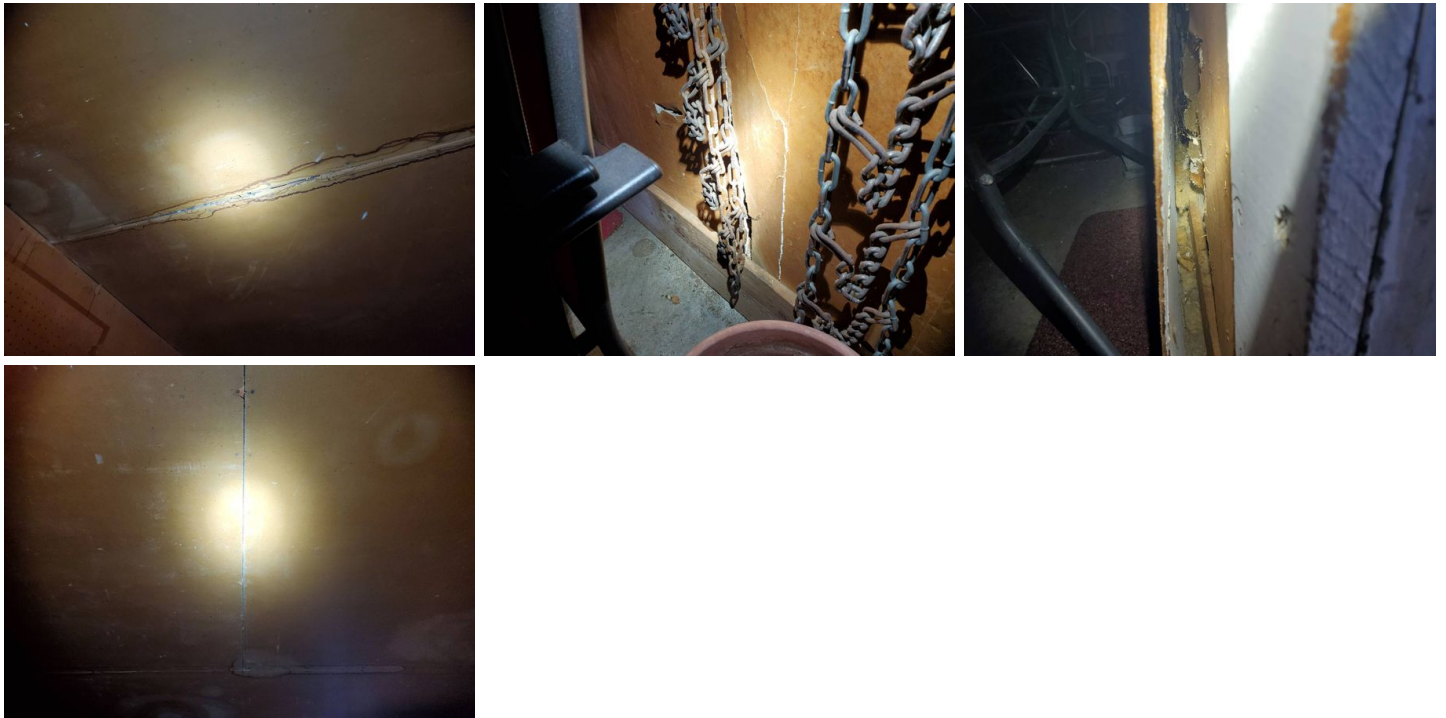
Unsealed drywall observed in the garage limits the firewall separation between the garage and attic/interior. A proper firewall barrier must be maintained to prevent or slow the spread of potential fire and fumes in the garage. I recommend drywall be serviced/re-sealed by a qualified drywall repair professional.

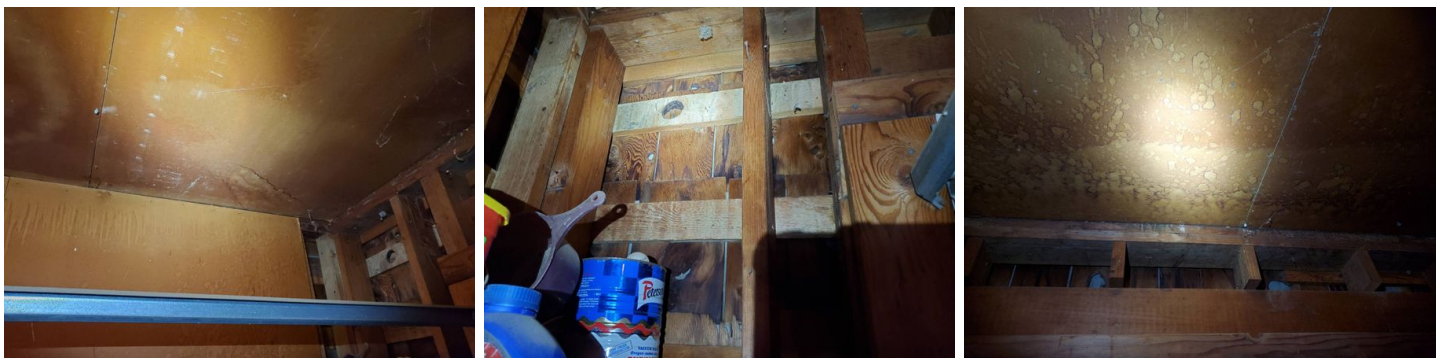
4.1.2 Walls, Ceiling & Firewall Separation

Water stains/damage was observed in the garage. Observed conditions that can lead to leaking have been noted in the roof section. I recommend consulting a drywall repair professional for service and monitoring after roof service is complete.

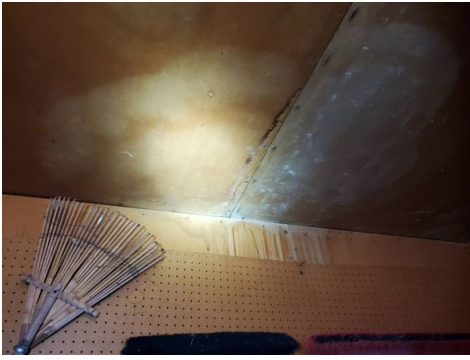
WATER STAINS/DAMAGE (FROM ROOF LEAK)

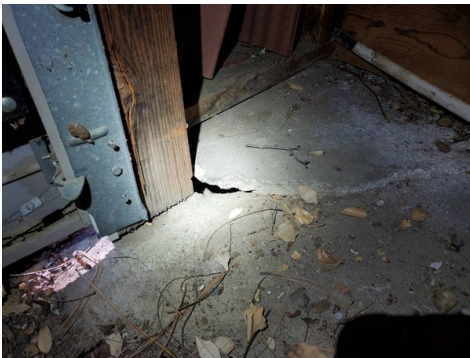
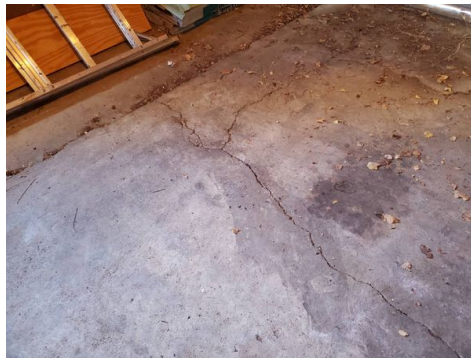
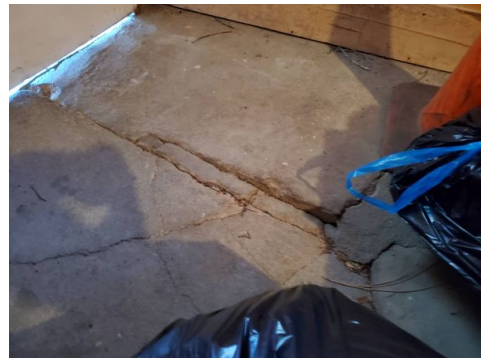
CONCRETE SLAB CRACKS/CHIPS

The garage concrete floor/slab is cracked in some areas. Additionally, uneven areas of the concrete slab could present a tripping concern. A concrete/foundation repair professional should be consulted to review/service.

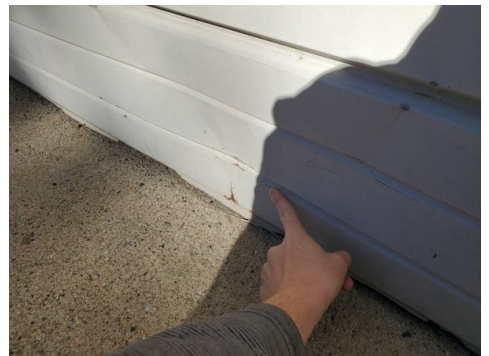
DENTED/CRACKED DOOR PANEL(S)

Dented/bent and cracked garage overhead door panel(s) observed. A licensed garage door repair professional should be consulted to service or replace.

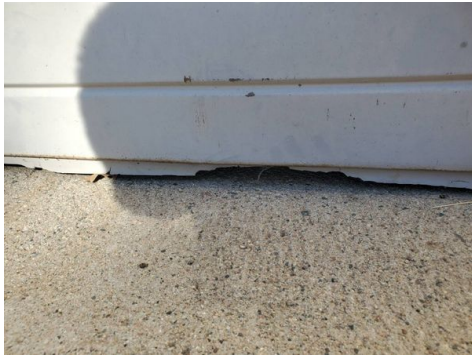
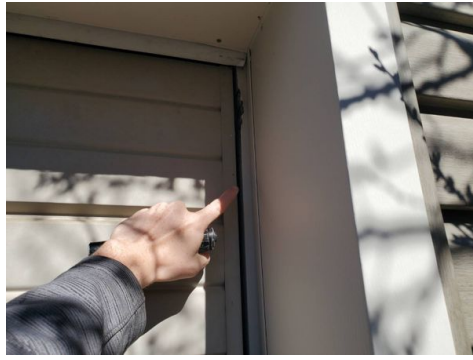
DAMAGED/SEPARATED WEATHER-STRIPPING

Weather-stripping installed for the garage overhead door is damaged/separated or missing in some areas. I recommend consulting a qualified professional for replacement/installation as needed.
