RESIDENTIAL HOME INSPECTION REPORT

532 N Hassayampa Dr
Prescott, AZ 86303

MARCH 1, 2024

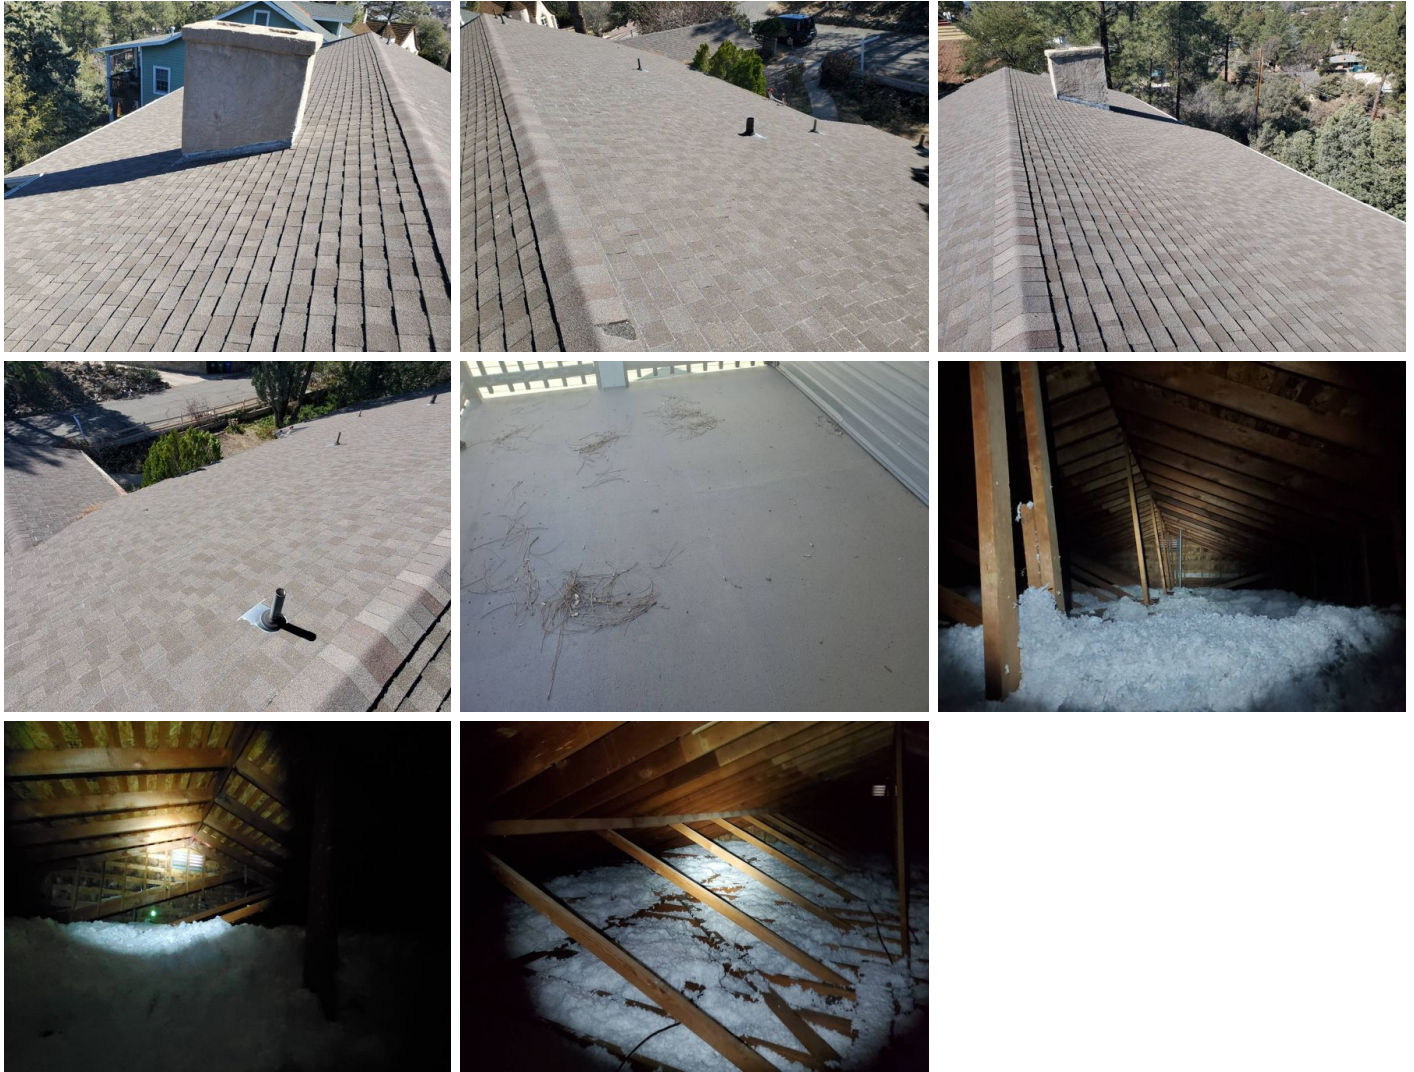
Evidence of roof leaking (not original roof)

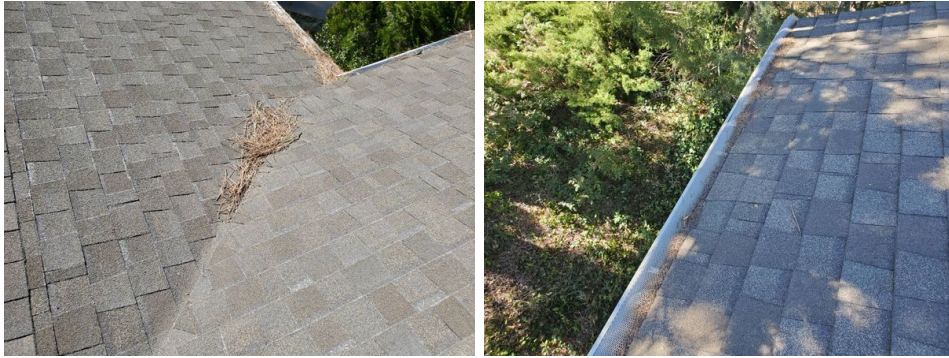
Dust/debris accumulation was observed on the roof. Debris accumulation can lead to limited drainage and water intrusion. I recommend debris be removed by a qualified professional/roofer.

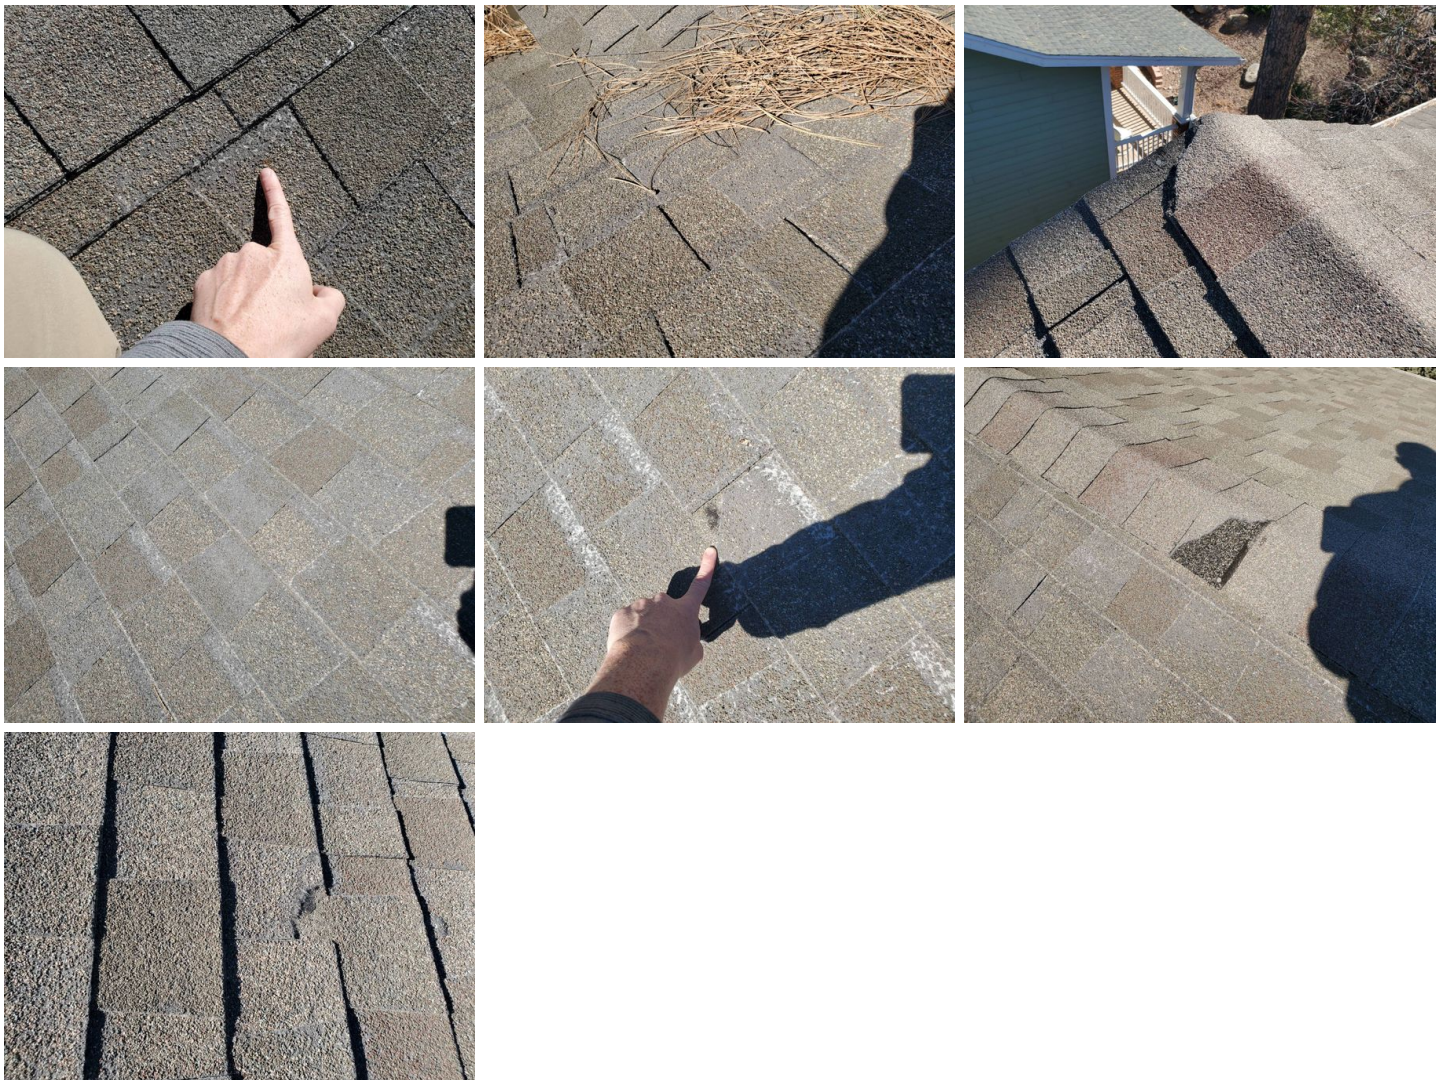
5.1.2 Roof Coverings

Physical damage/granule loss was observed at some of the asphalt shingles. I recommend consulting a licensed roofing professional for assessment/service.

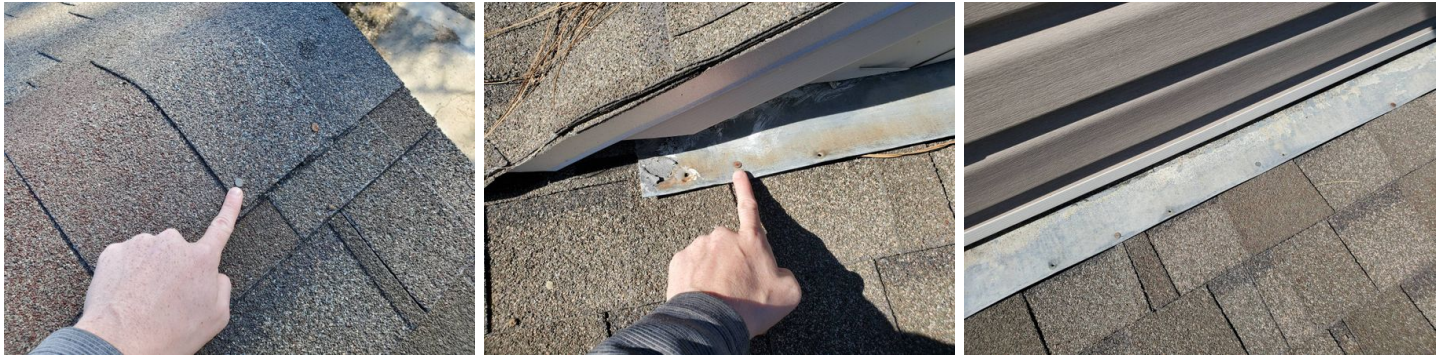
5.1.3 Roof Coverings

Exposed/unsealed fasteners that penetrate the roof covering can (potentially) lead to water intrusion. I recommend having these fasteners sealed by a qualified roofer.

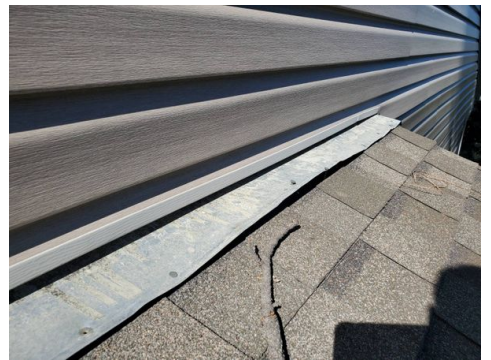
5.2.1 Flashings

Loose/lifted flashing was observed. I recommend consulting a qualified roofer to secure flashing as (and when) necessary to help prevent moisture intrusion due to wind driven rain and to help prevent further flashing displacement due to high wind.

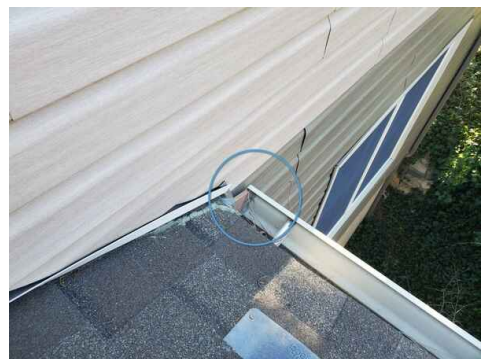
5.2.2 Flashings

Kick-out flashing is missing at the intersection of the roof covering and sidewalls in some areas. Kick-out flashing helps prevent moisture intrusion into the wall cavity and/or will help prevent exterior siding damage. I recommend adding kick-out flashing. A qualified roofer can be consulted for service.

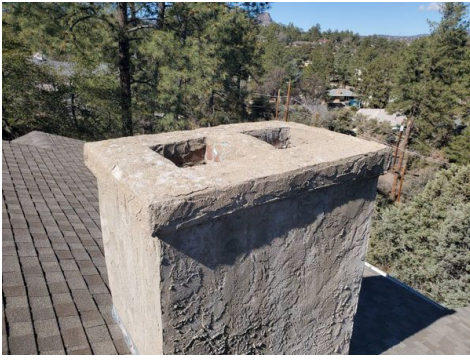
There is no spark arrester installed at the top of the chimney flue. A spark arrester will help prevent sparks from leaving the flue and will also help prevent birds from flying in. I recommend consulting a qualified/licensed professional to install a spark arrester.

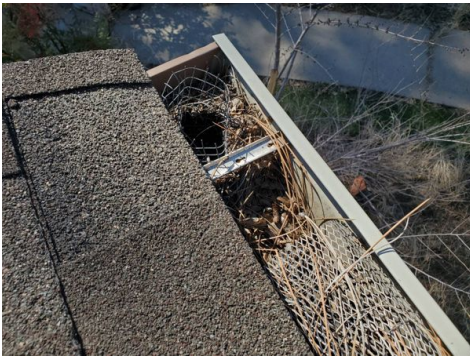
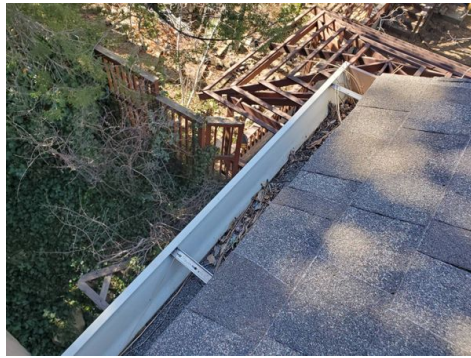
CLEAR GUTTERS

Debris observed in the roof gutters can/will limit drainage. I recommend clearing gutters as/when necessary.

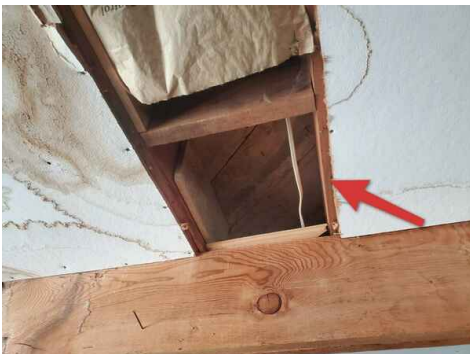
LOW AND MISSING INSULATION

Underfloor insulation is missing in some areas. Additionally, the attic access panel is also missing insulation. I recommend consulting a qualified professional to add/install insulation where low and missing.

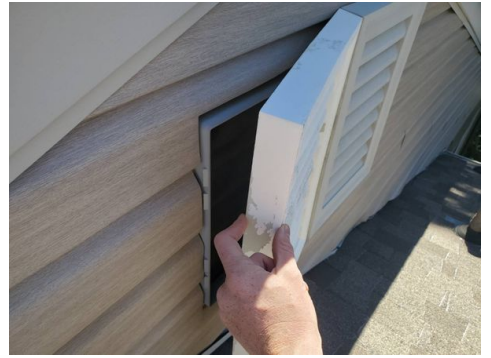
A gable vent cover is loose from the attachment to the exterior wall and should be further secured to limit water entry into the attic. I recommend consulting a licensed professional for service.

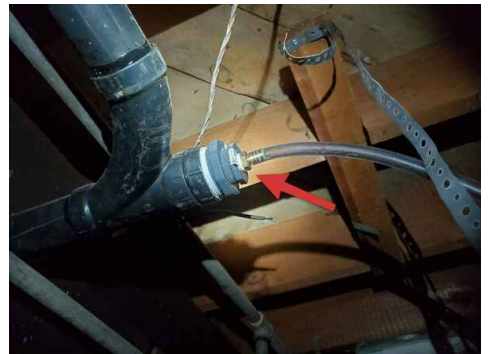
The cooling system condensate drain terminates into a plumbing drain pipe in the downstairs utility room. This is commonly considered to be an improper cross connection by industry professionals as it could be a direct connection to a source of contamination. I recommend having the drain reinstalled with an established air gap by a qualified plumber/HVAC professional.

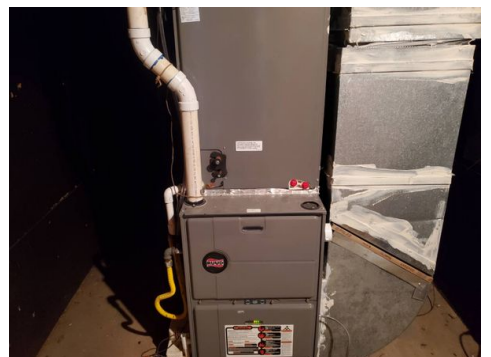
NO CONDENSER UNIT/AC

An air handler/furnace unit is present however, an exterior condenser unit has not been installed. A condenser unit would be necessary to provide cooled air to the home. I recommend consulting a licensed HVAC contractor to install a condenser unit.

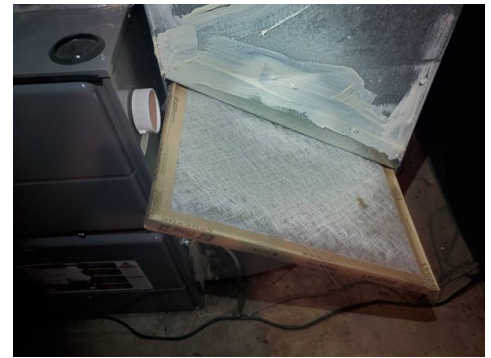
The air filter(s) are dark/dirty and should be replaced so proper air flow may be established and to prevent dirt/dust accumulation within the system.

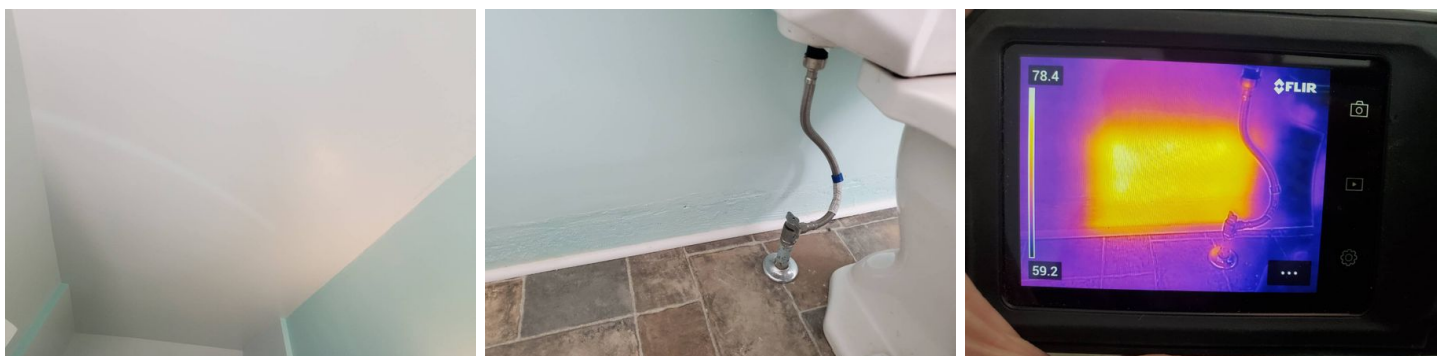
There is no heating/cooling source installed in the primary bathroom or downstairs main room. A supply register for the primary bathroom *could* be covered by drywall as observed using an infrared camera, however removal of drywall may be needed to confirm. A qualified HVAC professional can/should be consulted to review options/provide service.

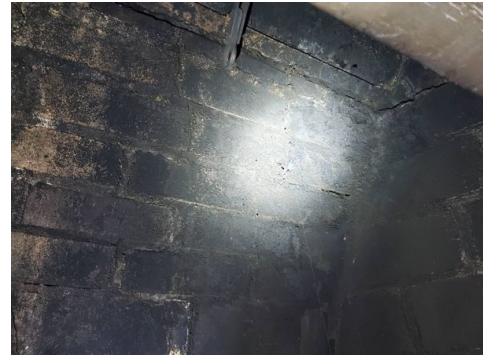
6.6.1 Fireplaces

Creosote build-up was observed at the top of the firebox and within the flue. Creosote is combustible and should be cleaned as often as necessary. I recommend service/cleaning and full evaluation of the flue by a qualified chimney (sweep) professional.

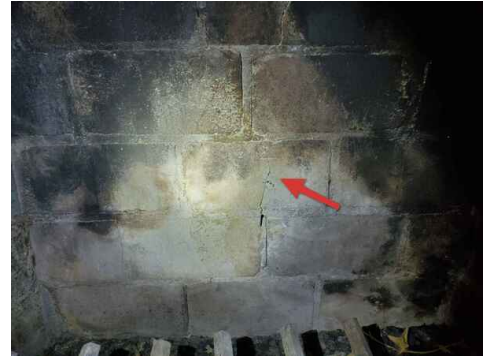
6.6.2 Fireplaces

Cracked and missing grout was observed within the firebox. I recommend having these areas resealed by a qualified chimney and fireplace repair professional prior to use.

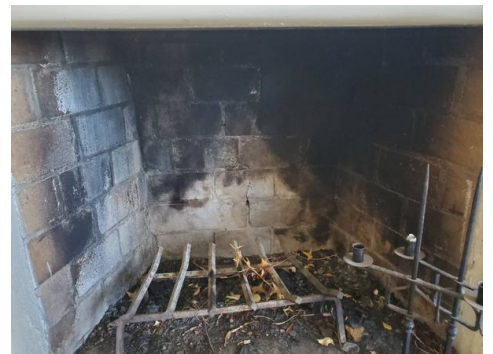
MISSING MESH SCREEN

A permanent protective mesh screen or glass door has not been installed at the fireplace. A mesh screen/door would limit embers from escaping the firebox. A qualified technician can be consulted to install these components as necessary.

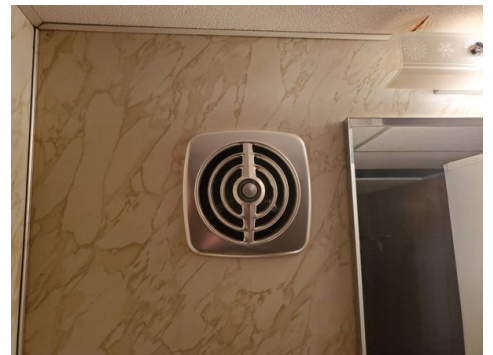
DOWNSTAIRS BATHROOM

I was unable to locate the termination of the downstairs bathroom ventilation fan duct. The duct should extend through the roof or exterior wall. I recommend consulting a qualified/licensed professional to further assess/service.

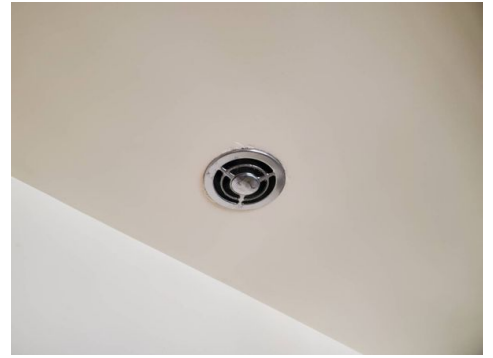
The ventilation fan is or could be considered noisy while in use. The fan may be able to be serviced for quieter operation or may need to be replaced. A qualified professional/electrician can be consulted for service.

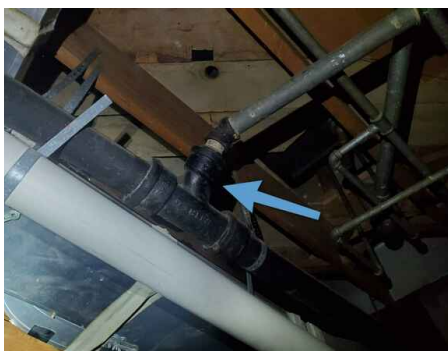
Drain, Waste, & Vent System : Cast Iron Drain Material

Older cast iron pipe is installed. Older metallic drain material can be prone to corrosion which can limit drainage and increase probability of obstruction. I recommend inquiry with the seller regarding drainage history for the home, specifically as it relates to issues with obstructions. Sewer scoping services are available to help determine the condition of the drain (and building sewer) pipe material(s).

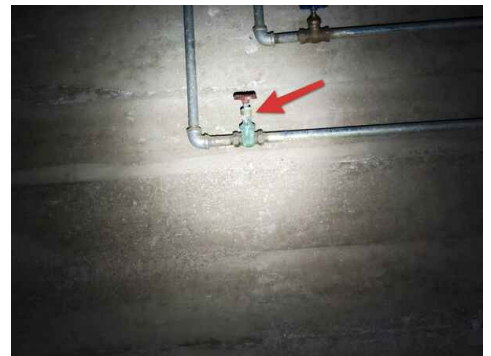
EVIDENCE OF LEAKING

BASEMENT

Evidence of (prior) leaking in the form of calcification/corrosion was observed. No active leaking was observed. The leak may have self sealed if not serviced. I recommend consulting a plumber to assess/service as it is not evident that service has been performed.

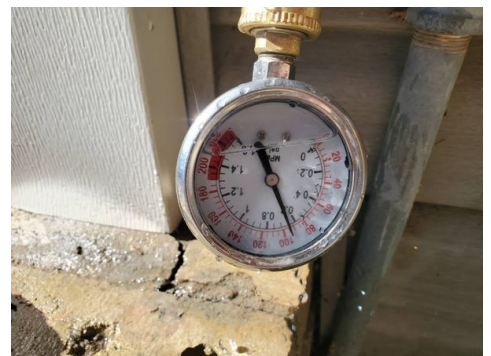
HIGH WATER PRESSURE

Utility water pressure exceeded 80 PSI at the time of the inspection. A maximum of 80 PSI is commonly recommended to limit stress on the interior water supply system and fixtures/fittings. I recommend consulting a licensed plumber to install a pressure reducing valve.

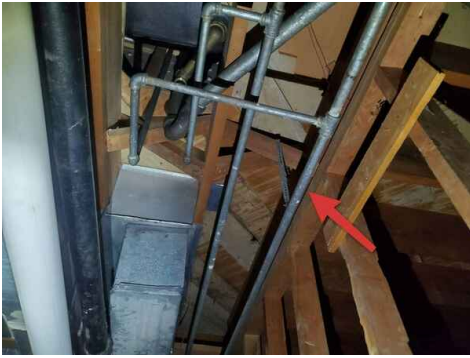
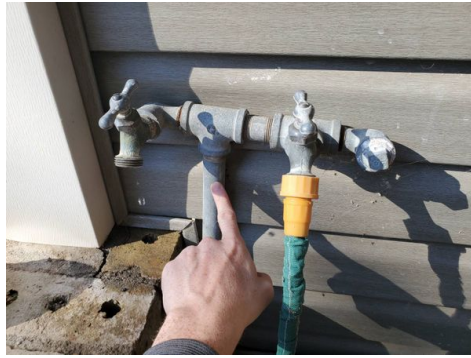
GALVANIZED WATER DISTRIBUTION PIPING

Galvanized water distribution piping was common when this home was built and is often changed out due to issues with corrosion, water restriction and/or leaking. Galvanized pipe was observed in some locations. I recommend evaluation of the extent of the remaining galvanized distribution by a qualified plumber to determine if replacement may be necessary.

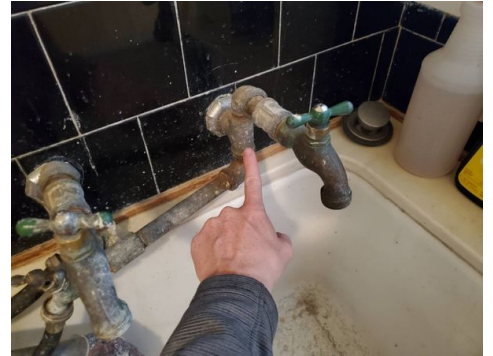
Plumbing distribution piping is loose/not secured. Distribution piping should remain secured to prevent movement and loosening of connections. A qualified professional/plumber can be consulted for service.

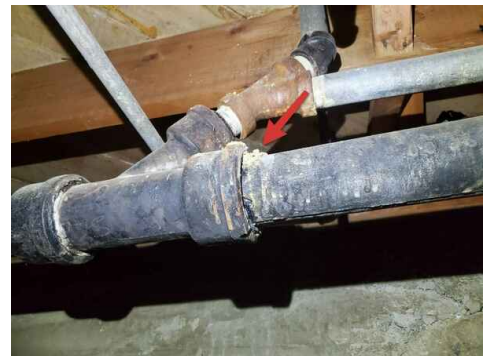
7.3.1 Drain, Waste, & Vent System

Evidence of leakage was observed at cast iron drain piping inside the basement. No active leakage was observed. I recommend consulting a licensed plumber for service.

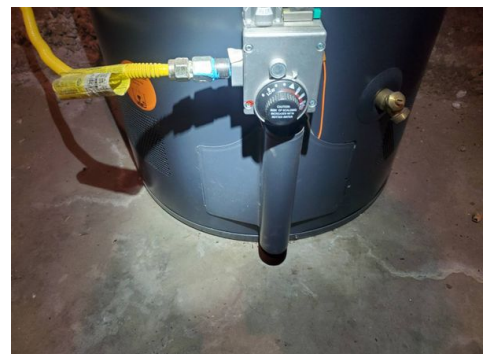
WATER HEATER DRIP PAN

There is no drip pan installed below the water heater to help catch water in the event of a leak. A qualified professional/plumber can be consulted to install a drip pan.

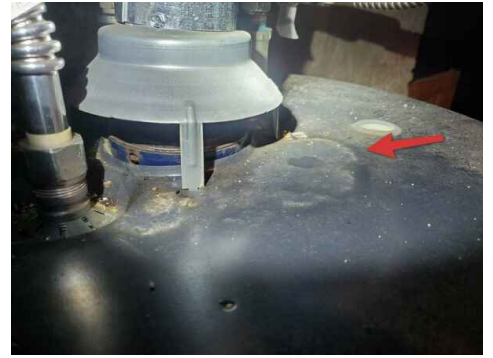
Condensation stains on the top of the water heater are common indication of back-drafting of exhaust gas around the draft hood. There can be multiple atmospheric pressure variables that might lead to back drafting of a natural draft gas appliance. I recommend further evaluation by a qualified plumber to determine if corrective action or adjustment will be necessary.

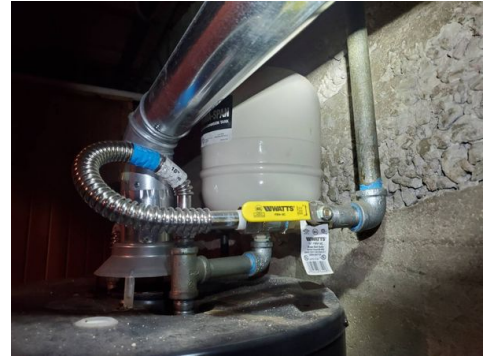
7.4.3 Hot Water Systems

The water heater expansion tank is not strapped/braced to the wall. This could place excessive strain on the connection. I recommend consulting a licensed plumber for service/to secure.

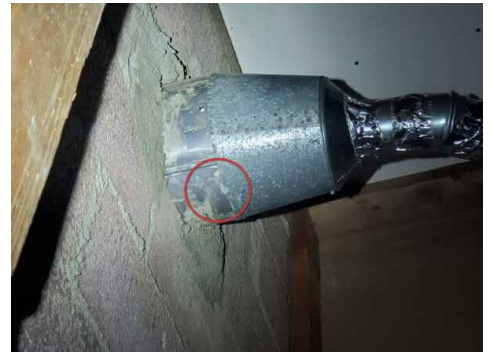
Water/condensation was observed dripping from the water heater gas flue into the basement. I cannot determine the cause. I recommend consulting a licensed plumber to determine the cause and to provide service options as necessary.

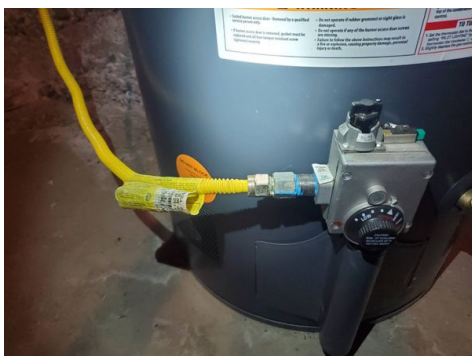
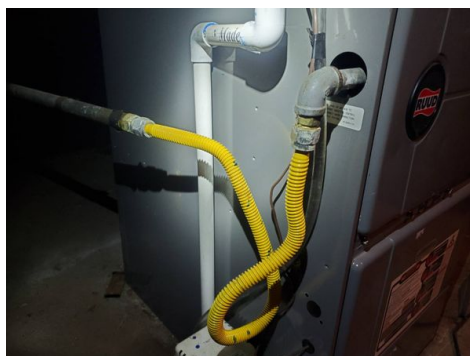
NO SEDIMENT TRAPS

There are no sediment traps installed for the gas fired appliances. Sediment traps can typically help to prolong the serviceable life of gas equipment. A qualified plumber can be consulted to install sediment traps.

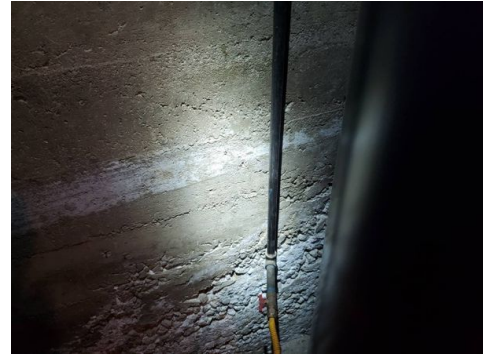
Gas distribution piping is loose and should be further secured to prevent unnecessary strain upon fittings. I recommend consulting a licensed plumber for service.

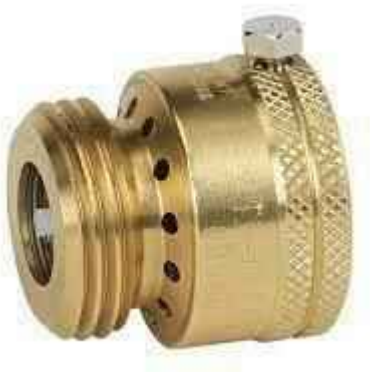
MISSING HOSE BIB VACUUM BREAKER(S)

FRONT OF HOME

A connected hose without a vacuum breaker may draw contaminated water into the clean/potable water supply. I recommend installing vacuum breakers where missing/before connecting hoses.

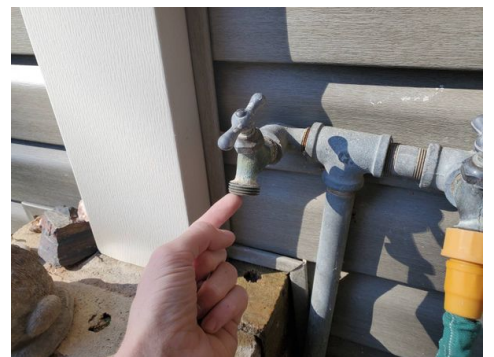
The hose bib drips with the handle fully closed. I recommend consulting a qualified professional/plumber for service or replacement.

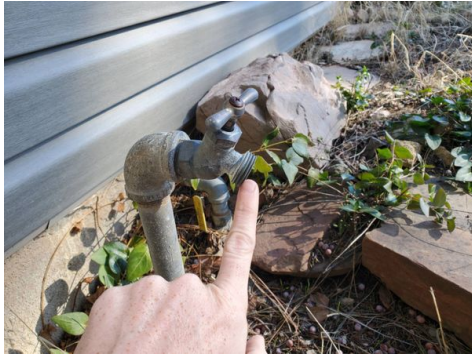
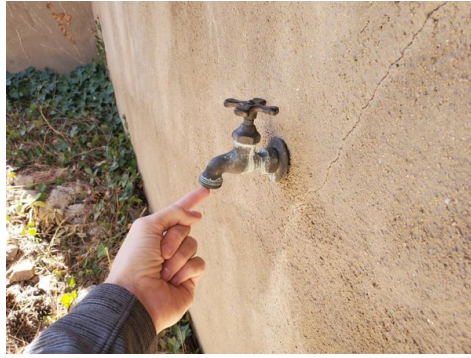
FRONT AND SIDE OF HOME

No water was available at the hose bib when it was tested. I recommend inquiry with the seller regarding functionality and consulting a licensed plumber for service if needed.

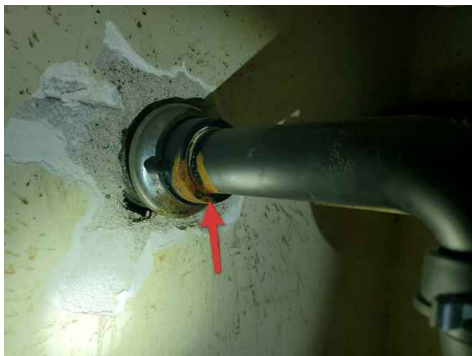
Laundry room/area

EVIDENCE OF LEAKING

Evidence of previous leaking/drain corrosion was observed. It is not evident that these leaks were serviced or repaired. Minor leaking can sometimes self seal however sinks should still be serviced/fittings should be tightened to prevent future leaking.

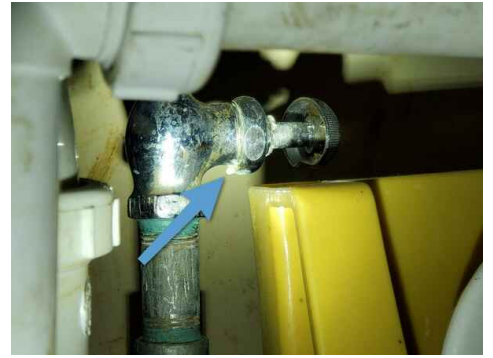
Calcification and/or corrosion was observed at sink supply/shut-off valves. While no active leaking or dripping was observed at the valves the condition could indicate securing/tightening or replacement is necessary.

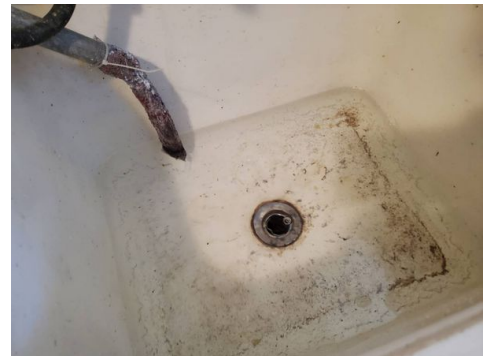
7.8.3 Sinks & Faucets

The sink was slow to drain when tested. I recommend having the drain/drain stop cleaned by a qualified professional.

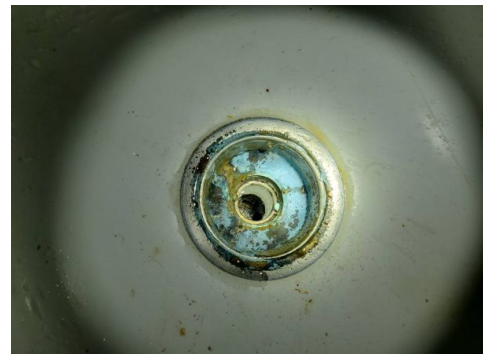
MISSING DRAIN STOP(S)

KITCHEN

Missing drain stop(s) observed. Drain stops should be replaced as foreign objects may easily fall into the drain(s). A qualified professional/plumber can be consulted for service.

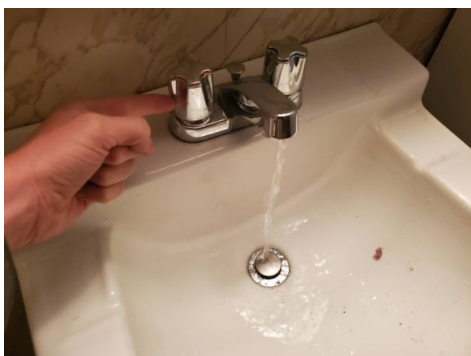
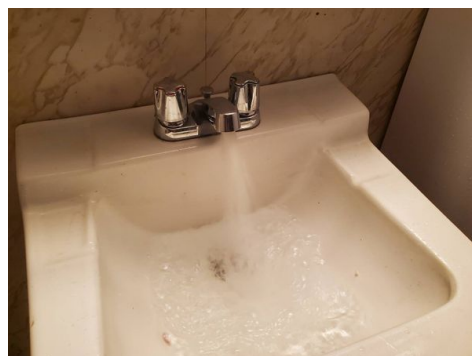
LOW WATER FLOW

Water flow is low to the downstairs bathroom sink when hot water is tested. However, the water flow has a sizable increase when a valve handle inside the adjacent shower enclosure is operated. I recommend consulting a licensed plumber for further assessment/correction.

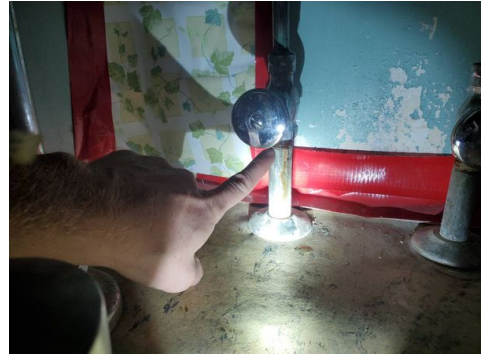
SUPPLY VALVE LEAK

A dripping/leaking sink supply valve was observed. I recommend consulting a licensed plumber for repair.

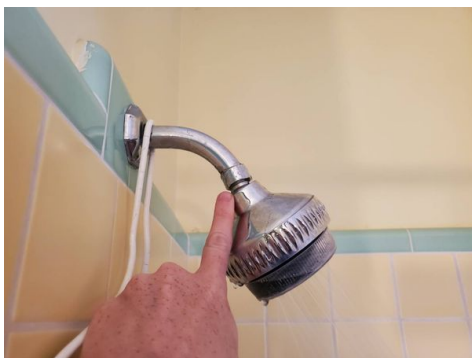
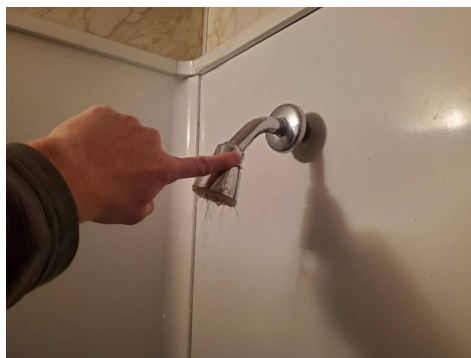
SHOWERHEAD LEAK (AT ATTACHMENT)

Leaking from the shower-head attachment observed. I recommend securing fittings to try to stop the leak or replacing the showerhead if necessary. A qualified handy person could be consulted for service if needed.

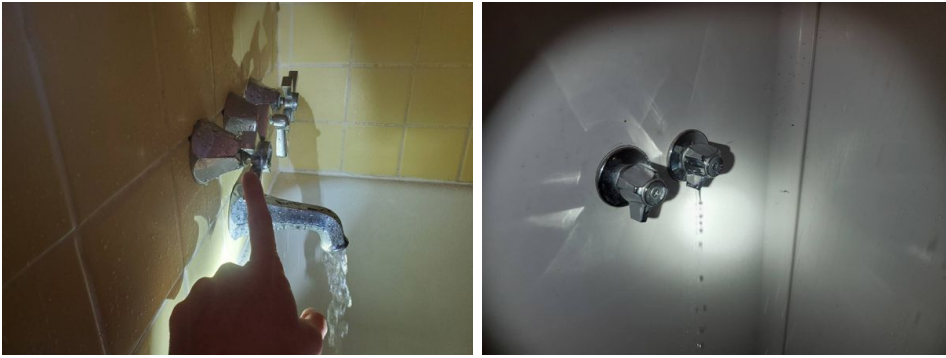
LEAKING HANDLE

Leaking was observed at the tub/shower control handle when tested. I recommend consulting a licensed plumber for repair.

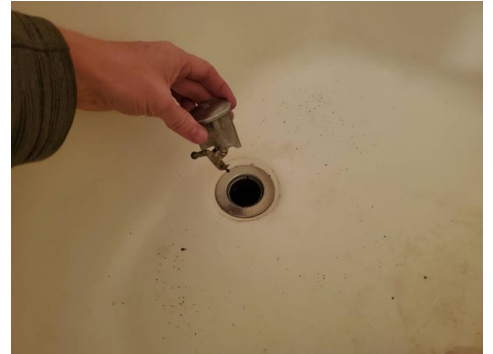
ATTACHED BATHROOM

The drain stop has been removed, possibly because it is no longer functional or is difficult to operate. A temporary rubber stop could be used or a qualified plumber could be consulted to reinstall a permanent stop.

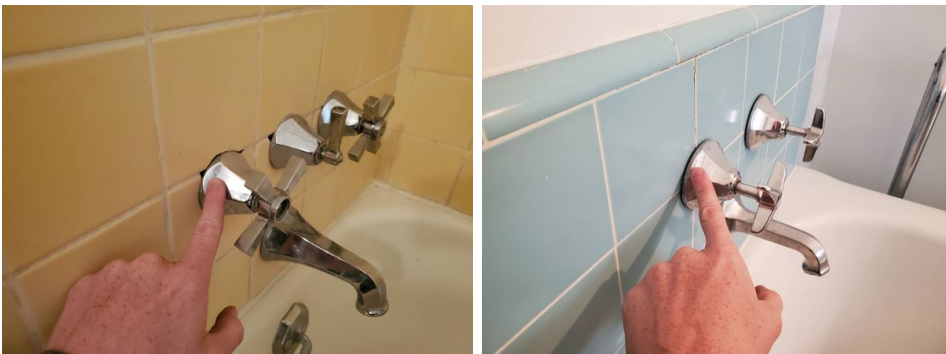
I recommend sealing/re-sealing around the tub/shower control trim ring, the tub spout and along the tubs to help prevent water intrusion into the wall openings.

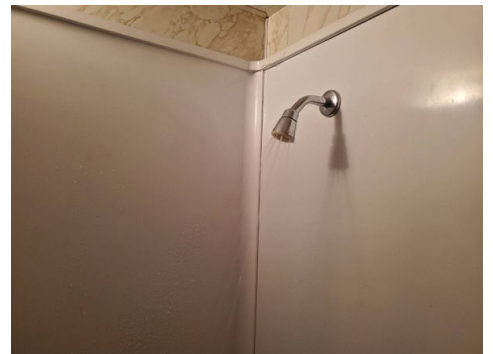
NO HOT WATER

No hot water was available at the downstairs bathroom shower when tested. I recommend consulting a licensed plumber for service.

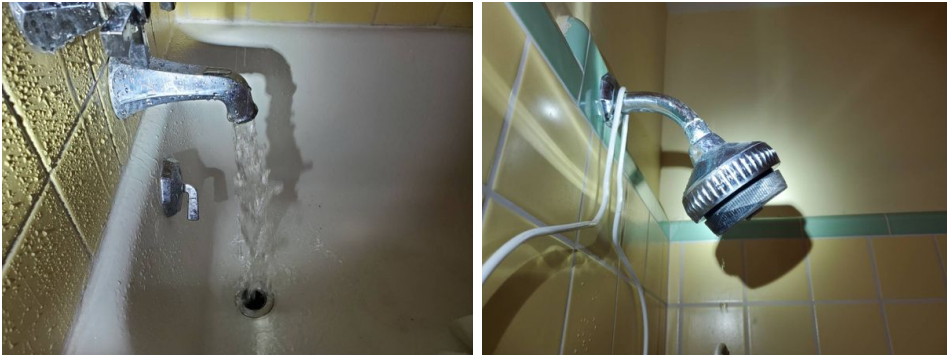
INOPERABLE TUB SPOUT DIVERTER

Water flows simultaneously through both the showerhead and tub spout regardless of whether the tub spout diverter pin is raised or lowered. Additionally, both the hot and cold water valve must be fully opened for water to flow through the showerhead. I recommend consulting a licensed plumber for further assessment/service.

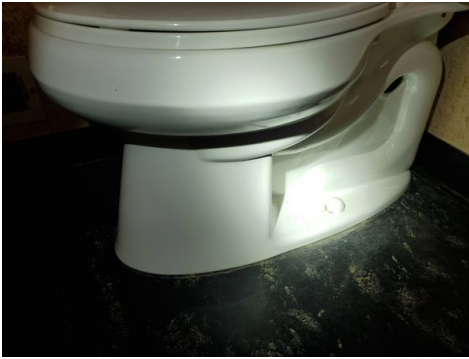
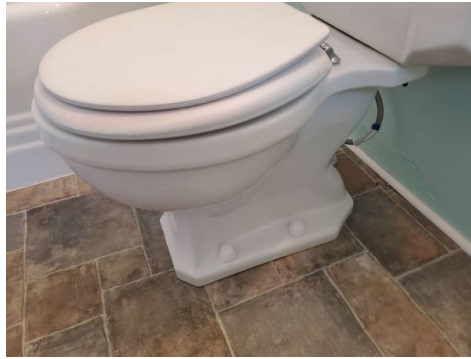
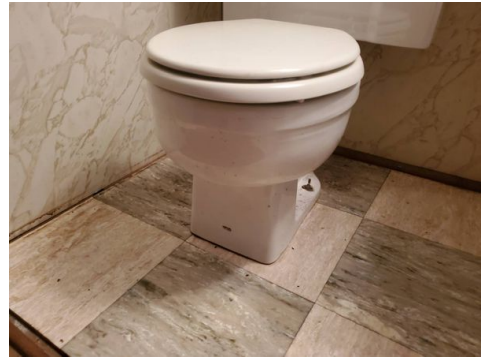
LOOSE TOILETS

The toilets are loose/able to be rocked or shifted. Toilets should remain tightly secured to floors to avoid displacement of the wax seal. No leaking was observed during the inspection. I recommend assessment/securing by qualified plumber.

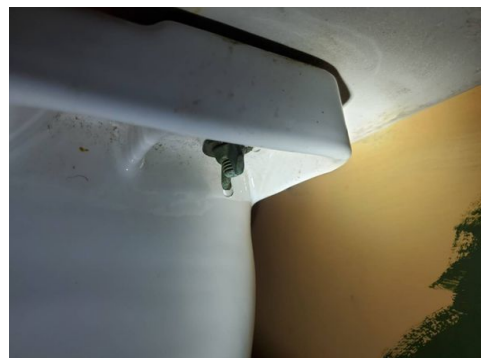
LEAK AT TANK ATTACHMENT

The toilet leaks at the attachment of the tank and bowl. I recommend consulting a licensed plumber for repair.

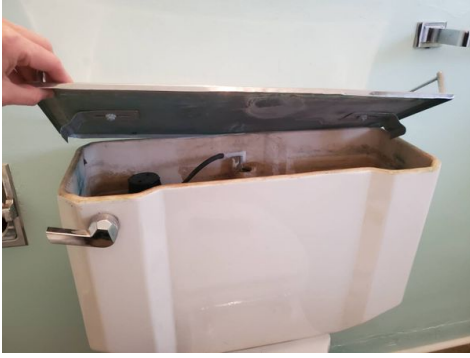
MISSING TANK LID

A lid for the primary bathroom toilet tank is missing. I recommend replacement.

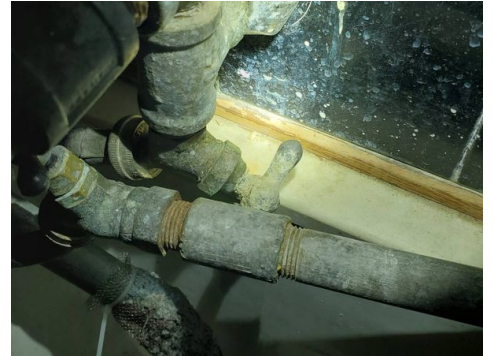
SUPPLY VALVE CORROSION

Corrosive build-up was observed at the washer supply valves. Corrosion can lead to water restriction, damage or leaking. These valves were not tested. I recommend having the valves replaced by a licensed plumber.

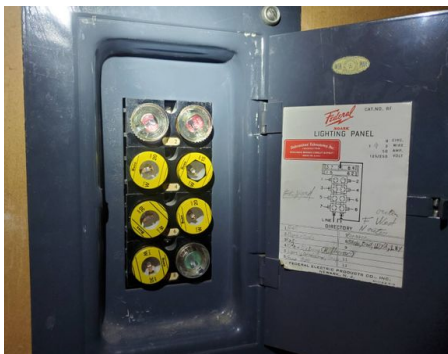
Service Equipment, Distribution Panels & Grounding : Fused Distribution Panel

A fused distribution panel is installed. This type of panel is no longer manufactured/widely installed and is considered to be outdated by many industry professionals. A licensed electrician should be consulted to assess for replacement.

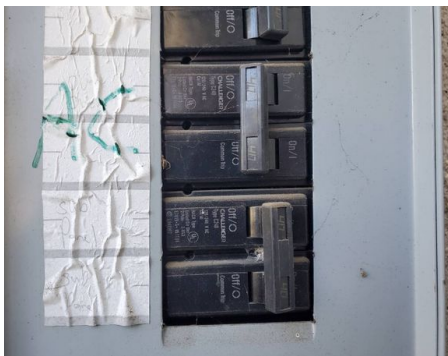
Branch Circuit Conductors & Over-Current Devices: Challenger circuit breakers

Challenger circuit breakers are installed in the main electric distribution panel. The Challenger brand is discontinued. Challenger circuit breakers are known amongst some industry professionals to be problematic due to issues with overheating and/or not tripping in an over-current situation. I recommend having the circuit breakers assessed by a licensed electrician.

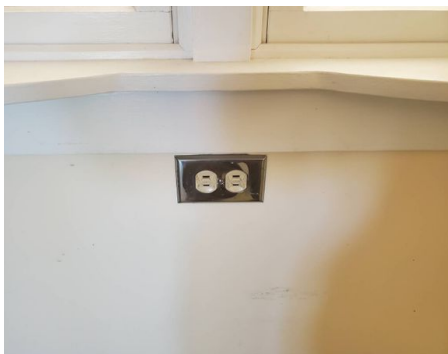
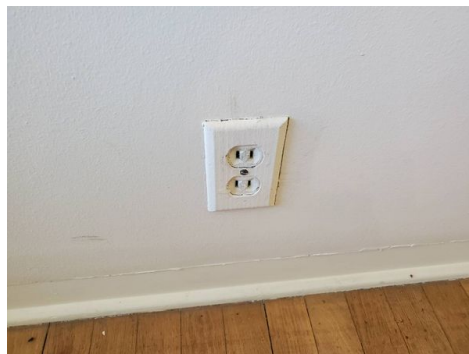
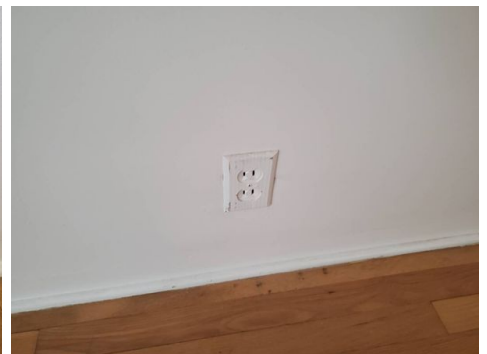
Receptacles & GFCI Devices : Two prong receptacles

There are multiple (ungrounded) two prong receptacles installed. I recommend consulting a qualified electrician to replace these receptacles where the use of an equipment ground will be necessary.

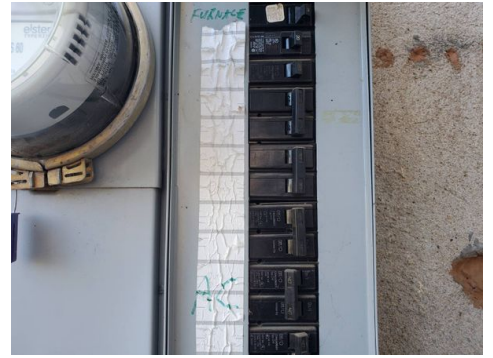
Some of the circuits are not labeled at the service panel dead front cover. Each circuit should be clearly labeled. An electrician can be consulted for service.

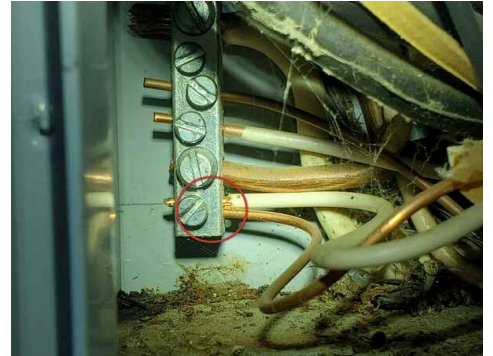
DOUBLE TAPPED NEUTRAL CONDUCTOR(S)

Neutral conductor(s) are sharing terminals. Neutral conductors are generally require to be independently terminated unless otherwise specified by the panel manufacturer. I recommend consulting a licensed electrician for assessment/service.

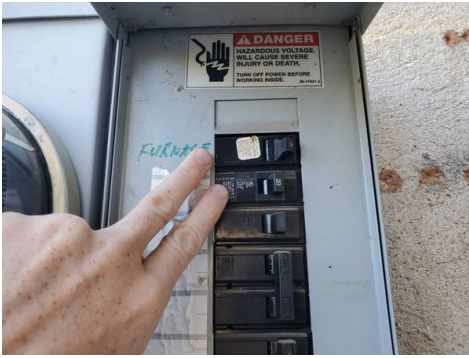
NON OEM BREAKERS

Circuit breakers are installed that were not manufactured by the electrical service panel manufacturer. Electrical service panel manufacturers typically require their own/specific breakers be installed. I recommend consulting a licensed electrician to assess/replace breakers if necessary.

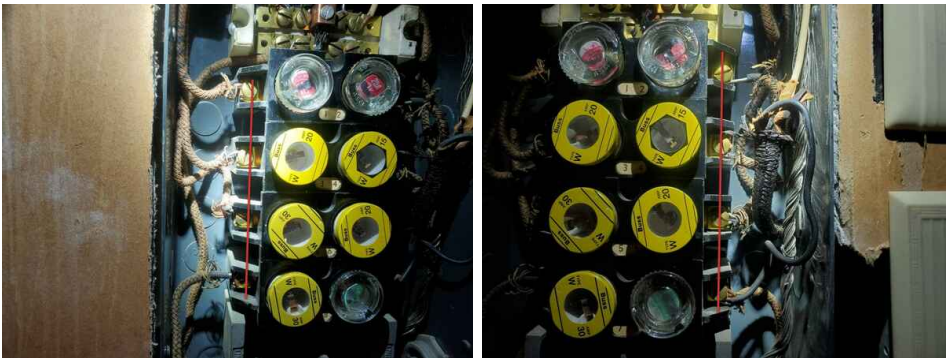
UNDERSIZED CONDUCTORS

Electrical conductors are undersized/too small for the connected overcurrent device(s) for some circuits. This can lead to issues with excessive heat. I recommend consulting a qualified electrician for service/correction.

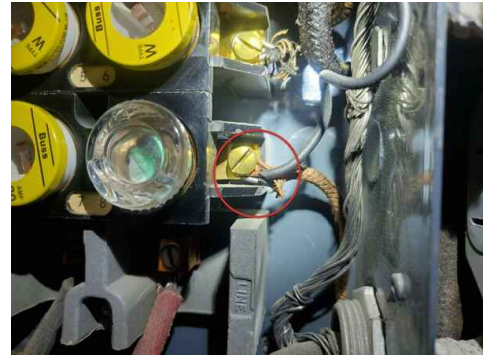
DOUBLE TAPPED FUSE

A fuse is double tapped. Fuses are often intended for termination of one conductor in each terminal. I recommend consulting an electrician for correction.

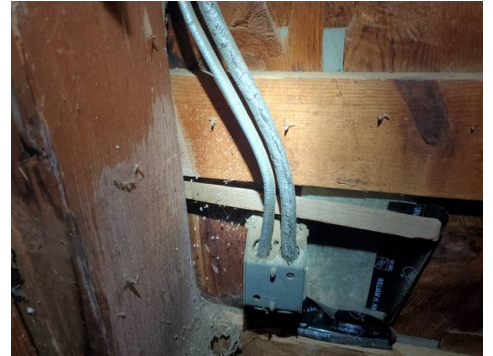
CLOTH NM CABLE

Older/original cloth braided non-metallic cable is installed. This type of electrical cable was common in older homes however is known to have undersized grounding conductors or missing grounding conductors in some instances. The cloth material is also known to become brittle and deteriorate. I recommend consulting a licensed electrician to evaluate material condition.

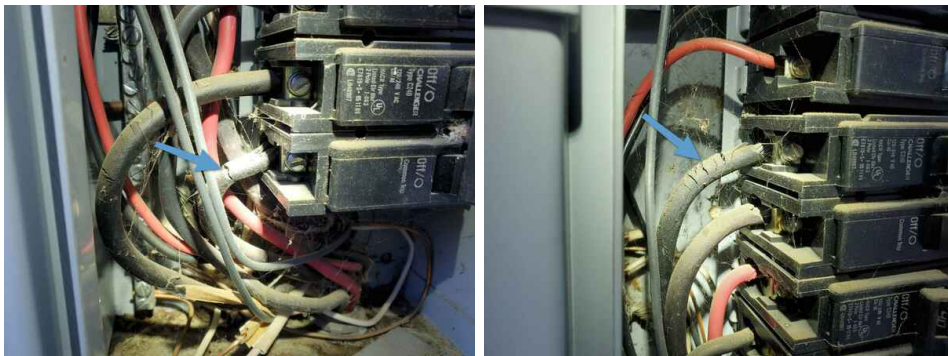
WORN/DAMAGED INSULATION

Insulation installed around electrical conductors in the main distribution panel is brittle/cracking, exposing conductors. I recommend consulting a licensed electrician for service/repair.

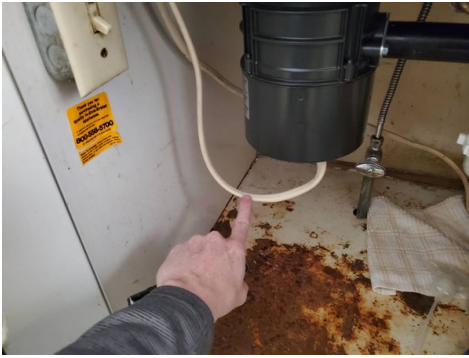
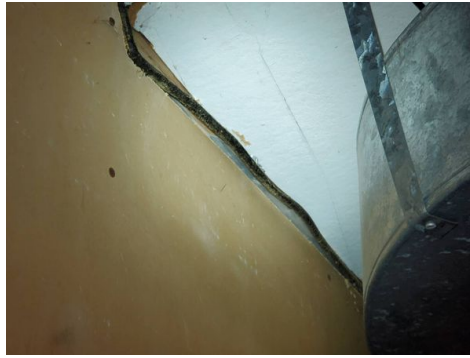
KITCHEN AND DOWNSTAIRS

Exposed non-metallic cable was observed. This type of electrical cable is intended for installation in areas such as wall cavities and in attics, not in open spaces where it may be contacted and damaged. I recommend consulting a licensed electrician for service/correction.

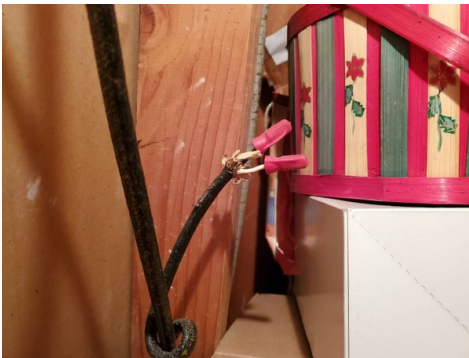
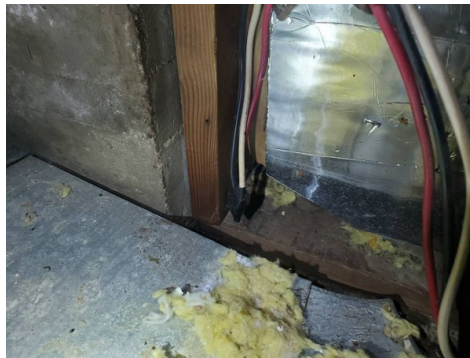
EXPOSED WIRES & SPLICES

Exposed electrical conductors/splices were observed. Splices should always be contained within enclosures. Conductors should always be contained within cable sheathing or conduit. I recommend consulting a licensed electrician for service/correction.

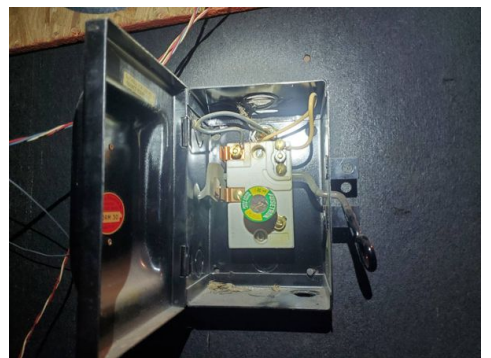
The interior cover is missing for the air conditioner service disconnect. Electrical conductors and terminals are exposed when the exterior cover is opened. I recommend consulting a qualified electrician to replace the inside cover or the entire disconnect if necessary.

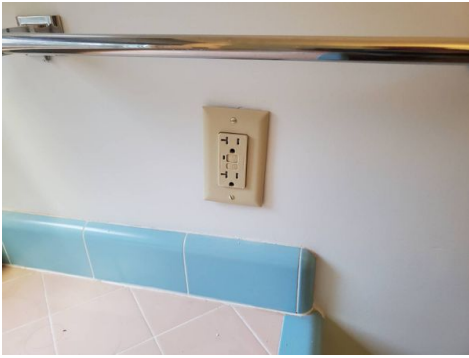
8.6.1 Receptacles & GFCI Devices

LOOSE RECEPTACLE(S)

Some of the receptacles are loose and easily moved within their enclosures or enclosures are loose in walls. I recommend securing where needed. An electrician can be consulted for service.

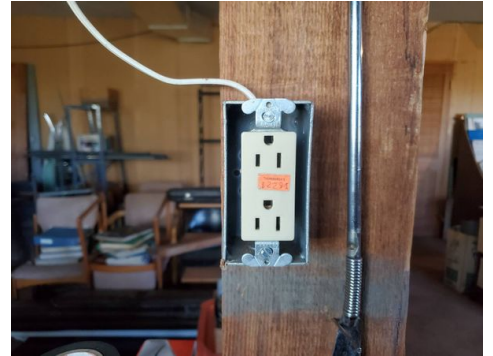
8.6.2 Receptacles & GFCI Devices

MISSING INTERIOR RECEPTACLE COVER(S)

Missing interior receptacle cover(s) observed. Each receptacle should have a cover so that conductors and terminals are not exposed. I recommend installing covers where missing.

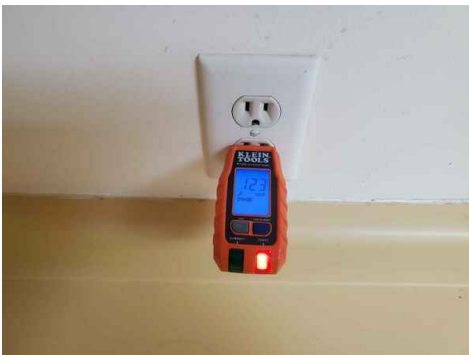
Kitchen

MISSING GFCI PROTECTION PER CURRENT STANDARDS

Ground fault circuit interrupters (GFCI's) are not installed in some locations where they are now required for safety purposes. I recommend consulting a licensed electrician to install GFCI protection where it is missing.
