RESIDENTIAL HOME INSPECTION REPORT

532 N Hassayampa Dr
Prescott, AZ 86303

MARCH 1, 2024

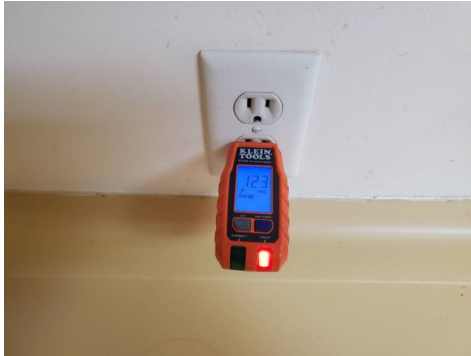
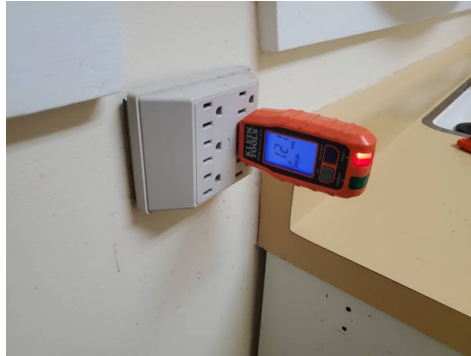
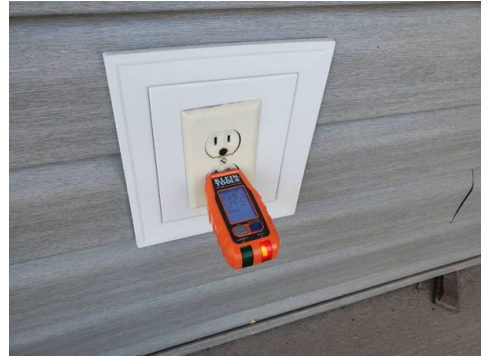
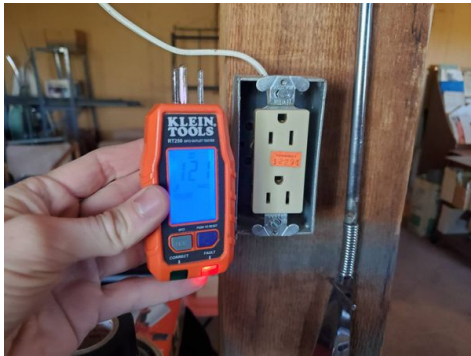
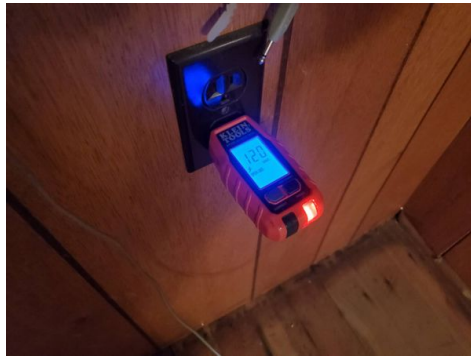
8.6.4 Receptacles & GFCI Devices

UNGROUND 3-PRONG RECEPTACLES

3-prong receptacles are not grounded or are wired with an open ground. I recommend consulting a licensed electrician for service/correction.

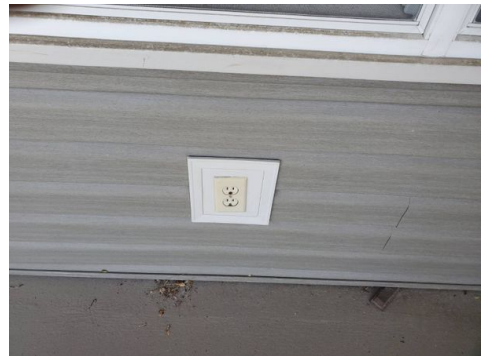
8.6.5 Receptacles & GFCI Devices

BALCONY

Receptacles installed outdoors should have specific outdoor-rated covers installed. I recommend replacing indoor covers with outdoor covers. A qualified professional/electrician should be consulted for service if needed.

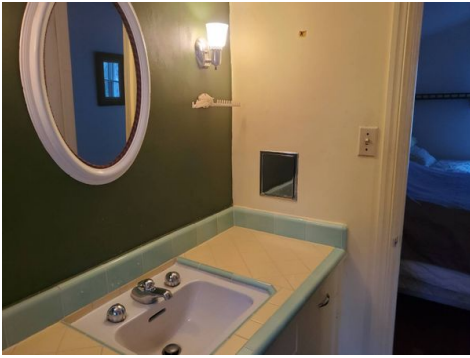
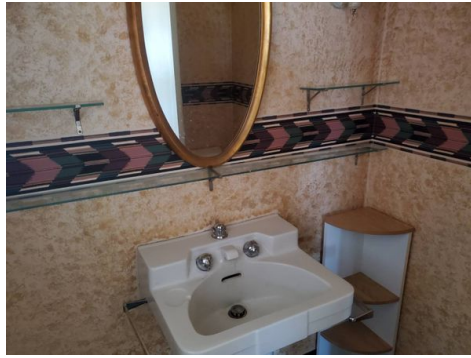
8.6.6 Receptacles & GFCI Devices

NO BATHROOM RECEPTACLES

There are no receptacles installed in the attached and half bathroom. I recommend consulting a licensed electrician to install receptacle if needed.

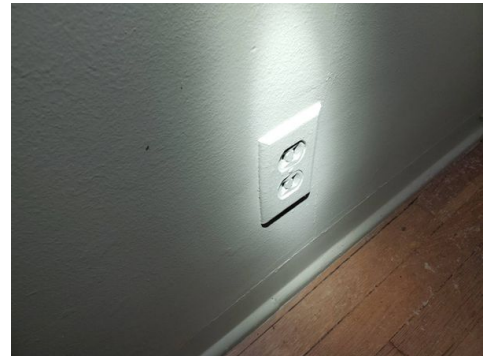
8.6.7 Receptacles & GFCI Devices

FAMILY ROOM

Some receptacles have been painted over. It is generally recommended that painted receptacles be replaced instead of cleaned. I recommend consulting a qualified professional/electrician for replacement.

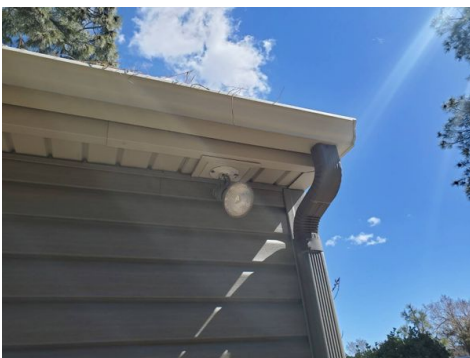
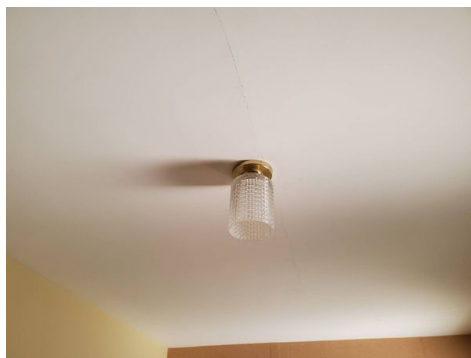
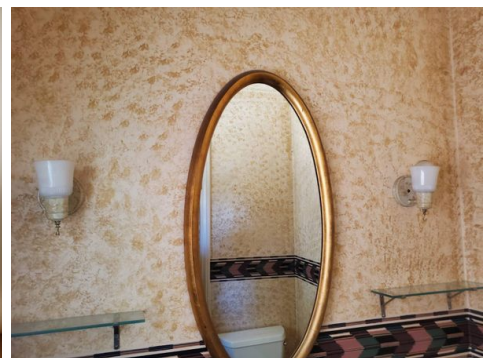
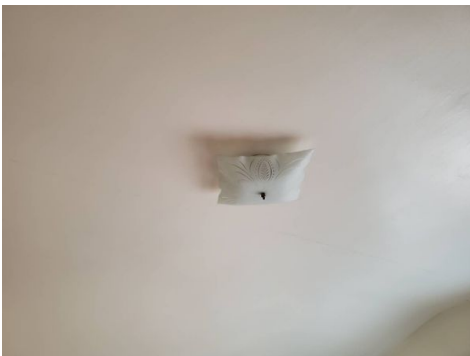
8.7.1 Light Fixtures, Ceiling fans and Switches

LIGHT(S) DID NOT RESPOND

Some of the lights did not respond when tested. I recommend requesting all missing and burnt-out bulbs be replaced so lights may be retested at final walk-through.

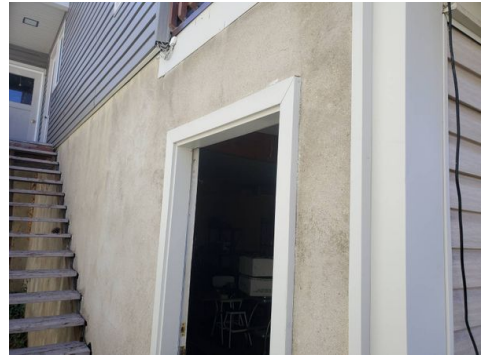
8.7.2 Light Fixtures, Ceiling fans and Switches

MISSING EXTERIOR LIGHT FOR DOOR

It is generally recommended (often required) that an exterior light be able to be turned on as you exit a home. There is no (switchable) exterior fixture installed near the door. I recommend consulting a qualified electrician to install a switchable fixture.

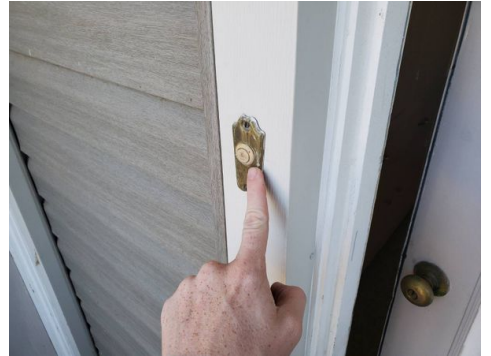
8.8.1 Doorbell

The doorbell did not respond when tested. I recommend consulting a qualified technician for service if needed.

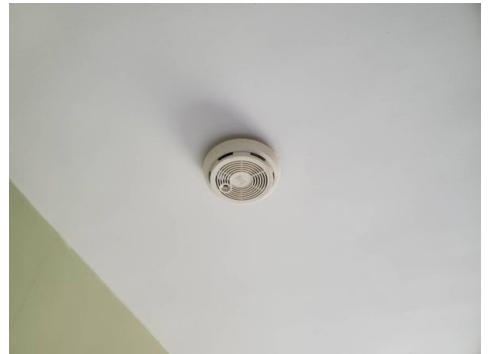
8.9.1 Smoke Detectors

10+ YEARS OLD

Some smoke detectors appear as though they could be older than approximately 10 years. It is generally recommended that smoke detectors be replaced at ten year intervals or less. I recommend replacement where necessary by a qualified professional/electrician.

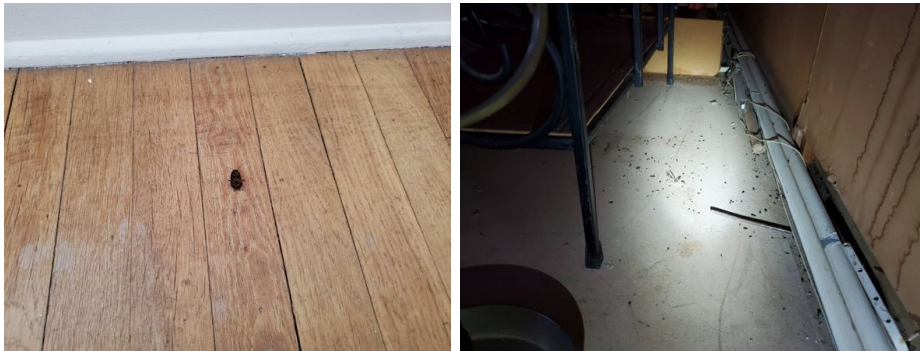
Deceased pests

Deceased pests and droppings were observed in the home. I recommend service as needed by a qualified pest control company.

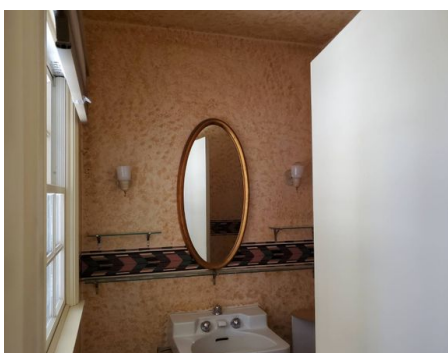
Walls & Ceilings : Wallpaper in bathroom(s)

Wallpaper is installed in one or more bathrooms. Please note that it is not uncommon for mildew-like growth to develop behind wallpaper due to high levels of moisture in bathrooms. Wallpaper is not removed or peeled during a standard Arizona home inspection.

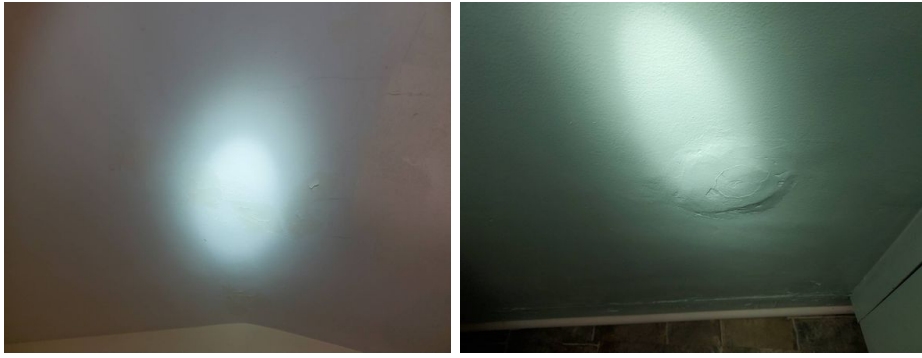
Attached and primary bathroom

Walls & Ceilings : Potential repairs

It appears as though drywall may have been repaired or patched and painted in areas.

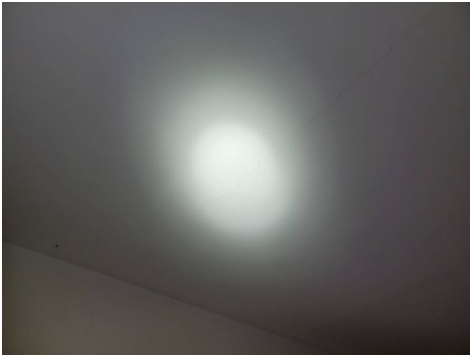
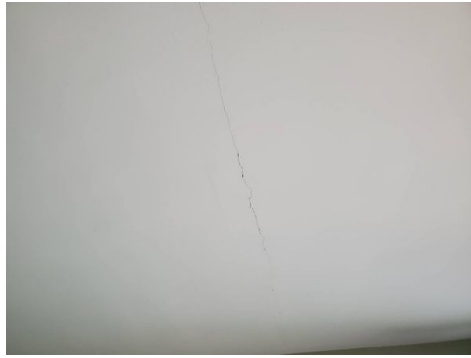
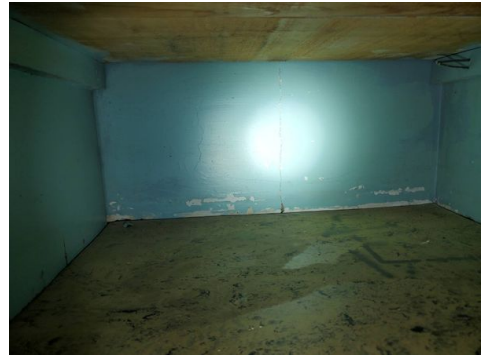
DRYWALL CRACKS

Interior drywall cracks and/or separated tape seams were observed. Drywall cracking appears as though it may be due to settlement/movement in some areas. I recommend consulting a licensed contractor to further assess drywall cracks/provide service options.

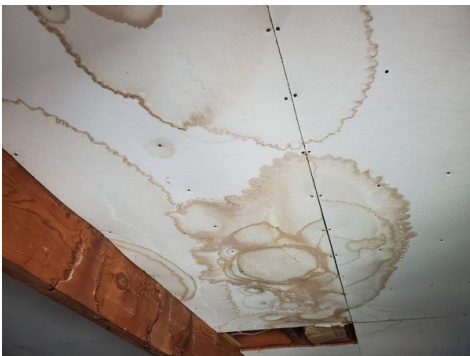
Downstairs

WATER STAINS (POTENTIAL ROOF/PLUMBING LEAKS)

Water stains/possible indication of roof and/or plumbing leaking was observed. No elevated moisture was detected with an infrared camera/moisture meter. I recommend inquiry with the seller regarding leak history. Observed conditions on the roof that could lead to leaking have been documented. A drywall repair professional or similar should be consulted for service.

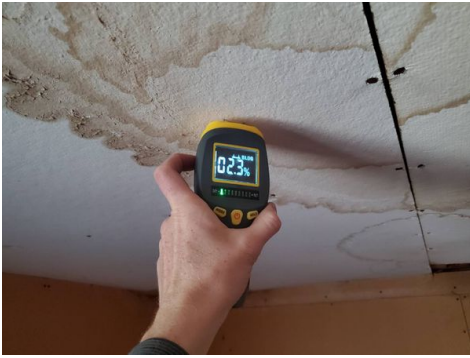
9.1.3 Walls & Ceilings

DAMAGED/OPEN DRYWALL

Damaged and open/unsealed drywall was observed. A drywall repair professional can be consulted for service.

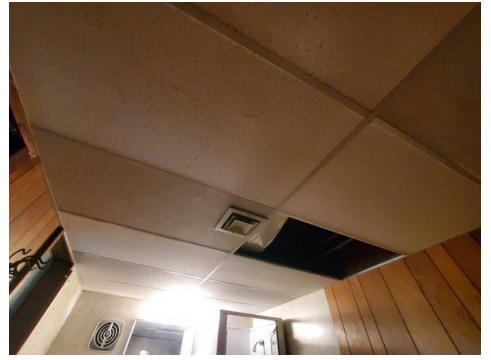
MISSING DROP-DOWN CEILING PANELS

Downstairs drop down ceiling panels are missing in some areas. A qualified professional can be consulted to install where needed.

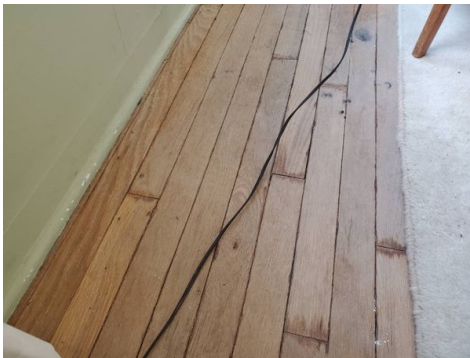
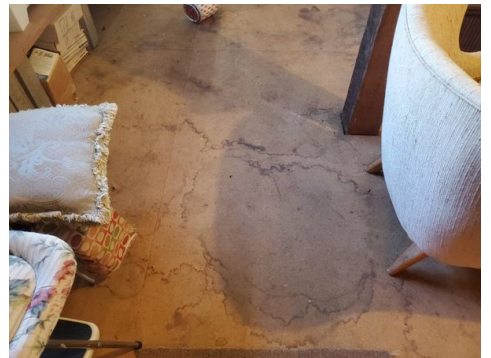
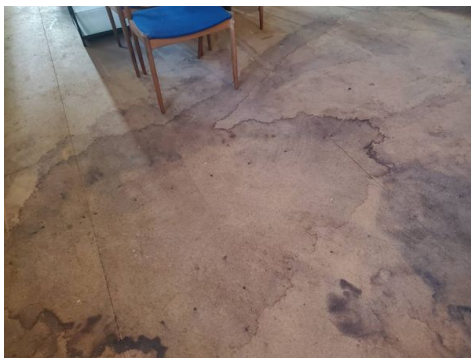
WATER STAINED FLOORING

Water stained flooring/subflooring was observed in the family/dining room and downstairs main room. No elevated moisture or excessive damage was observed. I recommend consulting a licensed flooring repair/installation professional for service.

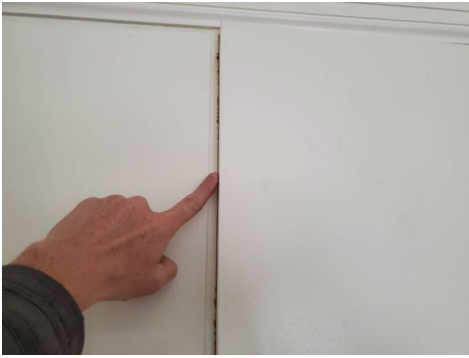
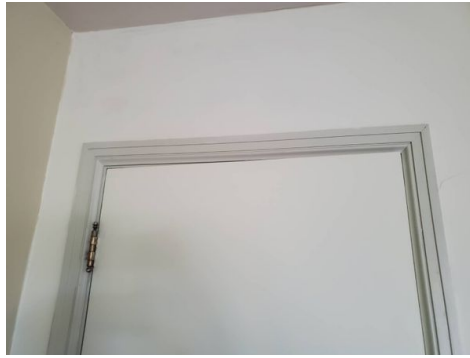
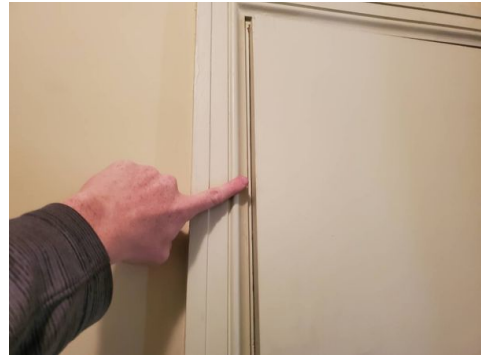
DOOR(S) RUB

Interior door(s) rub the door jamb when opening and closing. A door repair professional can be consulted for service/adjustment.

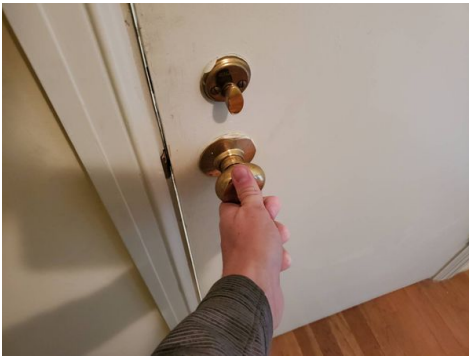
HALL AND DOWNSTAIRS

The interior door does not latch closed. Strike plate hardware can often be adjusted. A door repair professional can be consulted for service.

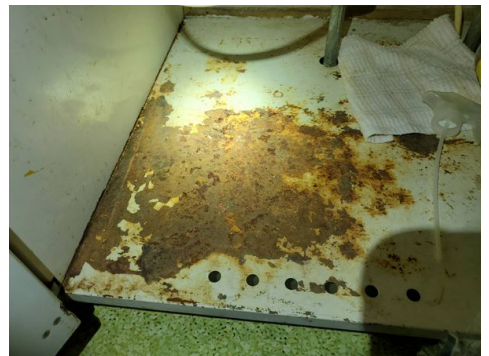
RUSTED PANELING

Rusted kitchen cabinet floor paneling was observed. Material would likely still be considered usable, however, could be replaced if needed.

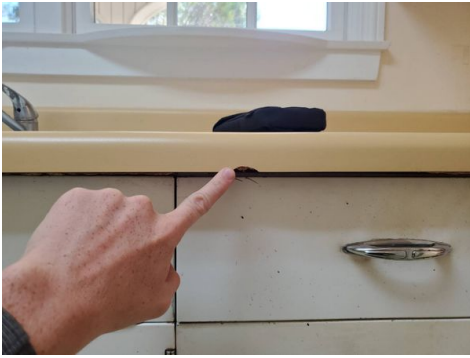
DAMAGED COUNTER FINISH

Damaged/missing countertop finish was observed. A countertop repair and installation professional can be consulted for service.

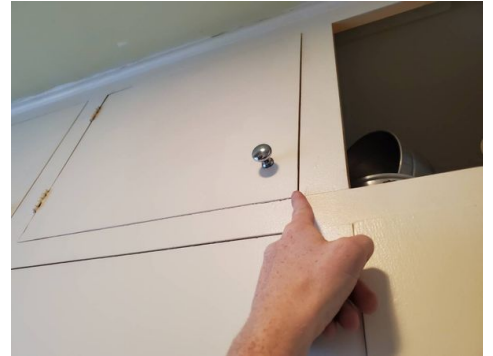
DOOR DOES NOT OPEN

A laundry room cabinet door is stuck in a closed position. A qualified cabinet repair professional can be consulted for service.

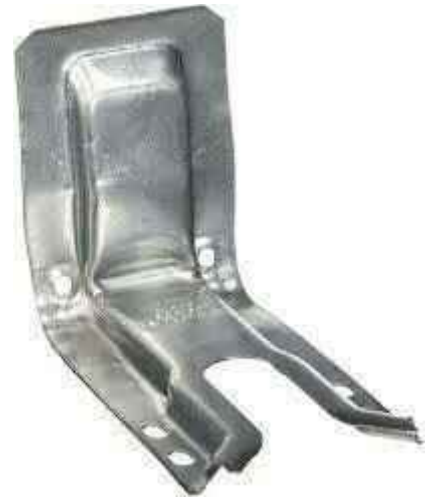
10.3.1 Range/Oven and Cooktop
MISSING ANTI-TIP DEVICE

There is no anti-tip device installed to secure the oven to the floor. This is a potential safety concern. I recommend consulting a qualified professional to install anti-tip device.
