BROWN & CO.
PROPERTY INSPECTIONS

RESIDENTIAL HOME INSPECTION REPORT

7218 N Vía De Paesia
Scottsdale, AZ 85258

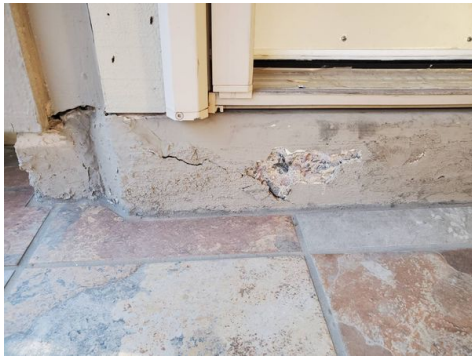
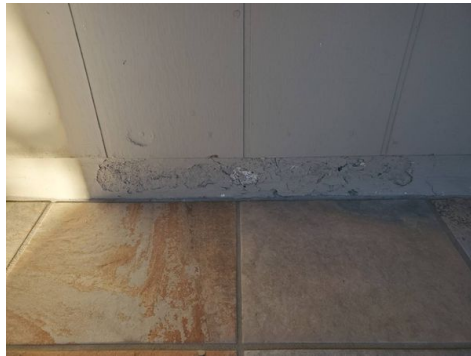
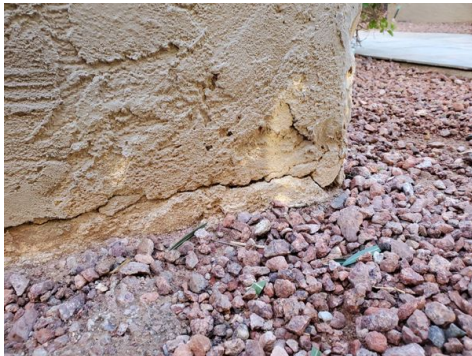
Cracks/fractures as well as spalling concrete conditions were observed. These are sometimes indications that rain water is not sufficiently draining away from the home. I recommend the affected areas be assessed and repaired by a licensed concrete/foundation repair professional. I recommend monitoring the foundation as well as drainage conditions around the foundation. Drainage conditions should be corrected anywhere water collects close to/against the foundation after rain.

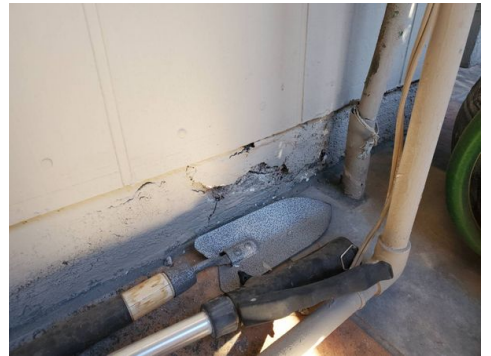
2.1.1 Foundation

SPALLING AND CRACKING

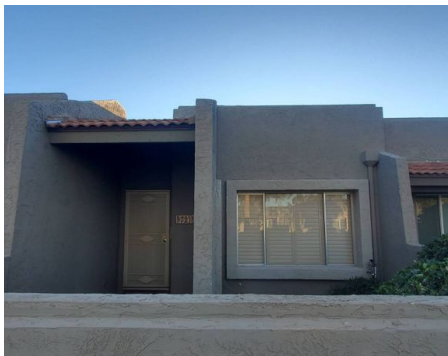
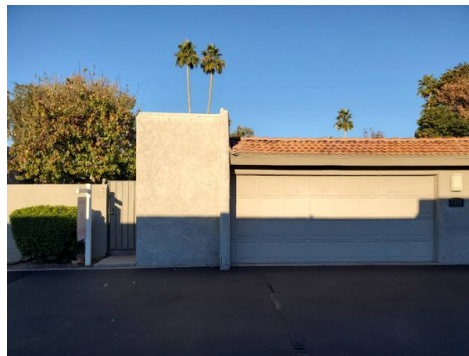
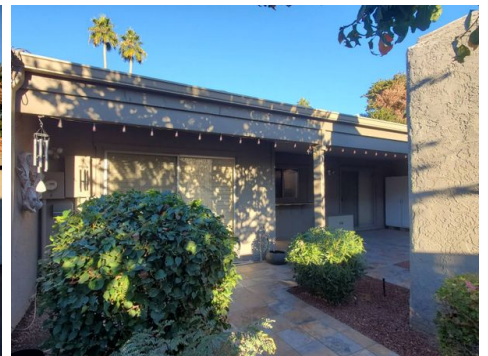
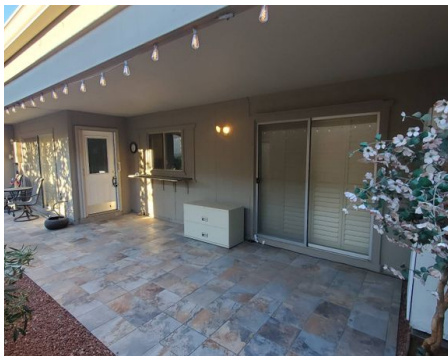
Reference Photos

Plywood/panel siding, Stucco
applied over masonry

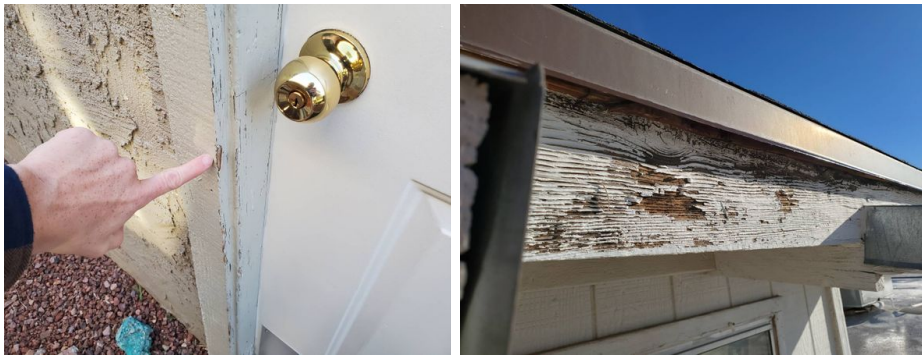
Exterior Paint : Minor flaking

Small areas of flaking paint were observed, however, paint overall appears in serviceable condition. Loose paint should be scraped and surfaces repainted.

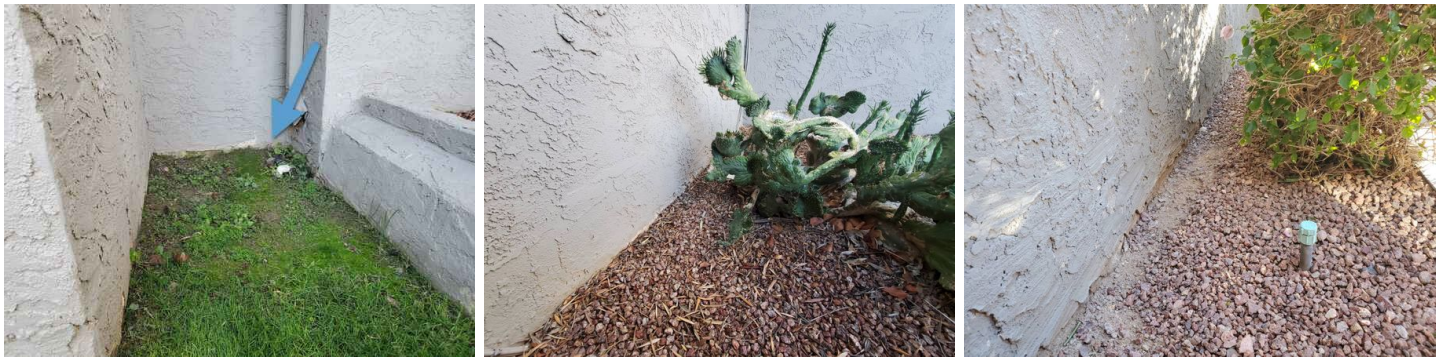
IMPROPER GRADE/SLOPE

Exterior grade is flat and/or negatively sloped in some areas. A slope of approximately **1 inch per foot away** from the foundation is recommended for at least the first few feet so that proper drainage can be maintained. I recommend grading conditions be corrected where necessary by a qualified grading or landscape professional.

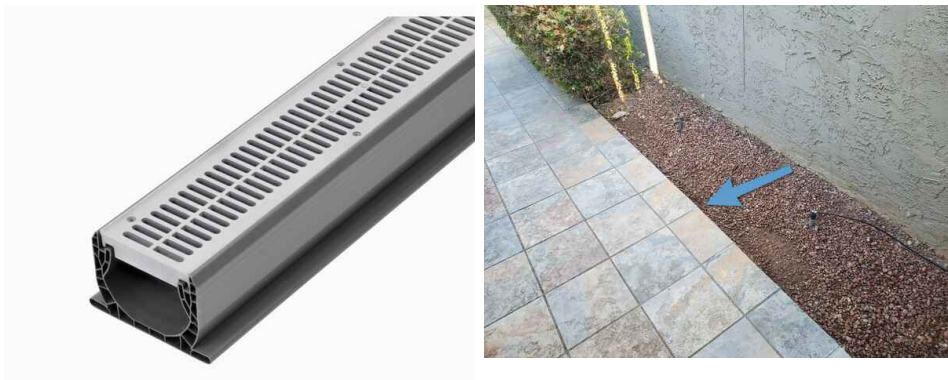
Drainage between the foundation and driveway/walkway areas appears limited. Rain water held against and/or allowed to drain below the foundation can cause concrete damage as well as structural issues. I recommend drain channels be installed where missing by a qualified hardscape contractor.

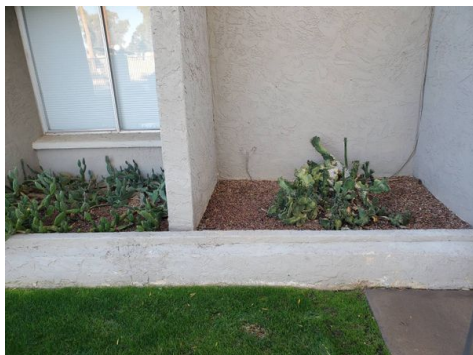
FRONT OF HOME

A planter is installed at the front of the home. Soil is held against the exterior wall in the area. Visibility of the wall is limited. This can cause moisture to be held against the wall which can lead to damage/deterioration. I recommend removing the planter.

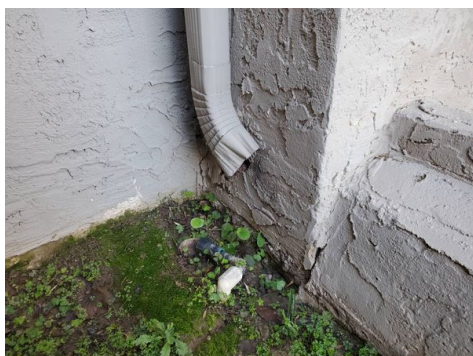
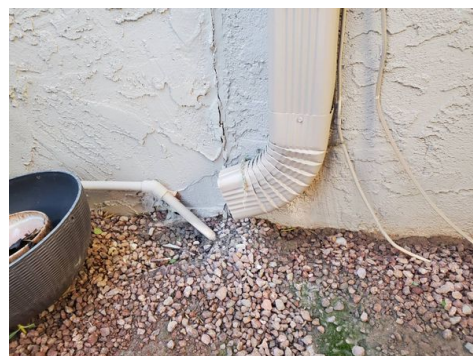
FRONT AND REAR OF HOME

Gutter downspout(s) terminate next to the structure. It is recommended gutters discharge a few feet away from the structure. A qualified professional can be consulted to extend downspouts where needed.

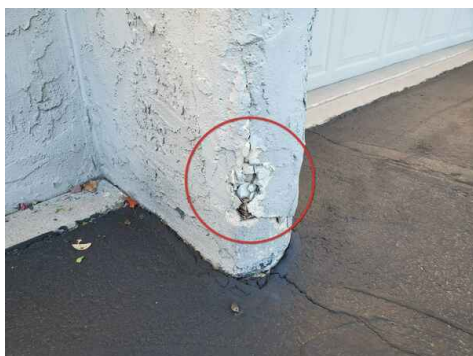
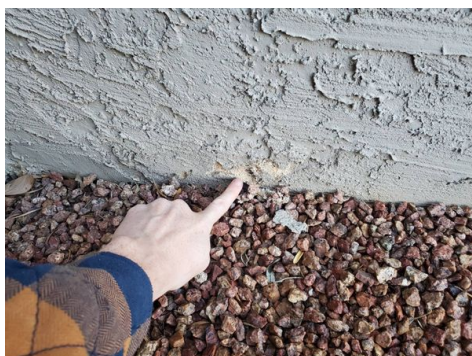
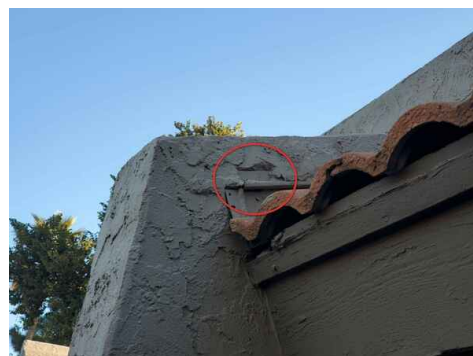
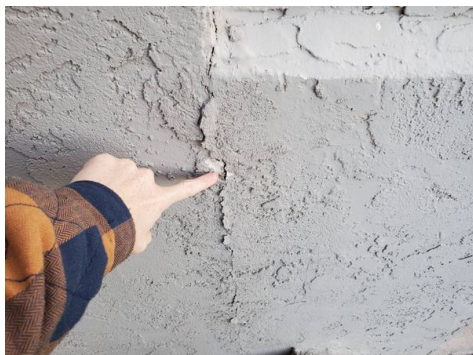
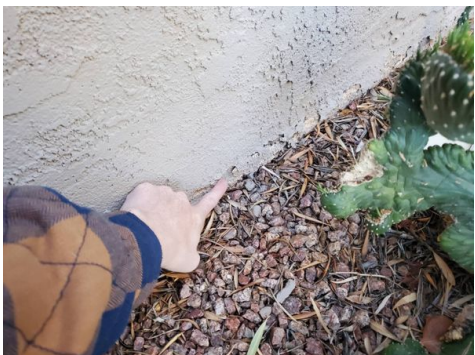
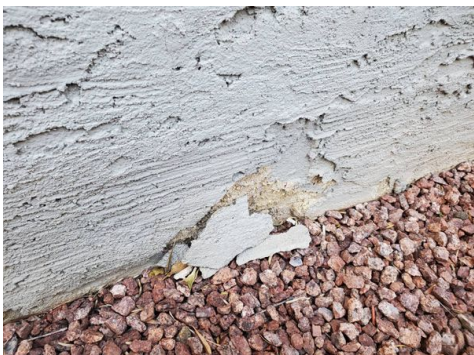
STUCCO CRACKS/CHIPS

Stucco cracks/chips and damage was observed in some areas. Cracking is often a result of the natural curing process however can also be an indication of settling or movement. Stucco cracks are typically be sealed when they reach the point where water could penetrate. A siding repair professional should be consulted for service.

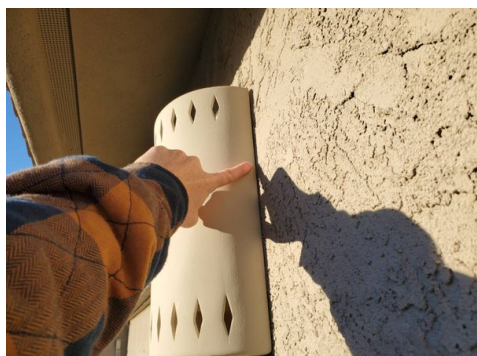
Some exterior light fixtures are loose and/or the enclosures are not sealed against the exterior wall. These exterior wall openings can allow pest and/or moisture intrusion. I recommend securing and sealing around all the exterior lights. A qualified handy person could be consulted for service if needed.

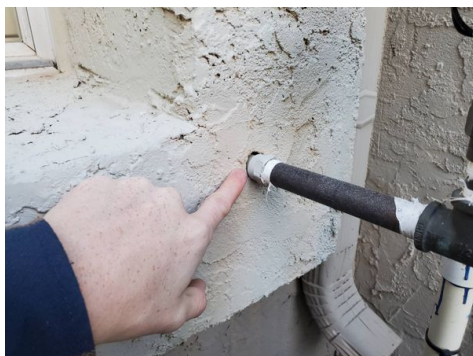
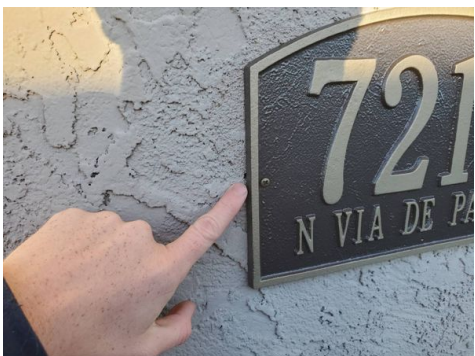
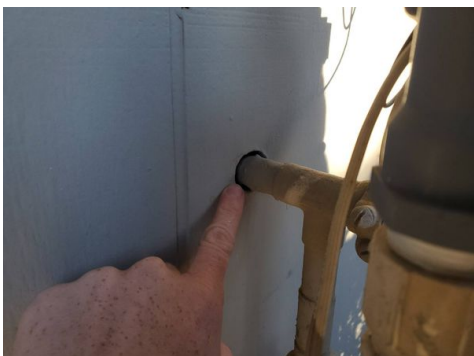
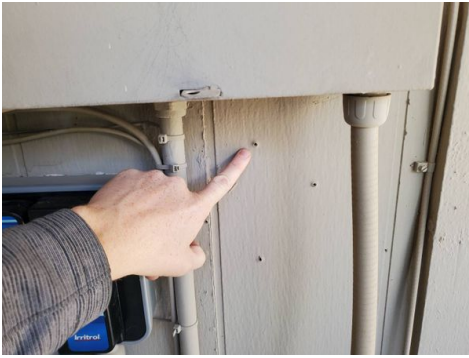
FRONT AND REAR OF HOME

Exterior wall penetration(s) are not sufficiently sealed in some areas. Openings/penetrations should be sealed with approved exterior caulk/sealant to prevent pest and moisture intrusion.

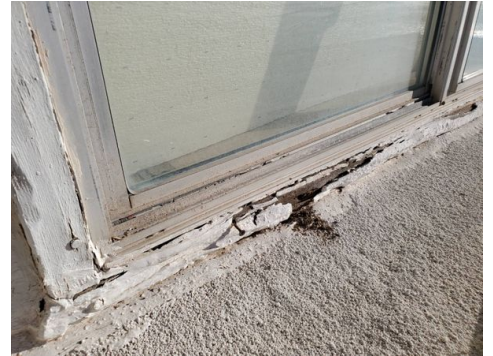
Water damaged exterior trim was observed at the roof surface. Water damaged materials should typically be repaired/replaced. I recommend consulting a siding repair professional for service.

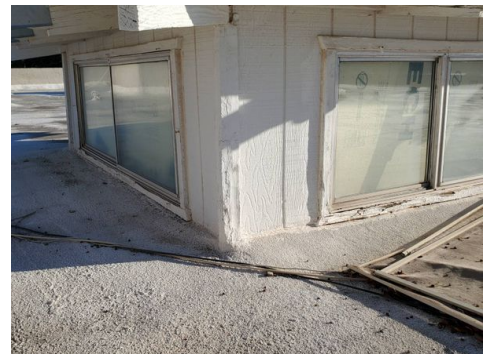
Siding is installed all the way to the roof covering. There should typically be a gap with visible flashing between siding and the roof covering. The condition may allow a degree of water damage along the roof-wall transition. I recommend monitoring and consulting a siding repair professional for service if/when necessary.

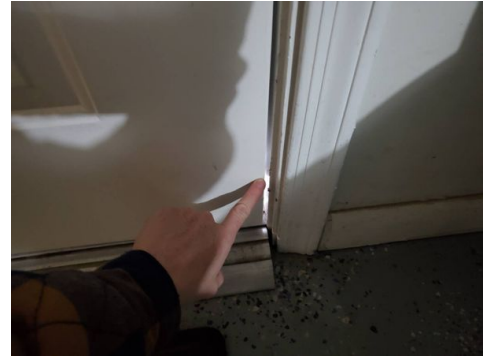
The garage and house rear exterior door is not sufficiently sealed when closed. This can lead to pest and moisture intrusion. I recommend adjusting the door and/or installing additional weatherstripping where needed. A door repair professional can be consulted for service.

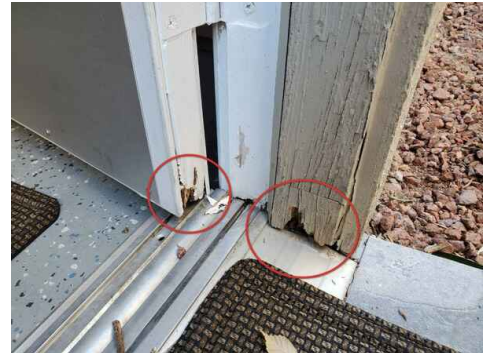
Water damage was observed at the garage exterior door/jamb. A qualified door repair professional can be consulted to replace material as needed.

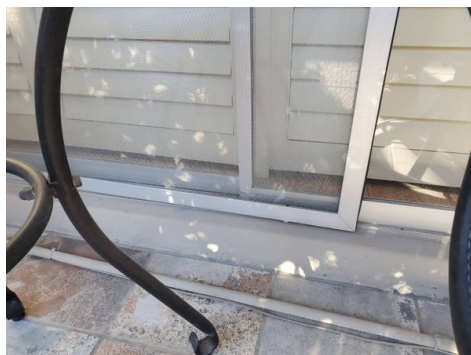
SCREEN DOORS HARD TO SLIDE

The screen doors could be considered difficult to slide. I recommend cleaning and lubricating the tracks. A qualified door repair technician could be consulted for service if needed.

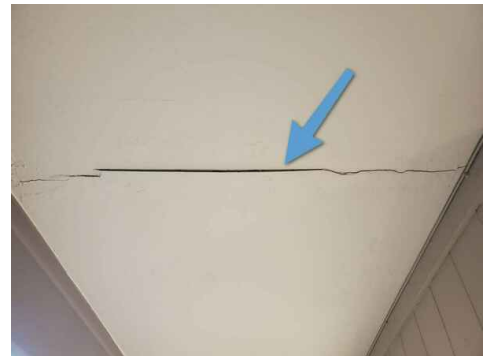
Loose drywall tape and/or visible tape seams were observed at the exterior drywall ceiling. A drywall repair professional can be consulted for service as needed.

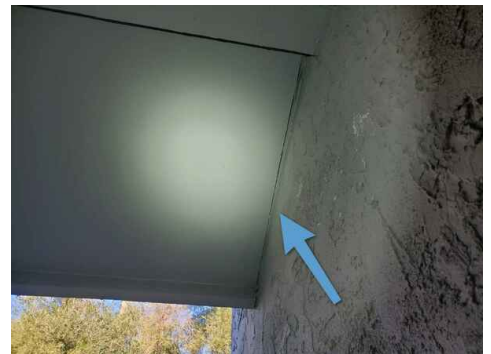
Separation between stucco and exterior drywall was observed. The intersection can be resealed as needed.

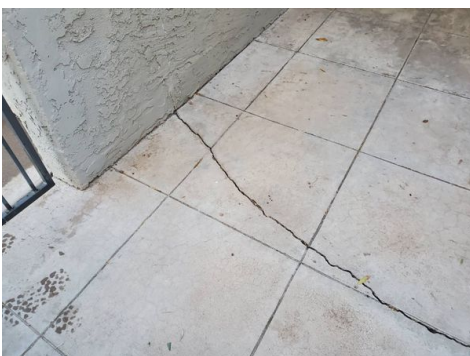
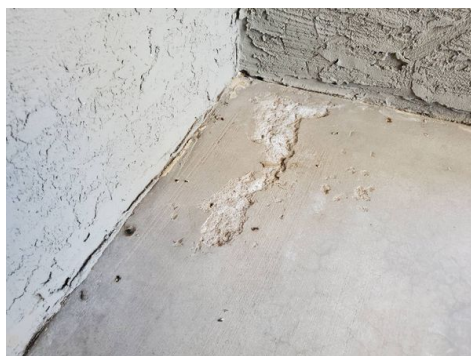
FRONT OF HOME

The exterior concrete slab is cracked/damaged. I recommend consulting a qualified professional for service/repair.

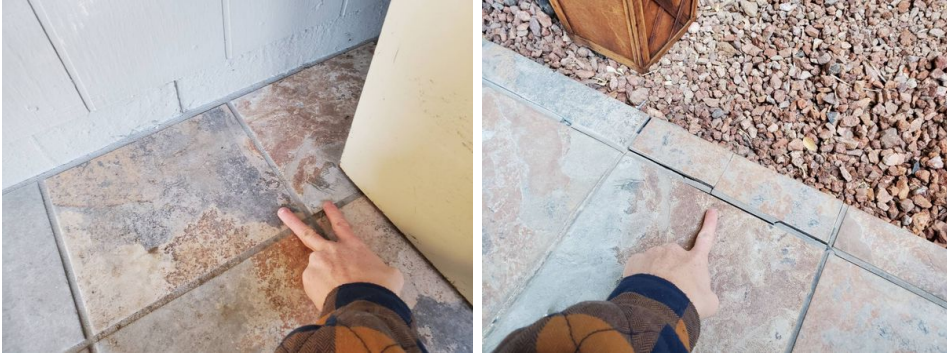
Some of the rear patio floor tile sound hollow when tapped/walked on as if they are not fully adhered. This could lead to cracking of tile and grout or lifting of tile. Furthermore, some cracked tile/grout was observed. I recommend repair by a qualified flooring professional.

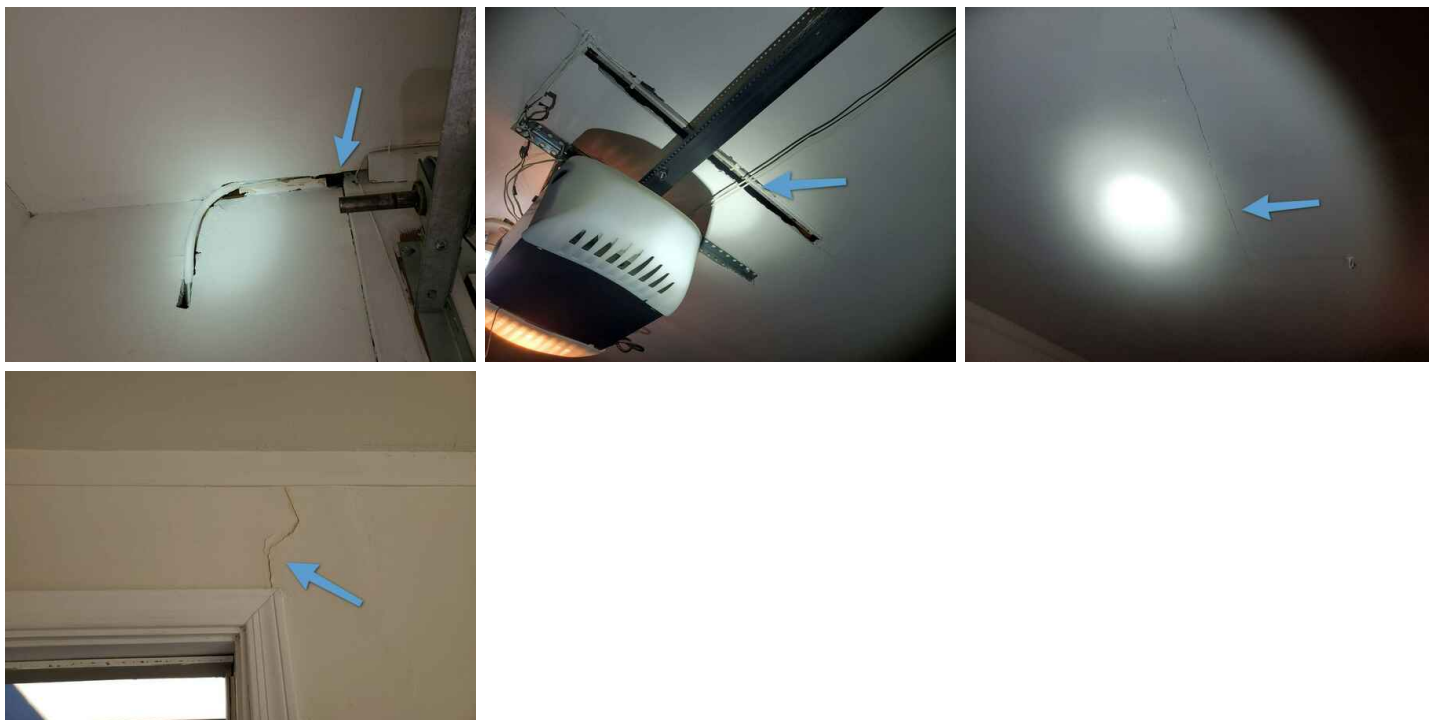
Drywall cracks/unsealed openings were observed in the garage on some walls that would not be considered a firewall. I recommend repair as needed. A drywall repair professional can be consulted for service.

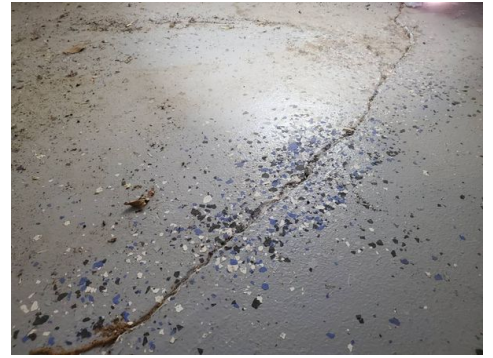
The garage slab/floor is cracked and there is a degree of separation and offset concrete. A concrete repair professional should be consulted for service.

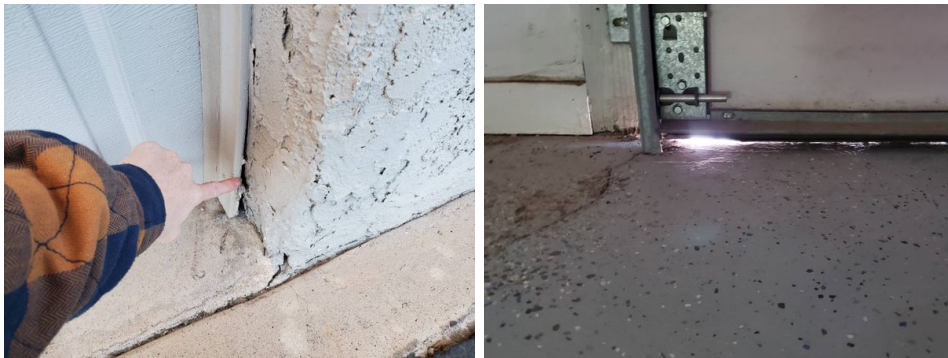
Loose, unsealed or open garage overhead door weather-stripping observed. This can lead to water intrusion into the garage through the overhead door opening even when the door is closed. Weather-stripping can usually be secured and sealed if not damaged.

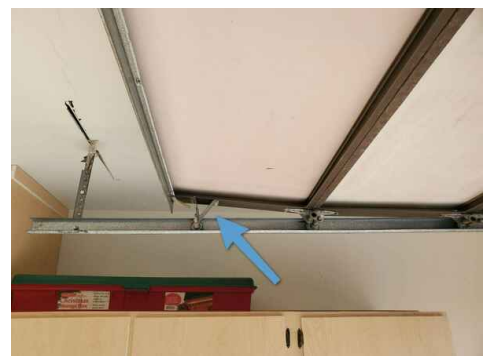
The garage overhead door is moderately noisy when opening and closing. This may be due to the installation of inconsistent door track roller hardware. The door appears mechanically sound otherwise. A garage door technician can be consulted to service the door as needed.

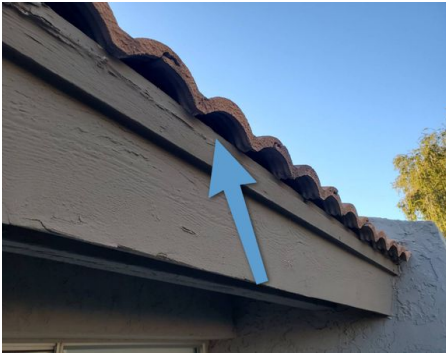
Roof Coverings: No bird block material installed

Please note there is no bird block material installed at the roof eaves. This material may not have been required when the home was built. A qualified roofer can be consulted to install bird block material as needed.

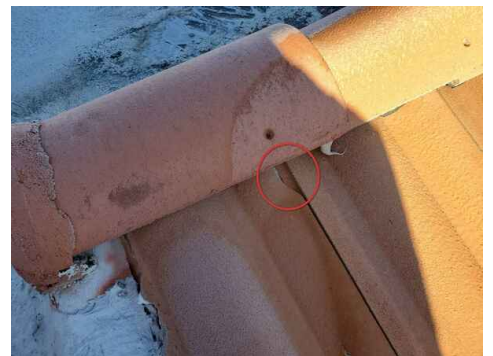
Some of the roof tile are cracked/damaged. This can lead to rain water penetrating below tile and can expose the underlayment to UV. Prolonged water runoff and UV exposure may lead to premature wear/deterioration of the underlayment below the tile. I recommend consulting a qualified roofing professional for service.

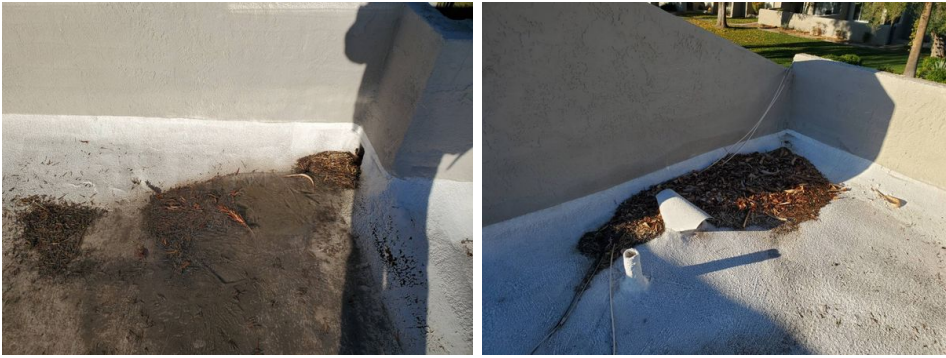
Dust/debris accumulation was observed on the roof. Debris accumulation can lead to limited drainage and water intrusion. I recommend debris be removed by a qualified professional/roofer.

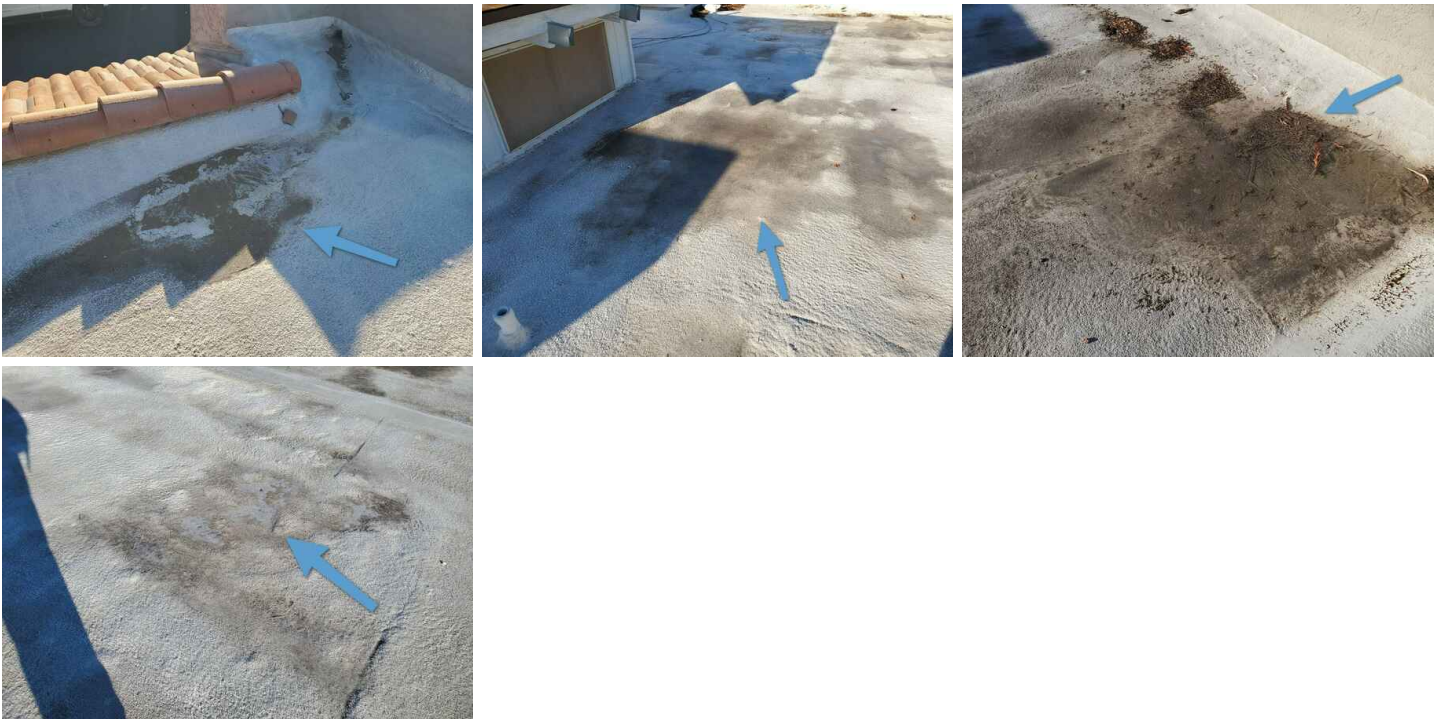
Areas of water retention/ponding were observed at the flat roof covering. Ponding water on the roof can prematurely deteriorate the roof covering material and lead to leaking. It will be important to keep the roof clear of dust/dirt and debris so that drainage is not further affected. I recommend consulting a qualified roofer periodically to assess the roof covering for signs of damage or deterioration.

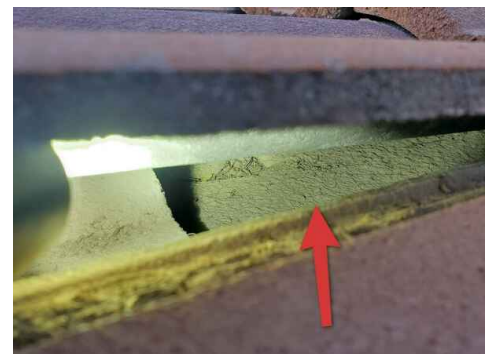
FRONT OF HOME

TILE ROOF UNDERLAYMENT

The tile roof underlayment installed appears to be original/approximately older than 20 years of age. The average/anticipated serviceable life of tile roof underlayment is approximately 20 to 30 years depending on material quality, quality of workmanship and other environmental factors. I recommend consulting a licensed roofing contractor to assess the underlayment condition. Please note I did not fully remove any roof tile during the inspection. Two tiles were lifted slightly. We do not guarantee the remaining serviceable life of the roof covering.

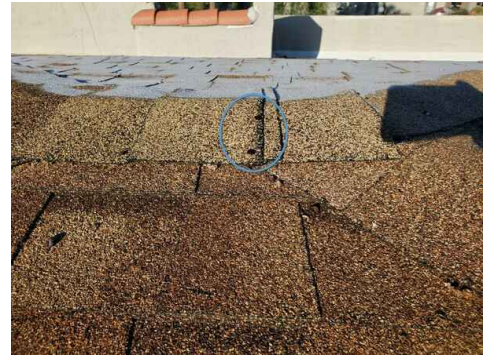
Exposed/unsealed fasteners that penetrate the roof covering can (potentially) lead to water intrusion. I recommend having these fasteners sealed by a qualified roofer.

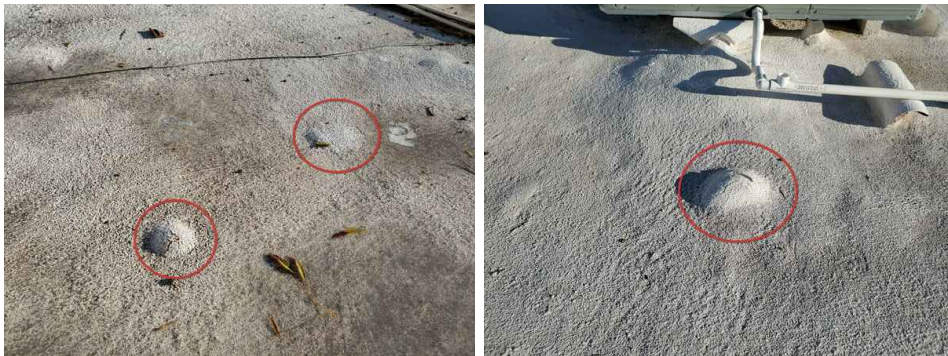
Blistering/raised areas were observed at the foam roof surface. This often indicates moisture/air is trapped underneath the roofing membrane at these areas. I recommend consulting a qualified roofer for repair.

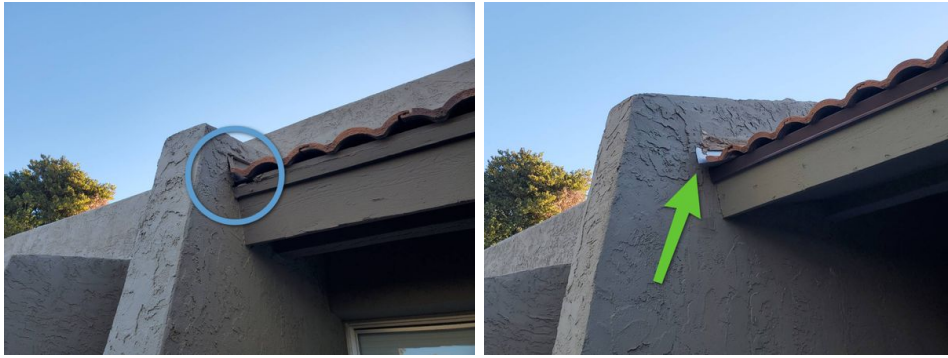
Kick-out flashing is missing at the intersection of the roof covering and sidewalls in some areas. Kick-out flashing helps prevent moisture intrusion into the wall cavity and/or will help prevent exterior siding damage. I recommend adding kick-out flashing. A qualified roofer can be consulted for service.

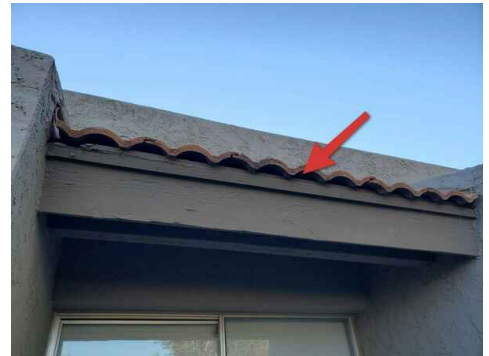
Metal flashing is missing between the roof covering and roof eave fascia. I recommend having permanent flashing installed by a qualified roofer.

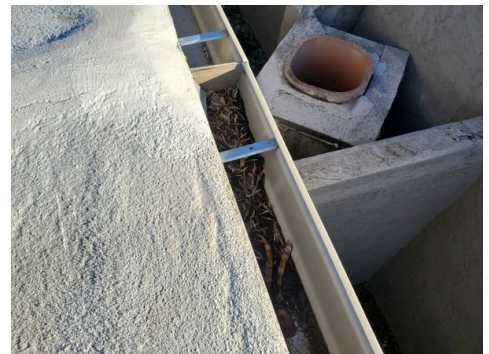
Debris observed in the roof gutters can/will limit drainage. I recommend clearing gutters as/when necessary.

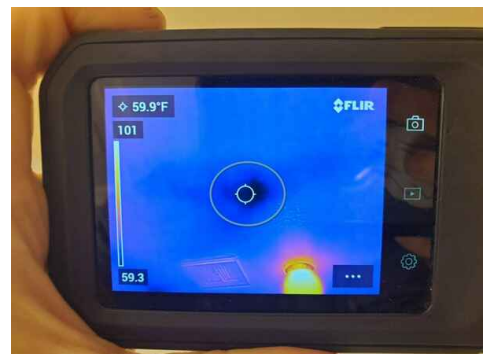
Attic insulation appears to be low, displaced, or missing as observed utilizing an infrared camera. I recommend consulting an insulation installer to add insulation where necessary.

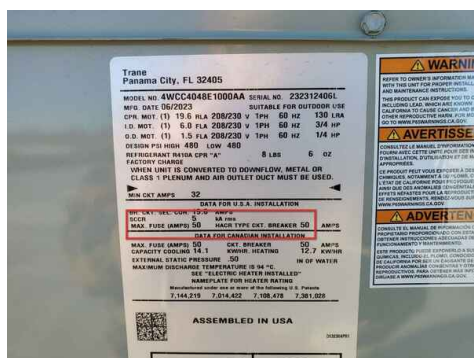
The circuit breaker installed for the cooling system compressor/condenser unit is oversized per the data label. I recommend consulting a licensed electrician for service/correction.

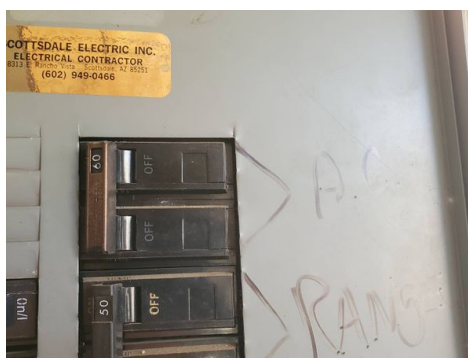
OVERSIZED BREAKER

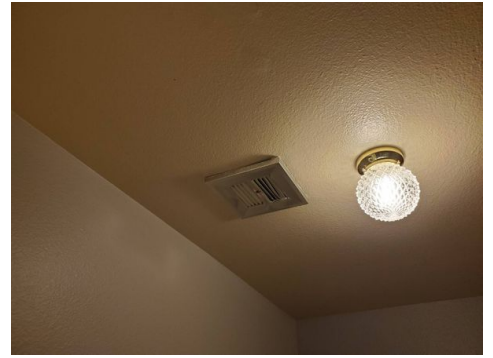
The ventilation fan did not respond when tested. I recommend service or replacement by a qualified professional/electrician.

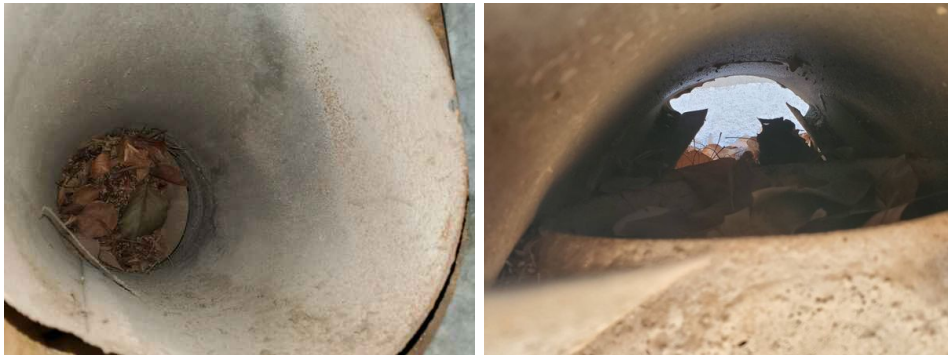
Debris accumulation was observed inside some ventilation fan ducts. A licensed professional should be consulted to remove debris from the ducts.

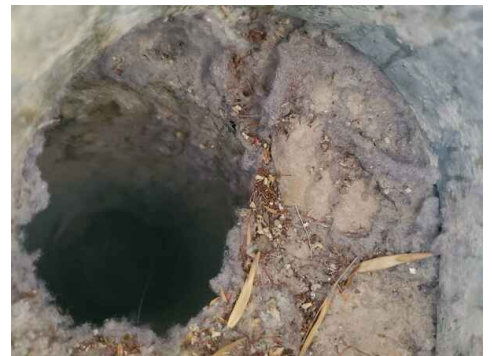
Accumulation of dryer lint was observed in the dryer vent. Lint is flammable and should be cleared periodically. I recommend having the vent cleaned by a qualified vent cleaning professional.

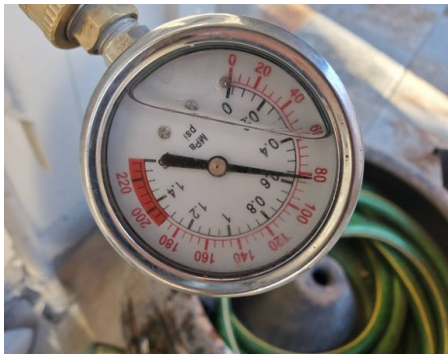
Water pressure close to/at 80 psi

Water pressure was close to/at 80 psi when tested. Pressure should be reduced if it exceeds 80 psi. I recommend re-testing periodically and consulting a licensed plumber to install a pressure regulating valve if pressure ever exceeds 80 psi.

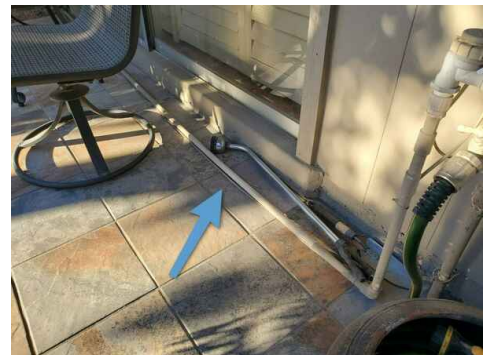
PIPING INSTALLED ABOVE WALKWAY

Irrigation distribution piping has been installed above the rear patio walkway surface. It would be considered preferable to have the plumbing installed below the walkway to prevent a tripping concern. A licensed plumber can be consulted to relocate plumbing as necessary.

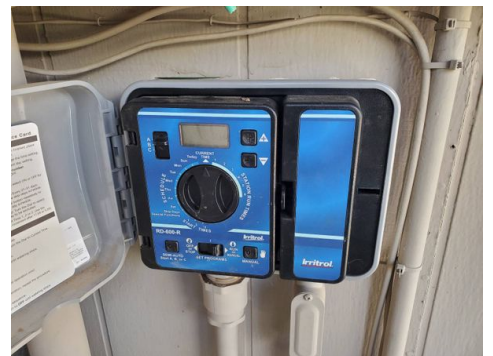
IRRIGATION TIMER NOT ABLE TO BE TESTED

The irrigation timer was unresponsive when I manually tested the timer using manufacturer's instructions. A qualified technician could be consulted for further assessment/service.

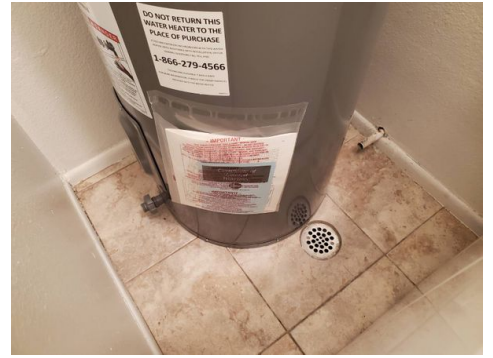
There is no drip pan installed below the water heater to help catch water in the event of a leak. A qualified professional/plumber can be consulted to install a drip pan.

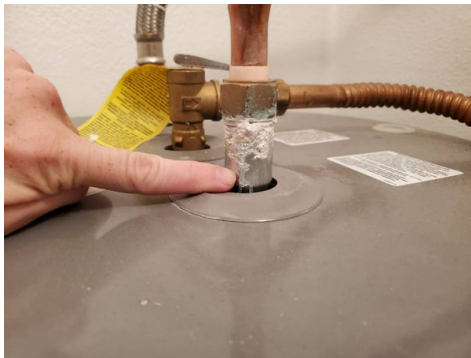
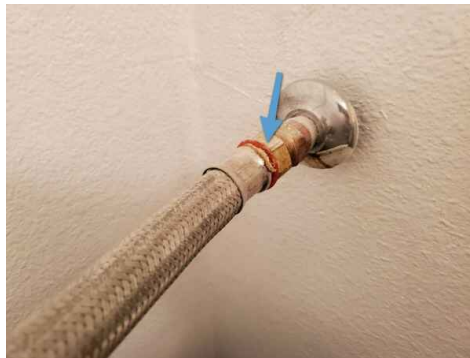
CORROSION AT INLET/OUTLET

Corrosive build-up was observed at the water heater inlet and/or outlet fittings. Corrosion can lead to water restriction as well as material damage resulting in leaking. I recommend consulting a licensed plumber for service

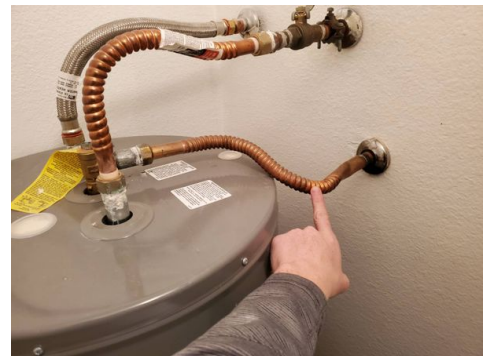
The water heater temperature/pressure relief valve discharge pipe termination could not be located. Monitoring for discharge is important so the pipe should terminate in a conspicuous/observable location. I recommend consulting a licensed plumber for further assessment.

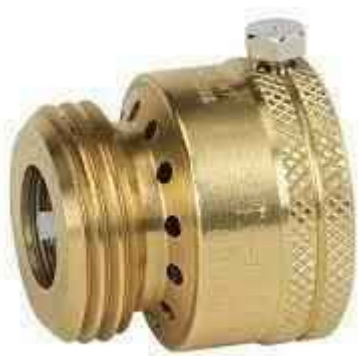
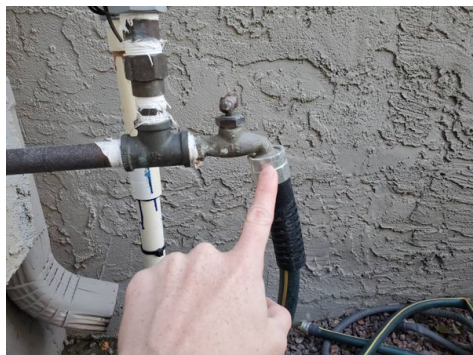
MISSING HOSE BIB VACUUM BREAKERS

A connected hose without a vacuum breaker may draw contaminated water into the clean/potable water supply. I recommend installing vacuum breakers where missing/before connecting hoses.

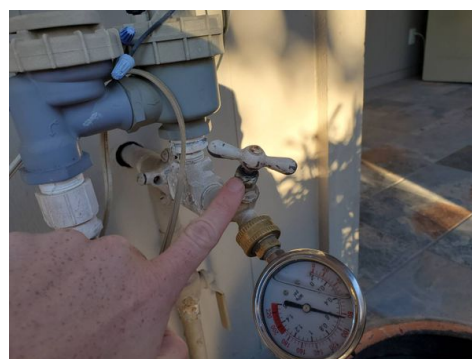
LEAKING HANDLE(S)

Some hose bibs leak at the handles while water is flowing. A qualified plumber can be consulted for repair or replacement.

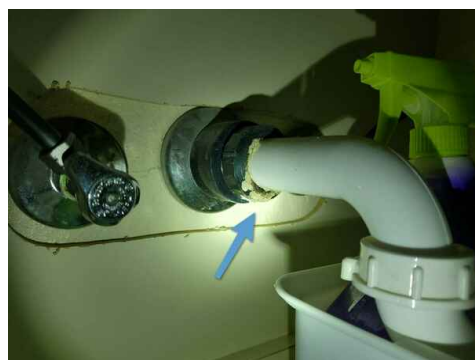
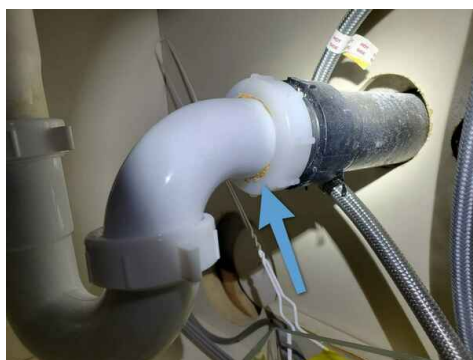
EVIDENCE OF LEAKING

Evidence of previous leaking was observed. It is not evident that these leaks were serviced or repaired. Minor leaking can sometimes self seal however sinks should still be serviced/fittings should be tightened to prevent future leaking.

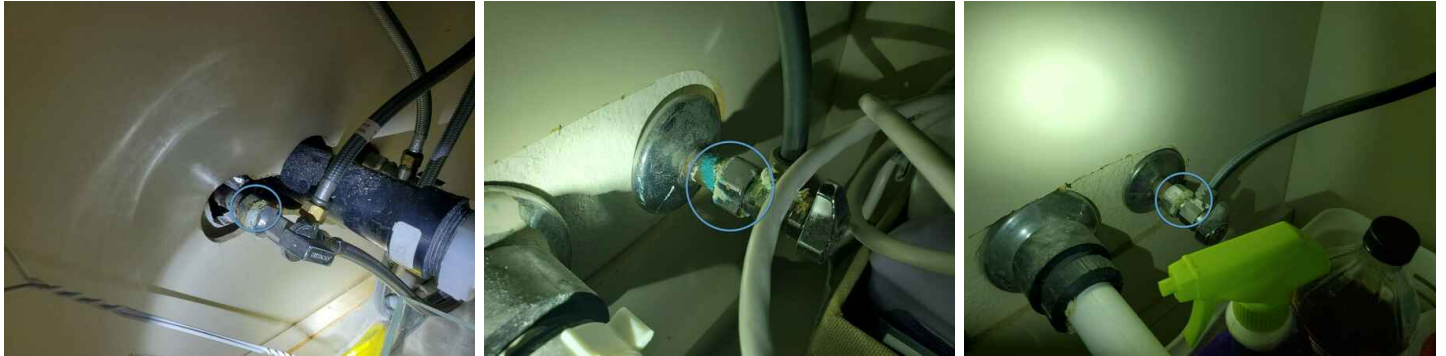
Calcification and/or corrosion was observed at sink supply/shut-off valves. While no active leaking or dripping was observed at the valves the condition could indicate securing/tightening or replacement is necessary.

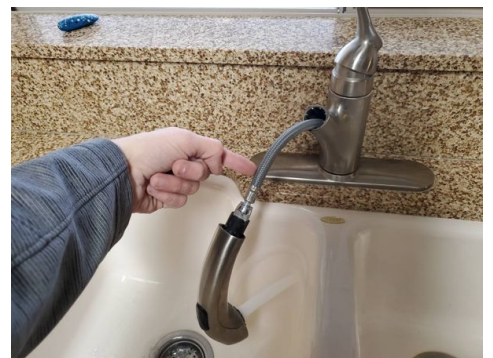
The extendable kitchen sprayer does not fully retract. This will sometimes be caused by the weight below contacting stored items or plumbing. A licensed professional/plumber can be consulted for adjustment if necessary.

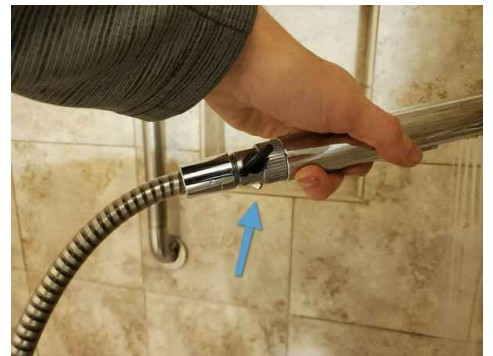
Leaking from the shower-head attachment observed. I recommend securing fittings to try to stop the leak or replacing the showerhead if necessary. A qualified handy person could be consulted for service if needed.

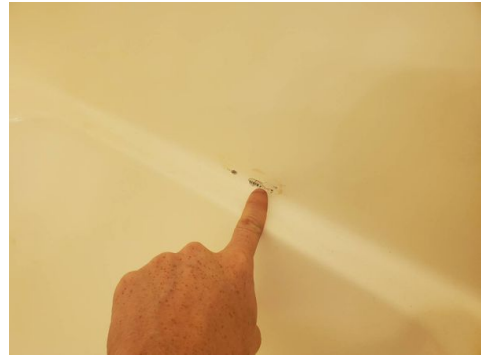
Chipped/damaged finish was observed at the tub. I recommend patching/resealing damaged areas. A qualified professional should be consulted for service if needed.

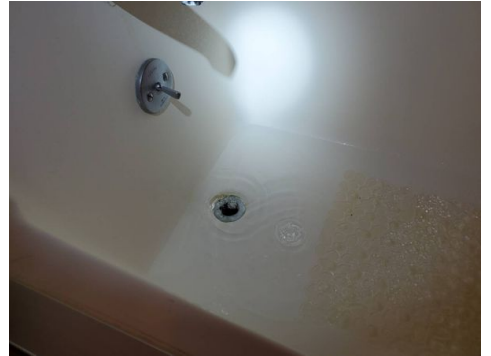
Slow drainage was observed when the tub/shower was tested. I recommend consulting a licensed plumber for service.

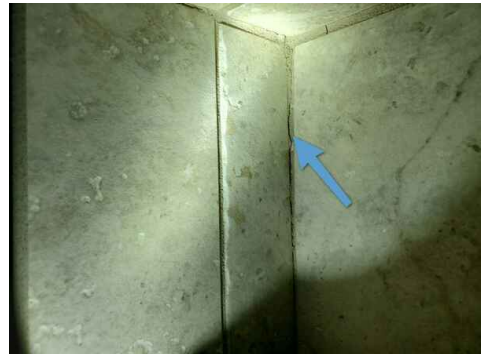
Minor grout cracking was observed. I recommend resealing as/when necessary to help prevent water intrusion behind these materials.

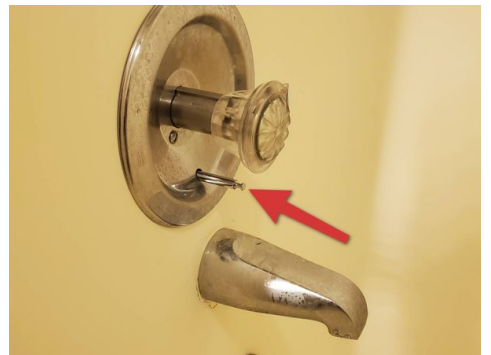
The diverter valve is seized/stuck in the shower position. Corrosion also observed at the tub spout. I recommend a qualified plumber service or replace the tub spout/diverter as needed.

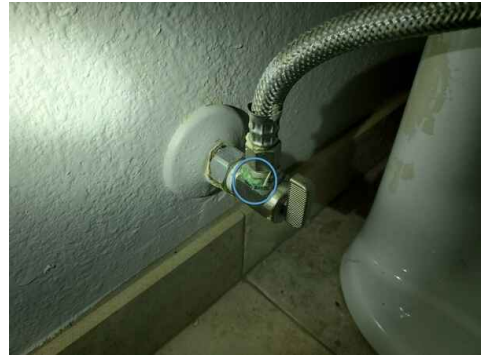
Calcium and/or corrosive buildup was observed at toilet supply valve(s). These conditions often indicate a degree of leaking and can restrict water flow. I recommend consulting a qualified professional/plumber to replace supply valves.

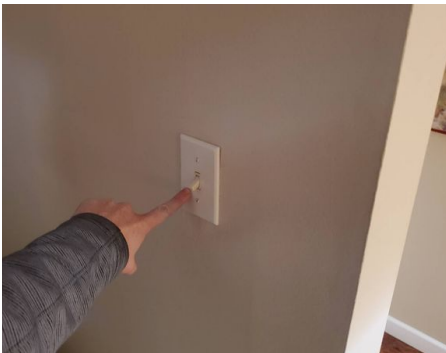
Great Room

I was not able to determine the function or operation of some switches. The switches may be disconnected. A qualified electrician could be consulted for further assessment.

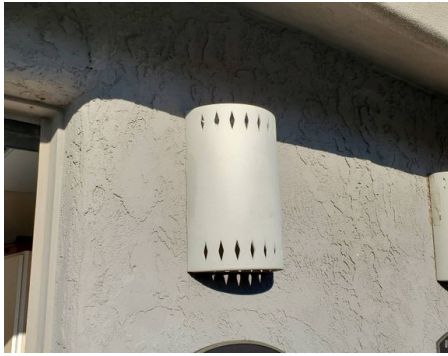
Light Fixtures, Ceiling fans and Switches : Not able to test (HOA)

No switches were located to test the rear exterior lights. The lights *may* be controlled by an HOA maintained timer and would turn on at night if functional.

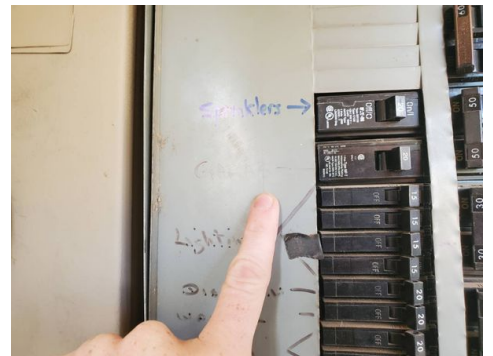
Circuit labeling at the main electric service panel dead front cover is fading however is still legible. I recommend re-labeling while still legible. An electrician should be consulted to re-label if needed.

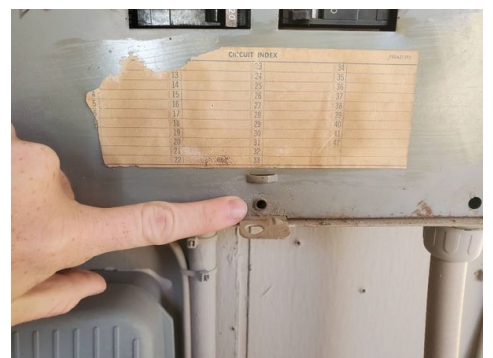
MISSING ONE DEAD FRONT SCREW

One of the fasteners to secure the main electric service panel dead front cover is missing. I recommend replacing the fastener. A qualified handy person or electrician can be consulted if needed.

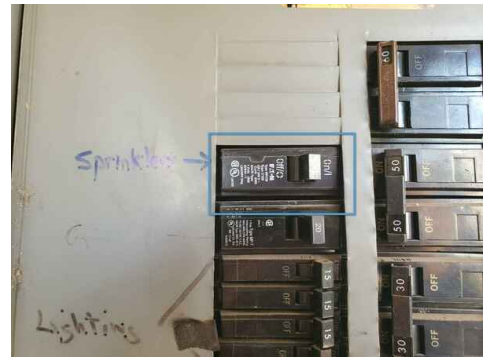
NON OEM BREAKER

A circuit breaker is installed that was not manufactured by the electrical service panel manufacturer. Electrical service panel manufacturers typically require their own/specific breakers be installed. I recommend consulting a qualified electrician to assess/replace the breakers as necessary.

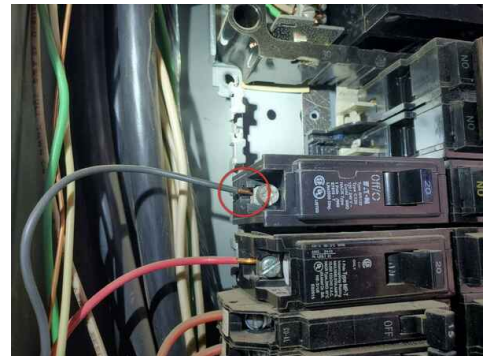
UNDERSIZED CONDUCTORS

Electrical conductors are undersized/too small for the connected overcurrent device(s) for some circuits. This can lead to issues with excessive heat. I recommend consulting a qualified electrician for service/correction.

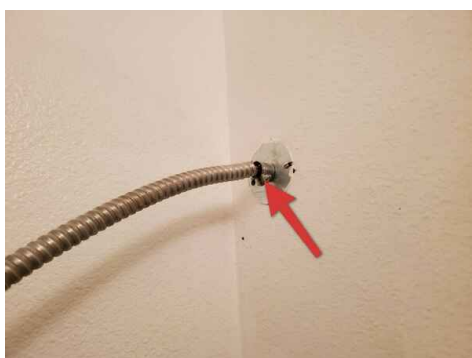
Electrical conduit is not properly secured at the connection and electrical conductors are partially exposed. I recommend consulting a licensed electrician for service.

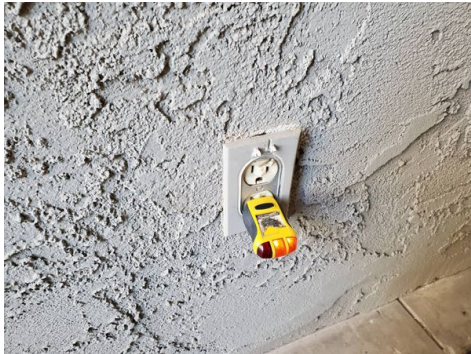
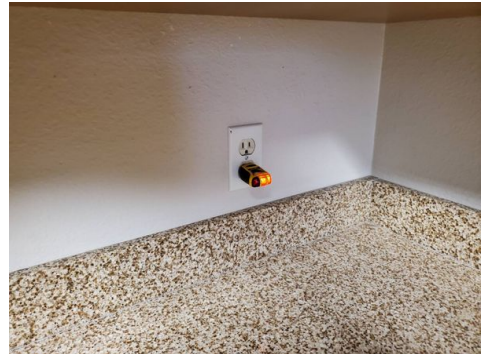
MISSING GFCI PROTECTION PER CURRENT STANDARDS

Ground fault circuit interrupters (GFCI) are not installed in some locations where they are now required. Although GFCI protection may not have been required in these locations when the home was built it is recommended as a safety precaution. I recommend consulting a licensed electrician to install GFCI protection where it is missing.

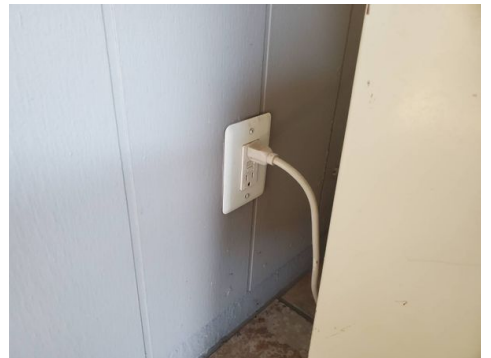
REAR OF HOME

Receptacles installed outdoors should have specific outdoor-rated covers installed. I recommend replacing indoor covers with outdoor covers. A qualified professional/electrician should be consulted for service if needed.
