BROWN & CO.
PROPERTY INSPECTIONS

RESIDENTIAL HOME INSPECTION REPORT

7218 N Vía De Paesia
Scottsdale, AZ 85258

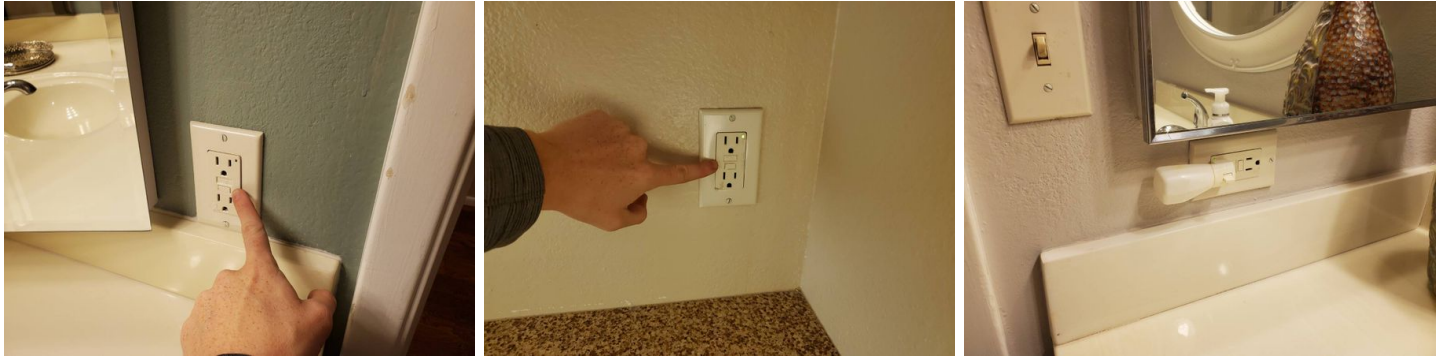
GFCI STUTTERS

The GFCI receptacles stutter when tripped. This could indicate the devices are nearing the end of its serviceable life and could become a safety concern if the receptacles do not trip quickly. I recommend replacement by a qualified professional/electrician.

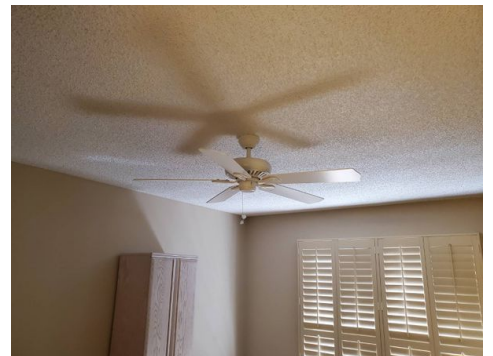
PRIMARY BEDROOM

The ceiling fan (motor) did not respond when tested. The fan was tested at wall switches and the pull chains. No remote was located. I recommend consulting a licensed electrician for service/repair.

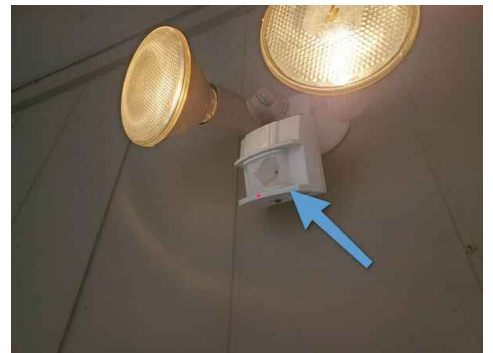
REAR OF HOME

The exterior motion sensing light fixture sensor cover is damaged/missing. A qualified electrician could be consulted for service if needed.

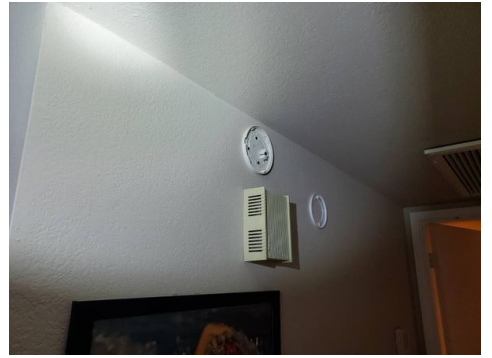
HALL

Smoke detector(s) have been removed in some rooms/areas. A qualified electrician could be consulted to replace if necessary.

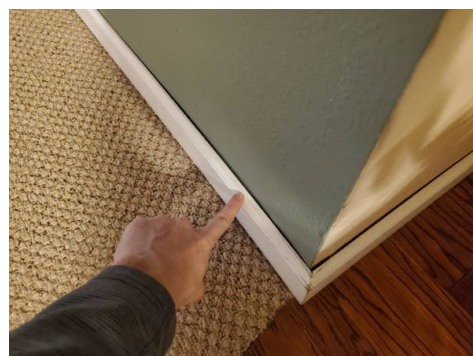
Baseboards are loose/separated from drywall in some areas.

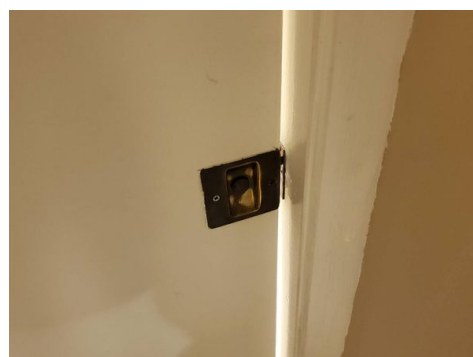
9.3.1 Interior Doors & Closets

POCKET DOOR LOCK

The primary bathroom pocket door lock does not fully engage. A door repair professional could be consulted for service if needed.

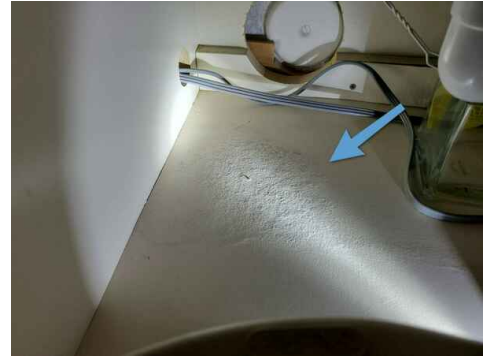
STAINS AND SWELLING

KITCHEN

Stains and damage/swelling was observed. Material feels solid. No indication of elevated moisture was detected with a moisture meter. Material would likely still be considered usable, however, could be replaced if needed.

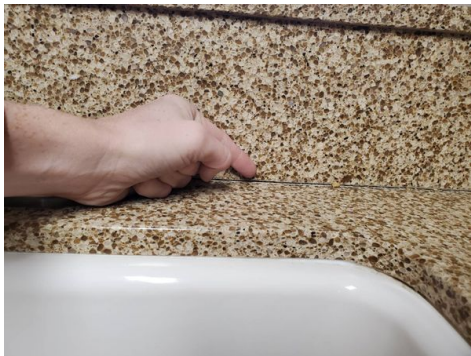
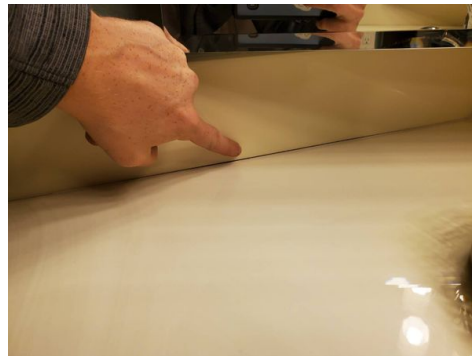
MISSING CAULK OR GROUT

KITCHEN AND BOTH BATHROOMS

Missing grout or caulk observed between countertop and backsplash in some areas. I recommend resealing the intersection to help prevent moisture intrusion.

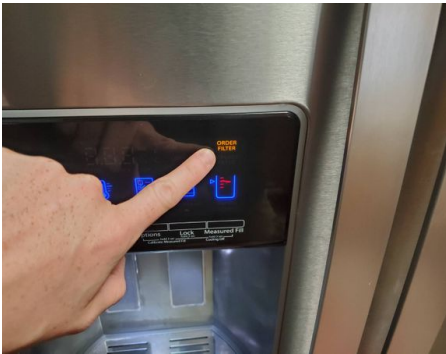
Refrigerator : Replace water filter

The "replace water filter" LED was illuminated at the refrigerator control.

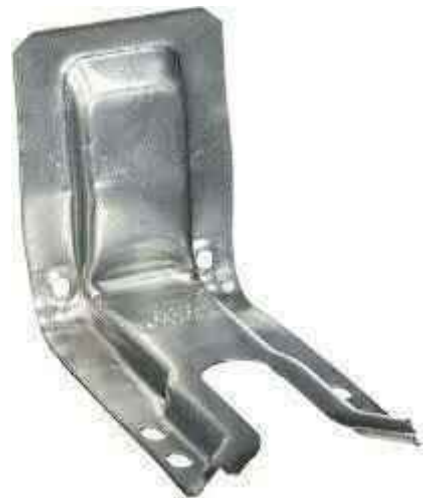
10.3.1 Range/Oven and Cooktop

MISSING ANTI-TIP DEVICE

There is no anti-tip device installed to secure the oven to the floor. This is a potential safety concern. I recommend consulting a qualified professional to install anti-tip device.
