RESIDENTIAL HOME INSPECTION REPORT

2149 S Olivewood
Mesa, AZ 85209

MARCH 11, 2024

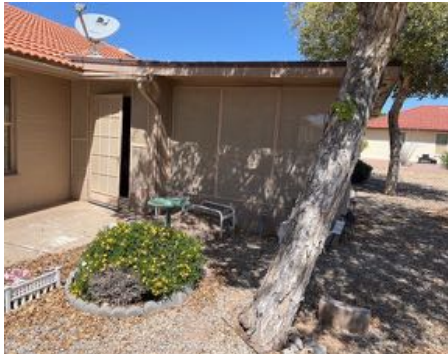
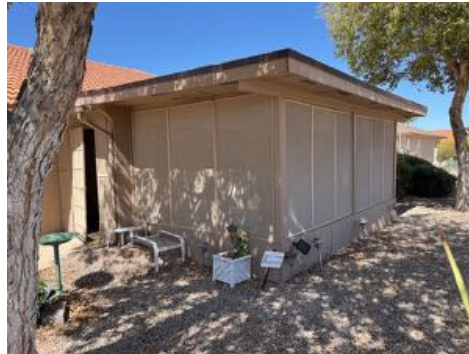
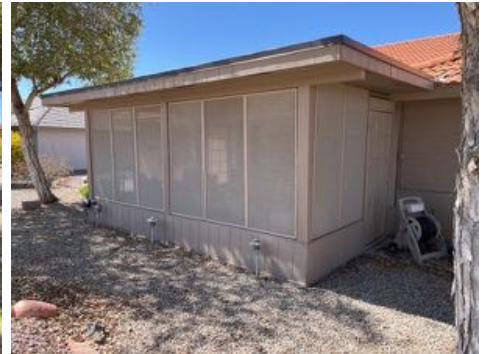
Wall Structure: Masonry Step Cracking

Masonry step cracking was observed as exterior wall(s). Step cracking is often an indication of settling. No large or open cracks were observed at the time of the inspection.

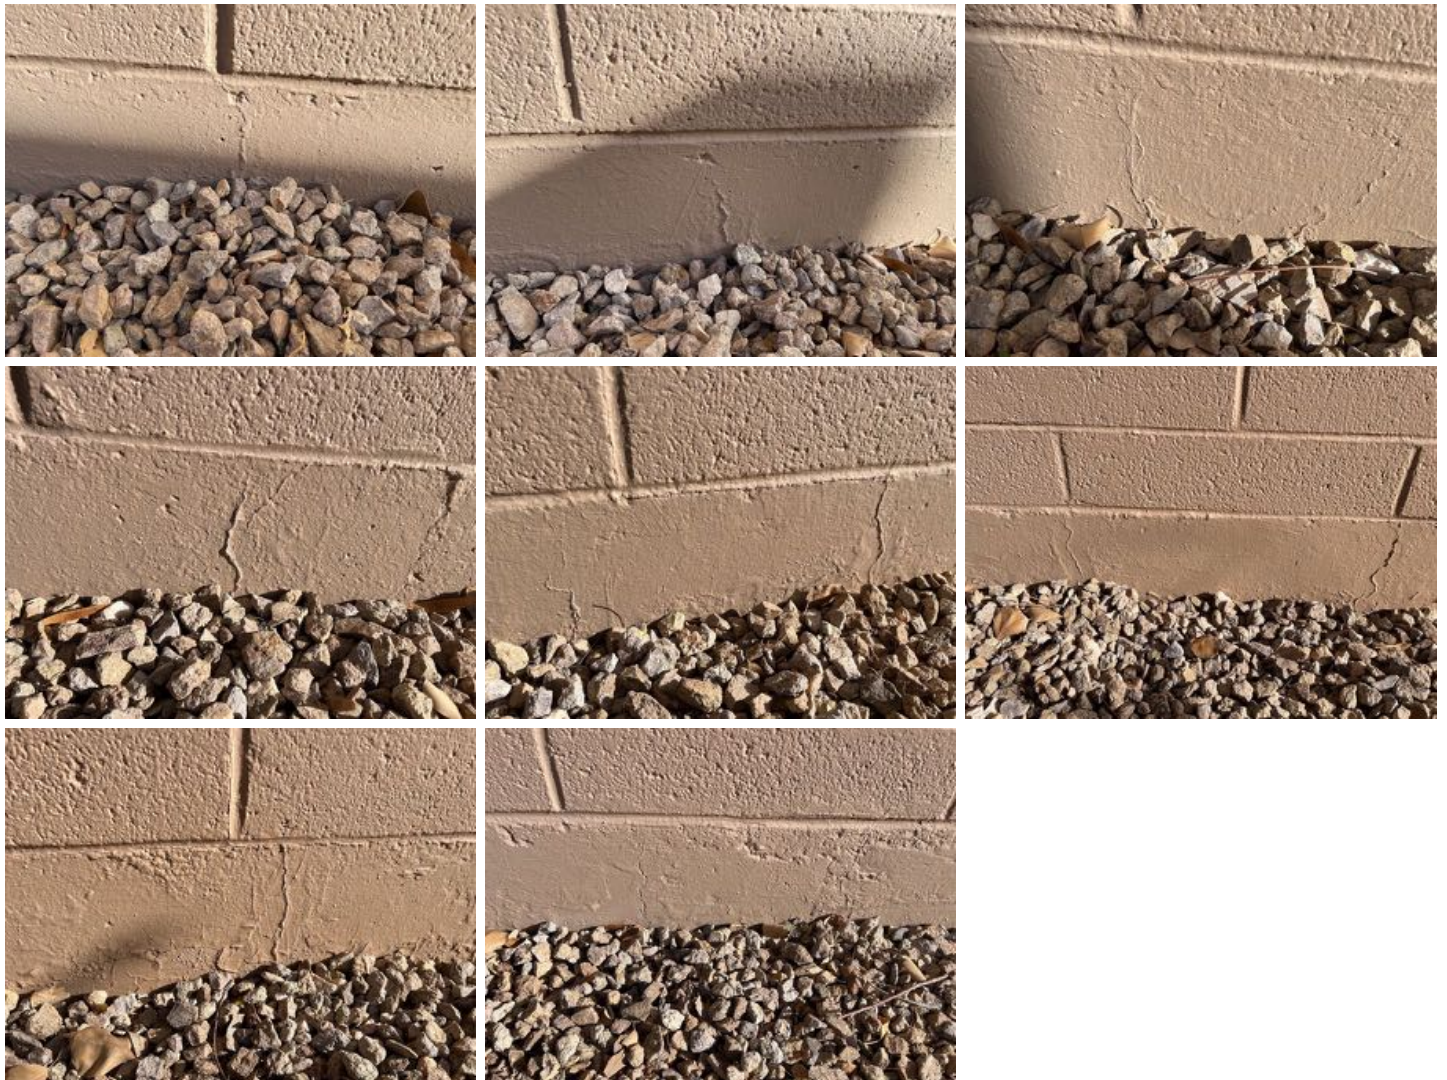
2.1.1 Foundation

VERTICAL CRACKS

TYPICAL CRACKS IN MULTIPLE LOCATIONS

Vertical fractures were observed. These cracks may have occurred during the natural curing process, or may be an indication of settling. Cracks should be resealed as to not allow water penetration. I recommend monitoring drainage conditions around the foundation and adjusting where necessary.

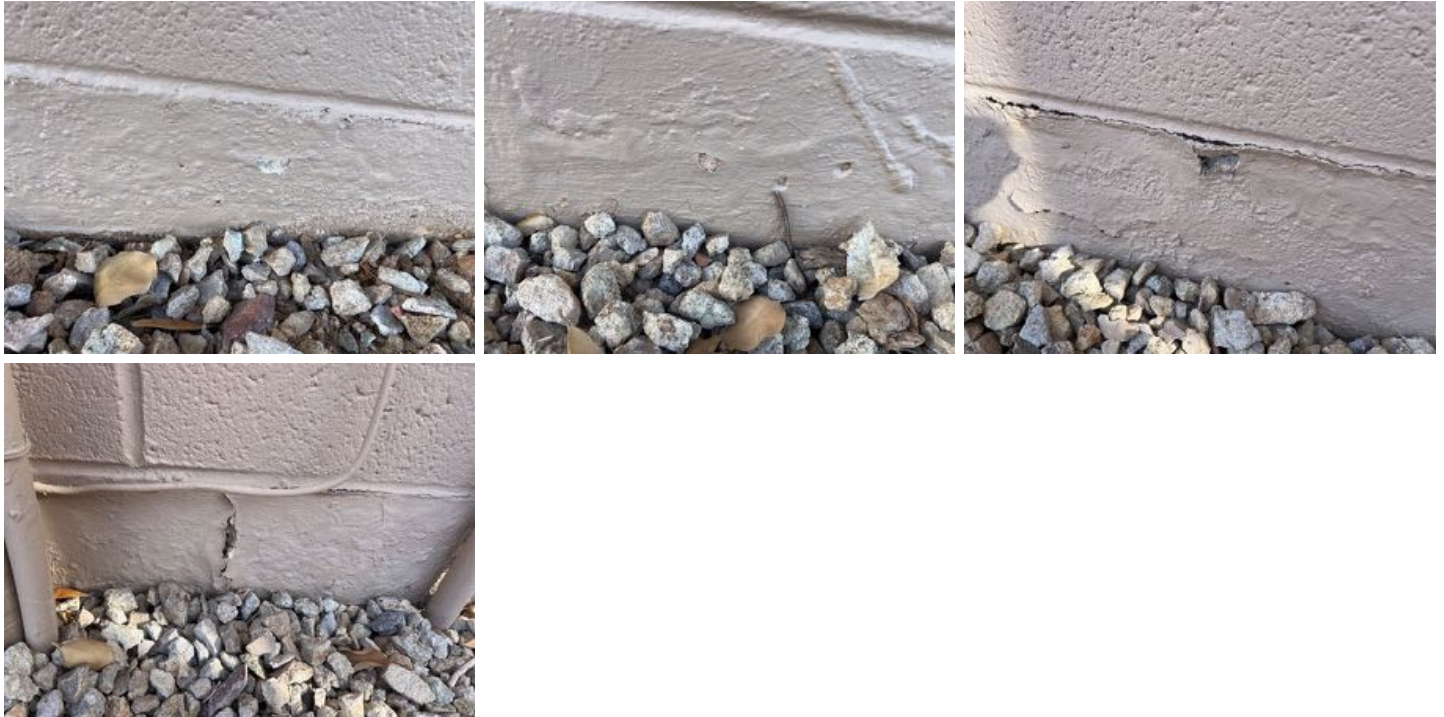
2.1.2 Foundation

CONCRETE FLAKING/SPALLING & CRACKS

Flaking/spalling and cracking of concrete was observed in some areas. Loose concrete should typically be scraped and recoated/repainted. A concrete/foundation repair professional should be consulted for service.

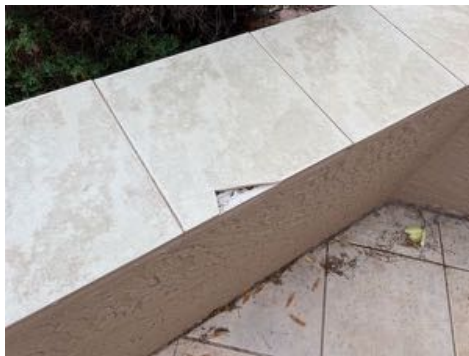
Driveway and Walkways: Paint is flaking

Paint is flaking on the walkway and some areas

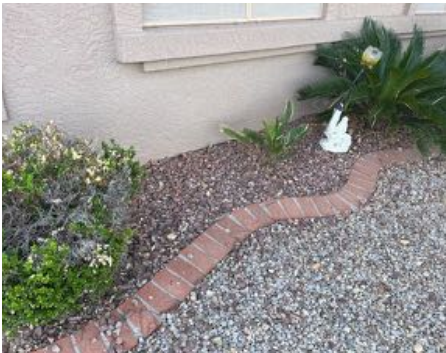
**Vegetation, Grading, Drainage & Retaining Walls: High-grade (masonry structure)**

Grade is high and covering the foundation in some areas. At least a few inches of the foundation wall should be exposed in all areas and a proper slope of approximately 1 inch per foot away from the structure should be maintained.

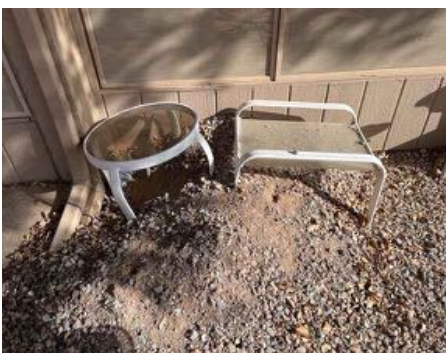
**Cladding/Siding, Flashing & Trim: Siding at grade level (addition)**

Siding is installed at grade level at added walls. This can lead to an increased risk of un-noticed wood destroying organism activity/damage as well as water damage to siding. I recommend monitoring for water damage/maintaining proper drainage as well as maintaining a regular pest control treatment schedule as determined by a qualified pest control company.

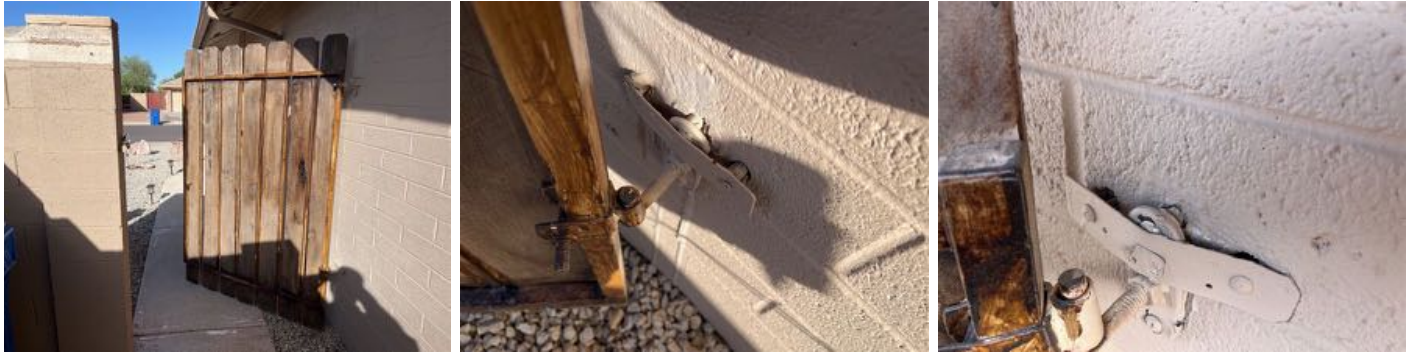
Gates : Functional gate/slightly weathered

The side gate is functional overall, however, is showing signs of wear including weathered planks and frame rust.

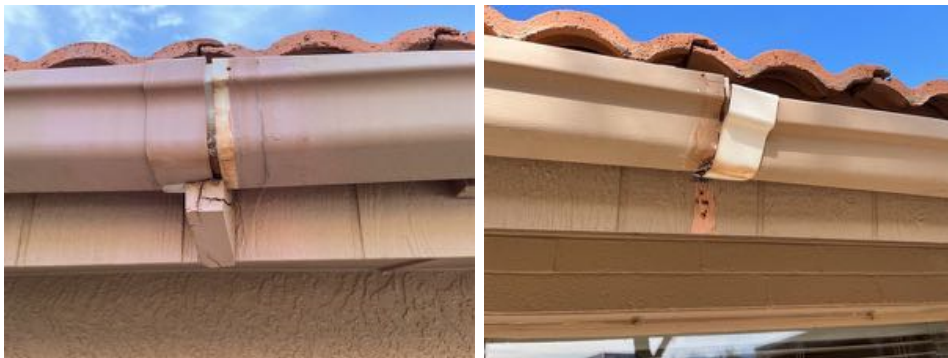
LEAKING GUTTERS (STAINS)

Evidence of leaking gutters was observed. I recommend re-sealing gutter intersections.

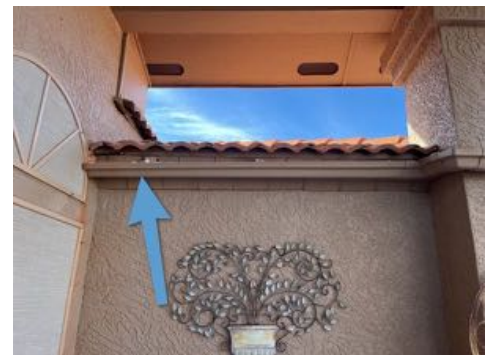
3.2.2 Vegetation, Grading, Drainage & Retaining Walls

Roof gutters are sagging in some areas. I recommend service/adjustment or replacement where necessary by qualified gutter installation professional.

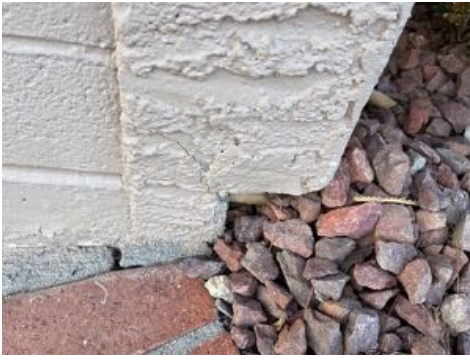
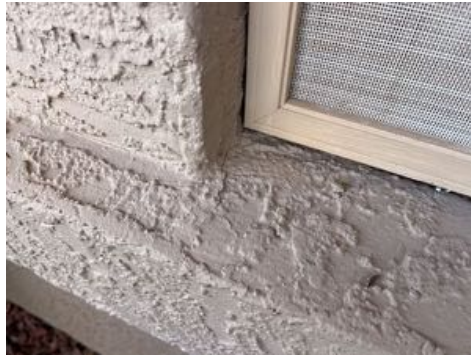
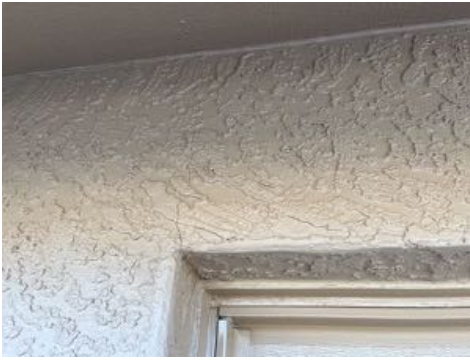
STUCCO CRACKS/CHIPS

Stucco cracks/chips were observed in some areas. Cracking is often a result of the natural curing process however can also be an indication of settling or movement. Stucco cracks are typically be sealed when they reach the point where water could penetrate. A siding repair professional can be consulted for service if needed.

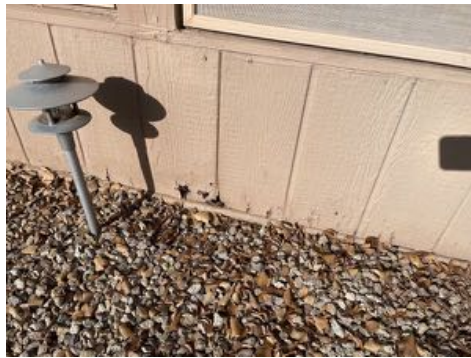
WATER DAMAGE

Water damaged exterior siding and trim was observed. Water damaged materials should typically be repaired/replaced. I recommend consulting a siding repair professional for service.

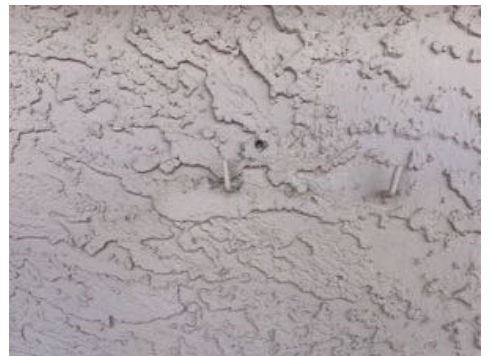
Unused hardware and/or are open hardware holes were observed. Unused hardware should be removed and all openings should be sealed/patched and painted.

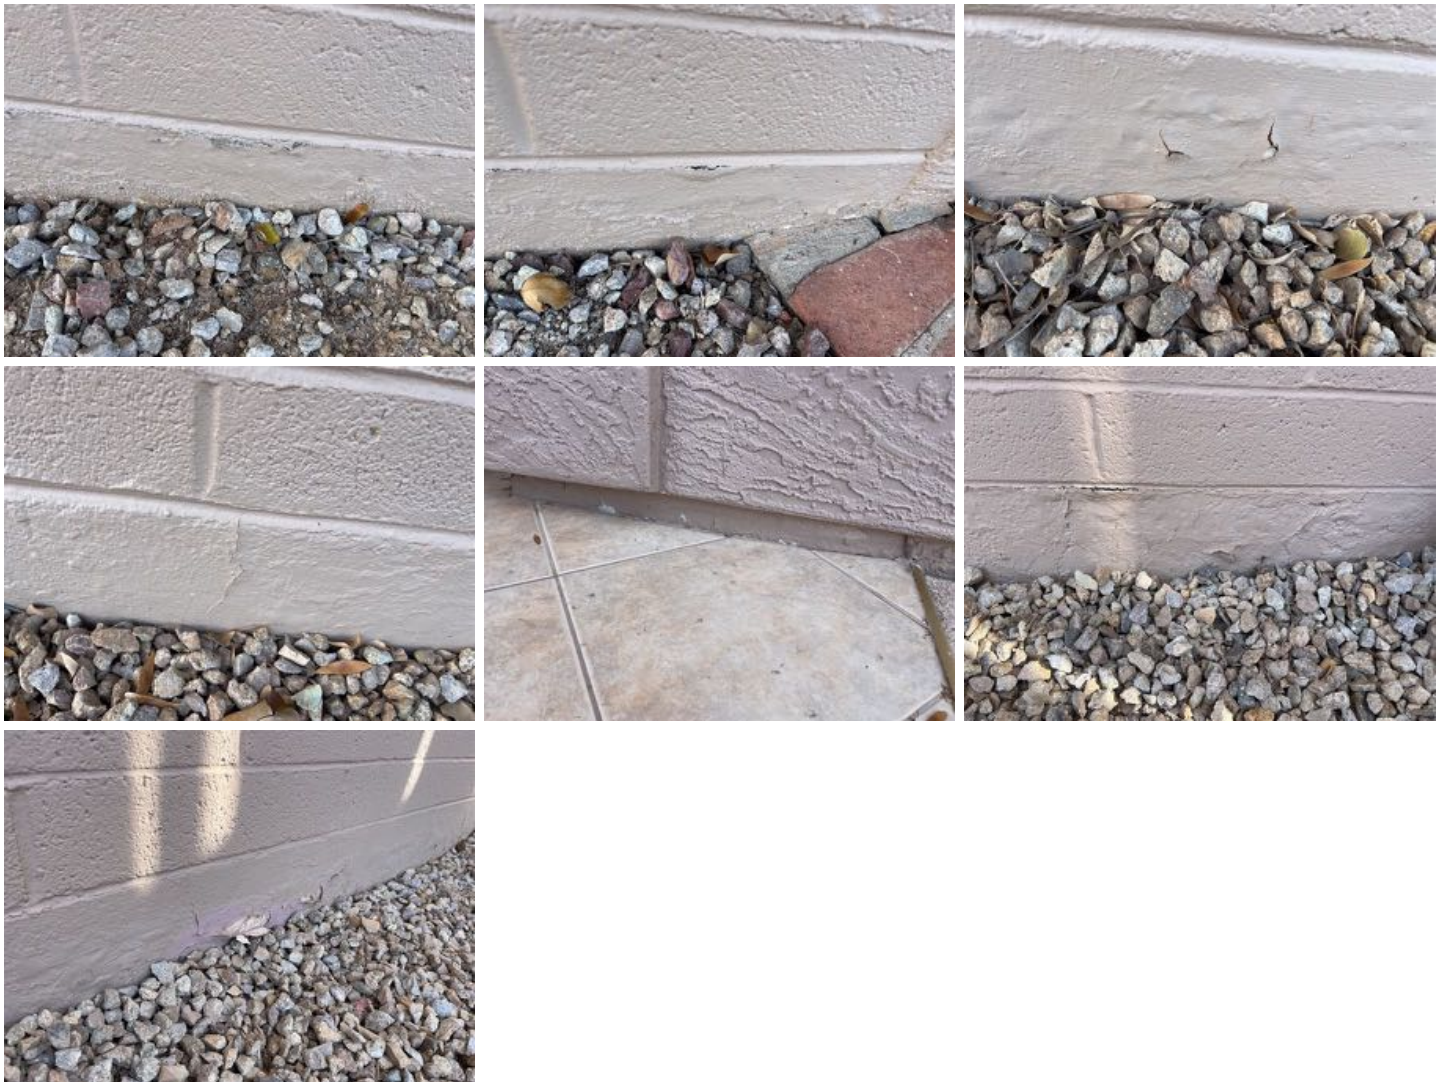
3.4.1 Exterior Paint

FOUNDATION PAINT

Peeling or flaking foundation paint was observed in some areas. The condition could be due to limited drainage in some areas or simply may be old/weathered paint. I recommend scraping and repainting as needed and monitoring for indications of water retention nearby.

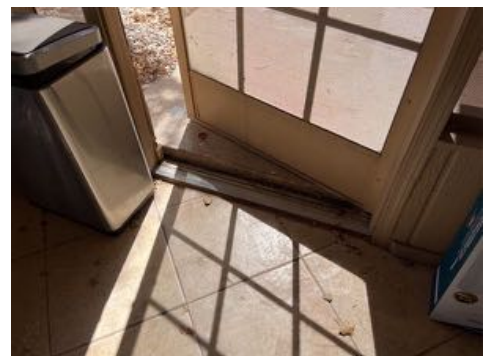
3.6.1 Exterior Entry Doors

The exterior door rubs the threshold making it difficult to open and close. A door repair professional can be consulted for service.

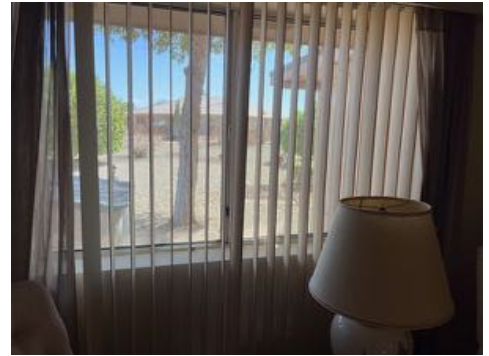
3.7.1 Windows

Some windows could be considered moderately difficult to open and close. A window repair professional can be consulted to service or adjust as needed for easier operation.

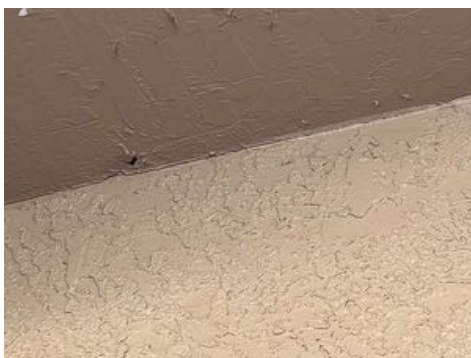
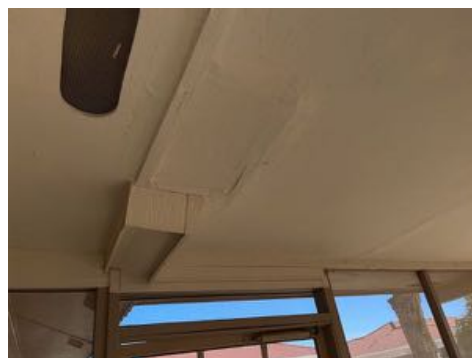
EXTERIOR DRYWALL CEILING (SEPARATION)

Loose drywall tape and/or visible tape seams were observed at the exterior drywall ceiling. A drywall repair professional can be consulted for service as needed.

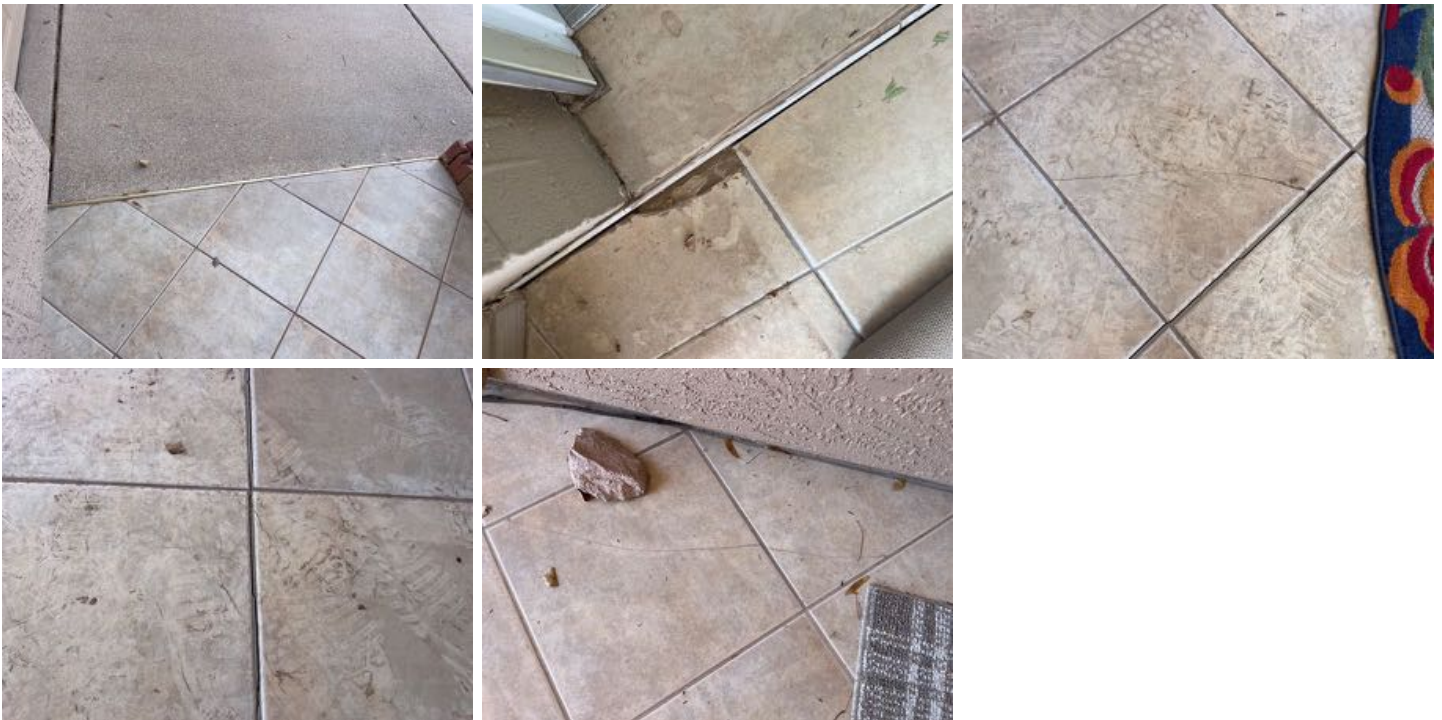
3.8.2 Porch/Patio, Deck, Balcony, Stoops/Steps, Railings & Areaways

CRACKED/DAMAGED TILE (FLOOR)

Cracked/damaged exterior floor tile were observed. The condition could indicate cracking of the concrete slab below in some cases. Water intrusion to below the tile/slab could worsen the condition with time. A hardscape repair professional can be consulted for service as needed.

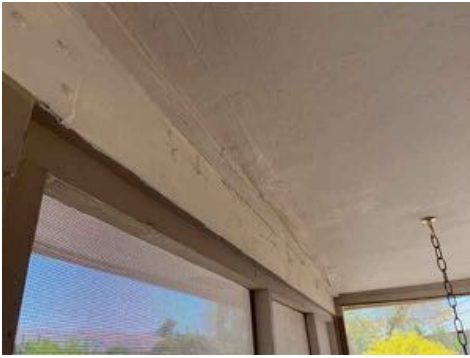
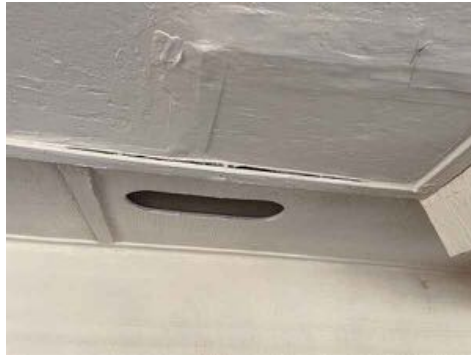
WATER STAINS/DAMAGE

Water staining/damage due to apparent roof leaking was observed at the exterior cover. Observed conditions on the roof that can contribute to leaking have been documented in the Roof section of this report. I recommend consulting a qualified professional for repair.

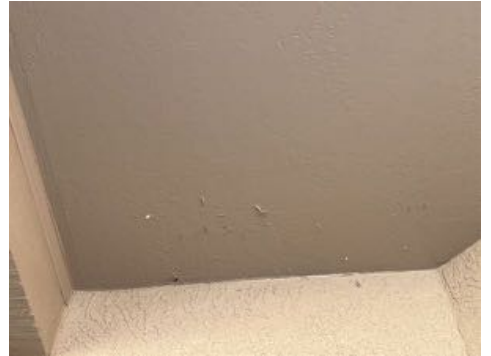
3.8.4 Porch/Patio, Deck, Balcony, Stoops/Steps, Railings & Areaways

Paint applied to exterior drywall ceilings is flaking and cracking. I recommend having drywall scraped and repainted as needed by a qualified painter.

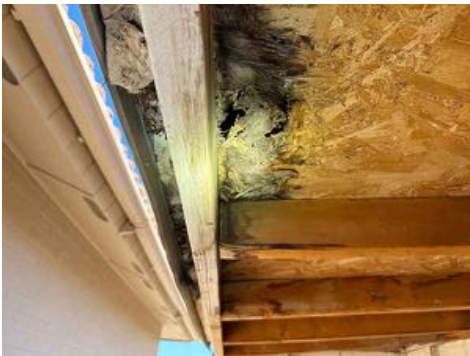
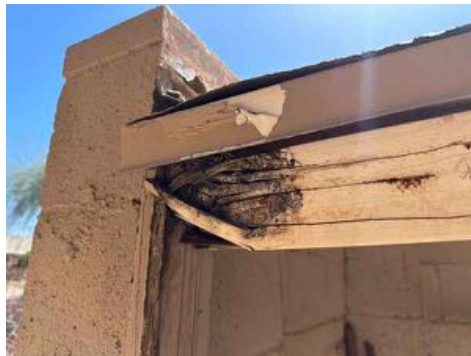
WATER DAMAGE

Water damaged framing was observed at the detached side storage structure. I recommend consulting a qualified professional for repair/replacement as needed.

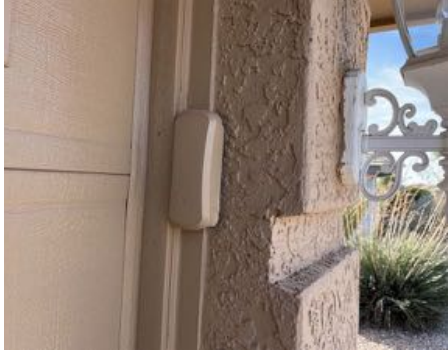
Garage Door Opener(s) & Safety Functions : Exterior control not tested

The exterior control for the garage overhead door operator was not tested as the code was not provided.

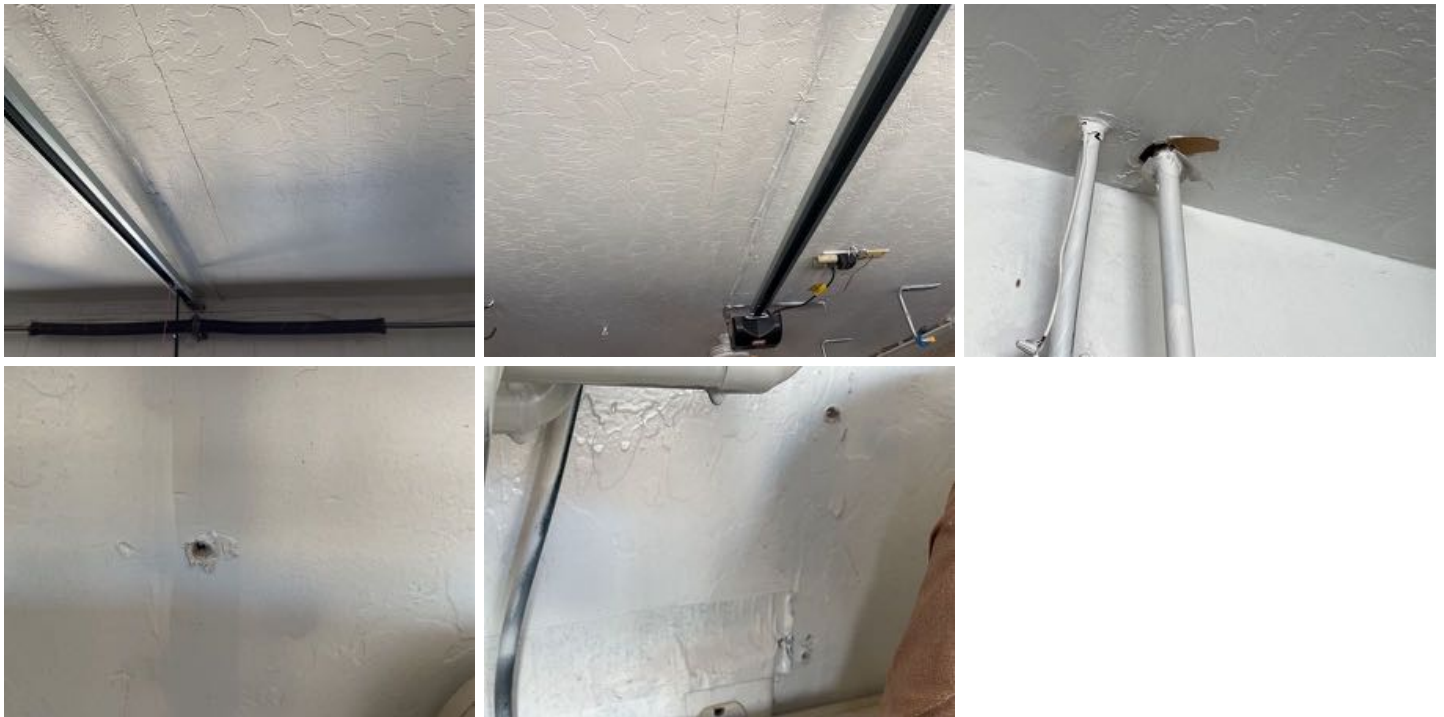
CRACKED/UNSEALED DRYWALL (FIREWALL)

Unsealed drywall observed in the garage limits the firewall separation between the garage and attic/interior. A proper firewall barrier must be maintained to prevent or slow the spread of potential fire and fumes in the garage. I recommend drywall be serviced/re-sealed by a qualified drywall repair professional.

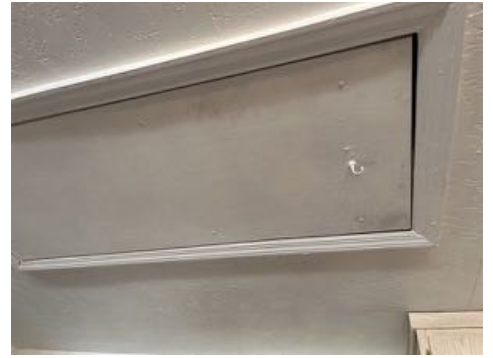
4.1.2 Walls, Ceiling & Firewall Separation

The wood panel secured to the attic pull down stairs limits the firewall separation between the garage and attic/interior. A proper firewall barrier must be maintained to prevent or slow the spread of potential fire and fumes in the garage. Possible corrections include the installation of fire-rated drywall or approved sheet metal. The opening should also be well sealed when stairs are up/not in use. I recommend the condition be corrected by a qualified/contractor.

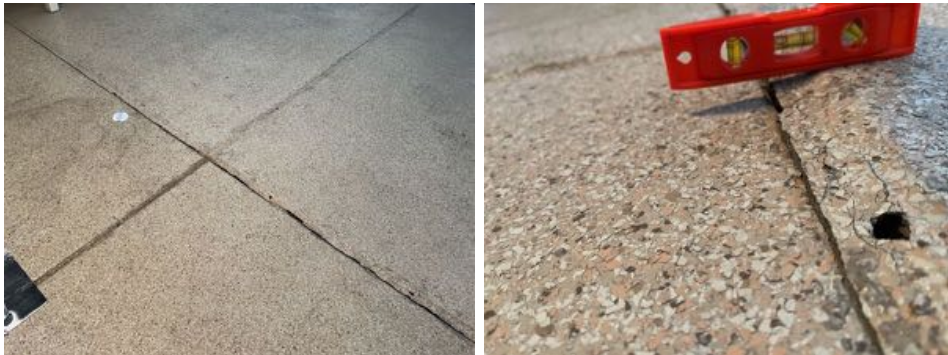
4.2.1 Floor

CRACKED/SEPARATED SLAB

The exposed slab in the garage is cracked and there is a degree of separation. I recommend consulting a licensed concrete/foundation repair professional for assessment and service.

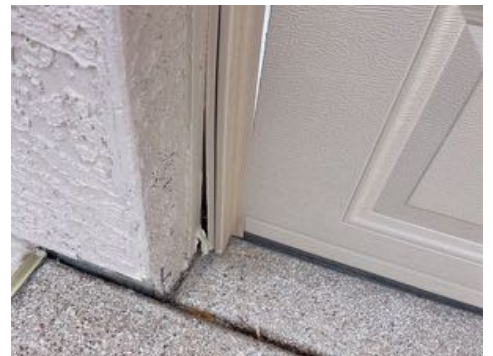
4.3.1 Garage Overhead Door(s)

Loose, unsealed or open garage overhead door weather-stripping observed. This can lead to water intrusion into the garage through the overhead door opening even when the door is closed. Weather-stripping can usually be secured and sealed if not damaged.

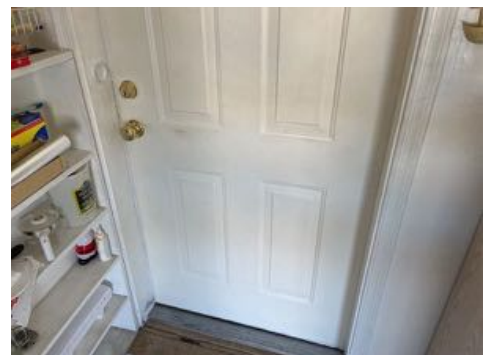
4.5.1 Fire Door (to interior)

The garage occupant/interior door is or may not be fire rated. It appears to be a hollow core door. This door should close and latch without assistance, be fully sealed and fire rated to maintain a sufficient firewall barrier between the garage and interior. I recommend consulting a door repair and installation professional to review/service.

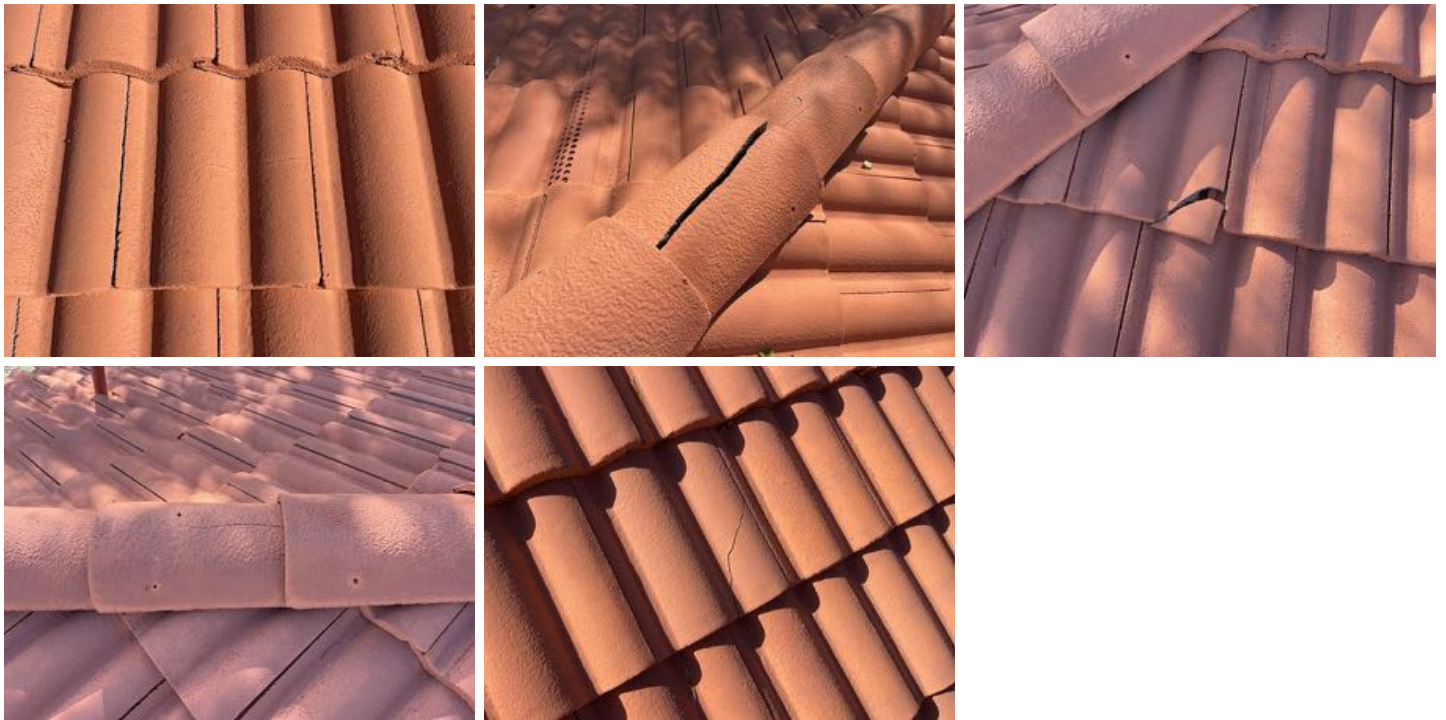
Some of the roof tile are cracked/damaged. This can lead to rain water penetrating below tile and can expose the underlayment to UV. Prolonged water runoff and UV exposure may lead to premature wear/deterioration of the underlayment below the tile. I recommend consulting a qualified roofing professional for service.

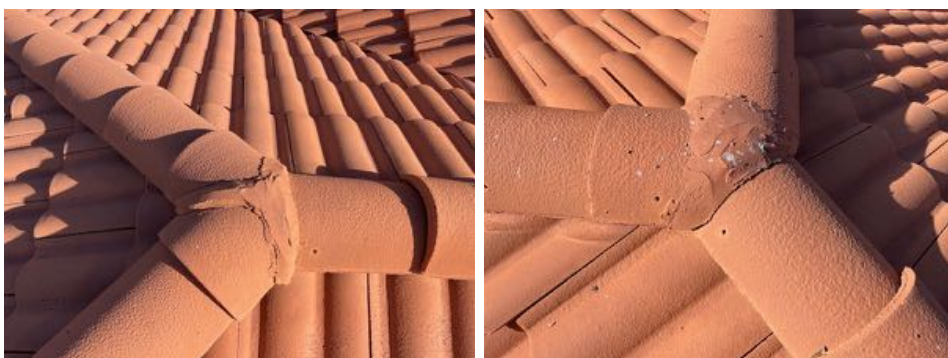
5.1.2 Roof Coverings

CRACKED MORTAR

Mortar at the tile roof hip and ridge connections and/or penetrations is cracked and/or separated. This can lead to rain water penetrating below tile. Prolonged water run-off along underlayment below tile may lead to premature wear/deterioration with time. I recommend having openings re-sealed. A roofer can be consulted for service.

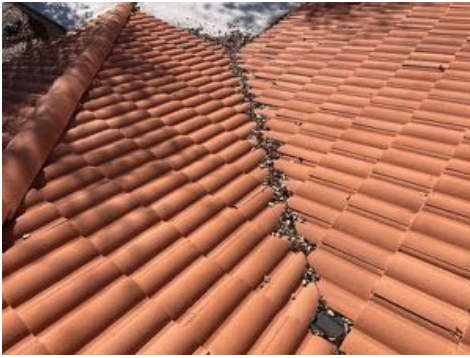
DEBRIS ON ROOF

Dust/debris accumulation was observed on the roof. Debris accumulation can lead to limited drainage and water intrusion. I recommend debris be removed by a qualified professional/roofer.

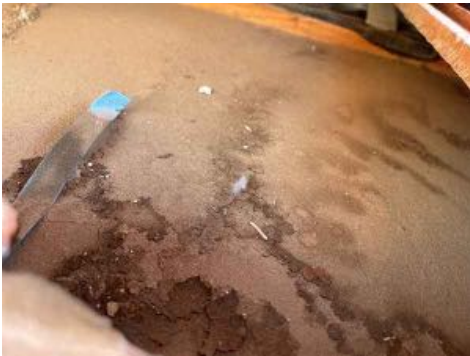
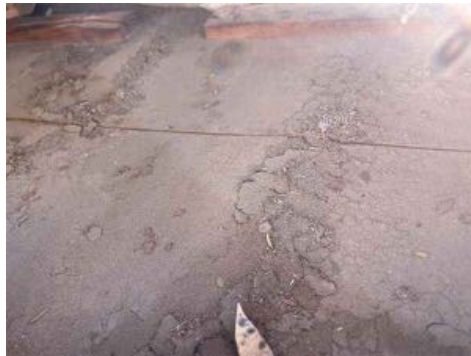
TILE ROOF UNDERLAYMENT

The tile roof underlayment installed appears to be original. The average/anticipated serviceable life of tile roof underlayment is approximately 20 to 30 years depending on material quality, quality of workmanship and other environmental factors. I recommend consulting a licensed roofing contractor to assess the underlayment condition. Please note I did not fully remove any roof tile during the inspection. Two tiles were lifted slightly. We do not guarantee the remaining serviceable life of the roof covering.

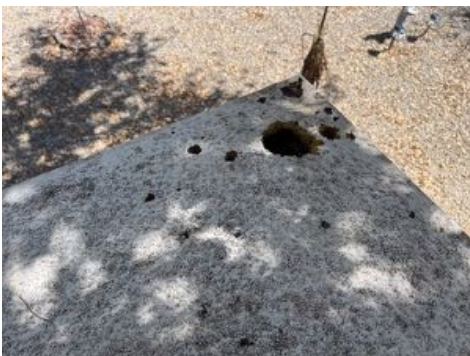
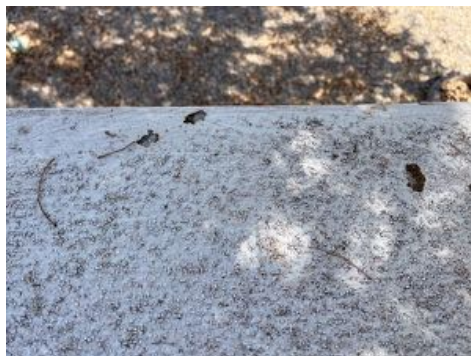
5.1.5 Roof Coverings

WEATHERED FLAT FOAM ROOF COATING

The flat Foam roof coating is cracking and worn/weathered in areas. I recommend consulting a qualified roof repair professional to review/service.

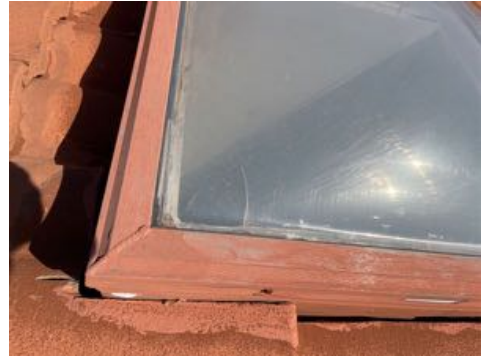
5.3.1 Skylights, Chimneys & Roof Penetrations

The skylight(s) are cracked/damaged. I recommend consulting a qualified roof repair professional for service or replacement.

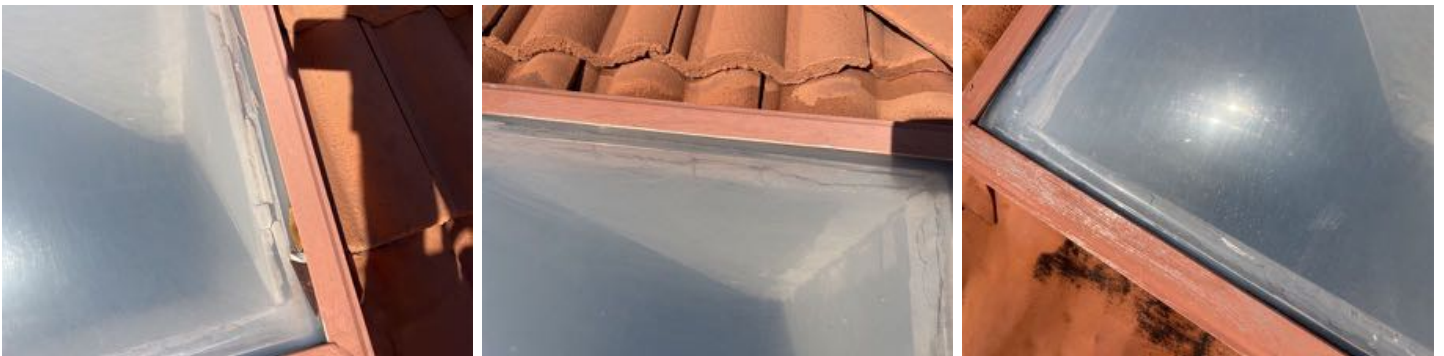
5.3.2 Skylights, Chimneys & Roof Penetrations

Interior water staining/damage was observed below skylight(s). This could indicate previous or ongoing leaking. I recommend inquiry with the seller regarding known leak history and further assessment above by a qualified roofer.

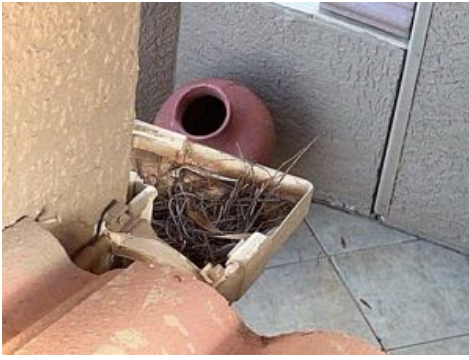
CLEAR GUTTERS

Debris observed in the roof gutters can/will limit drainage. I recommend clearing gutters as/when necessary.

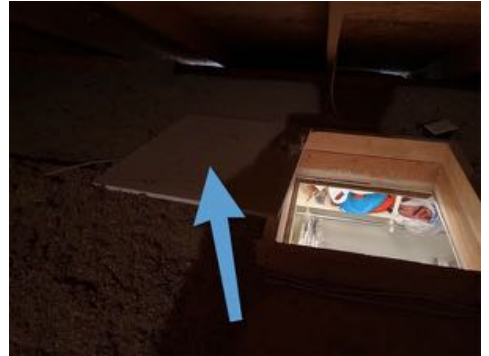
5.5.1 Attic Access

Insulation is missing or has been removed above the attic access. I recommend installing insulation to help with thermal efficiency in the room/area.

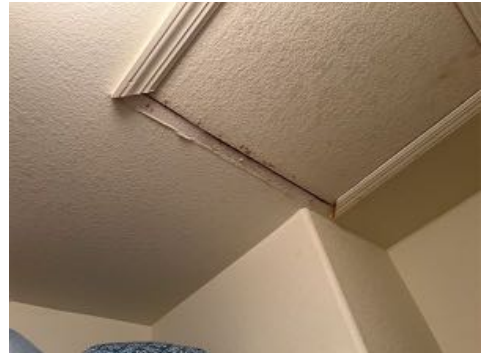
LOOSE TRIM

Trim installed to hold the attic access cover in place is loose and separating. I recommend securing trim so that the excess panel does not slip.

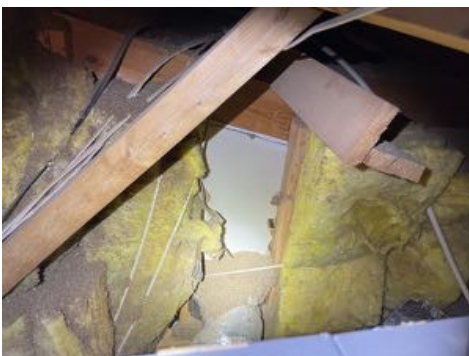
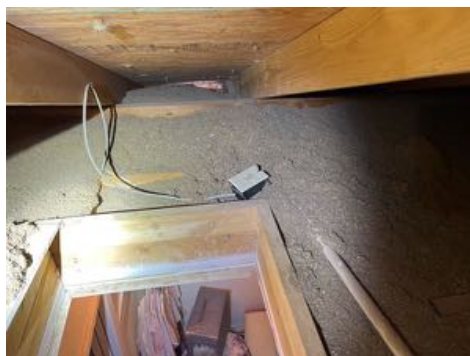
5.6.1 Insulation & Vapor Retarders

MISSING/DISPLACED IN SOME AREAS

Areas of missing or displaced insulation were observed. I recommend adding/replacing insulation where it is missing.

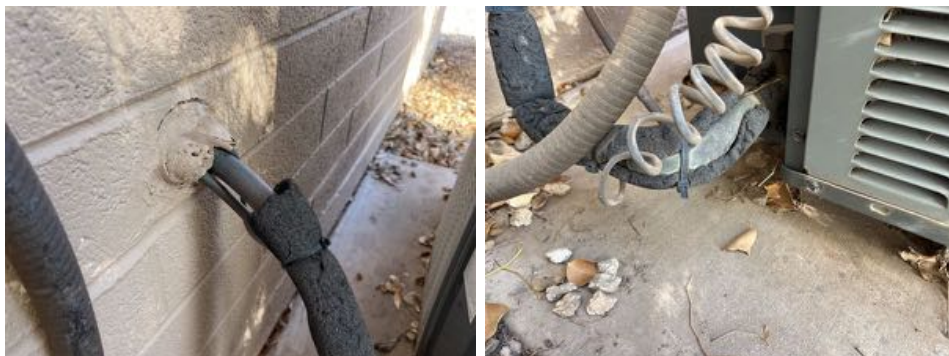
Insulation for the cooling system refrigerant line(s) is damaged, open or missing. This can lead to excessive condensation and dripping. I recommend consulting a qualified HVAC repair professional for service.

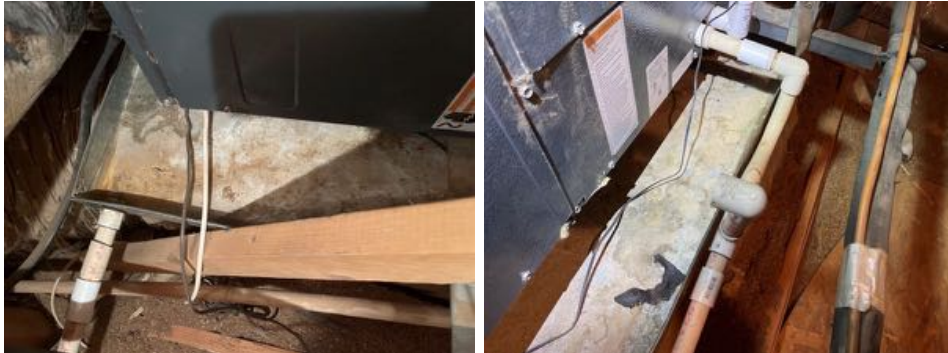
6.1.2 Central Cooling System(s)

Staining was observed in the air handler drip pan. Condensate will drip from the air handler into the drip pan below if the primary condensate drain becomes obstructed. I recommend inquiry with the seller regarding prior/recent HVAC service to help determine if these conditions are old. An HVAC professional should be consulted to clear the drain if necessary.

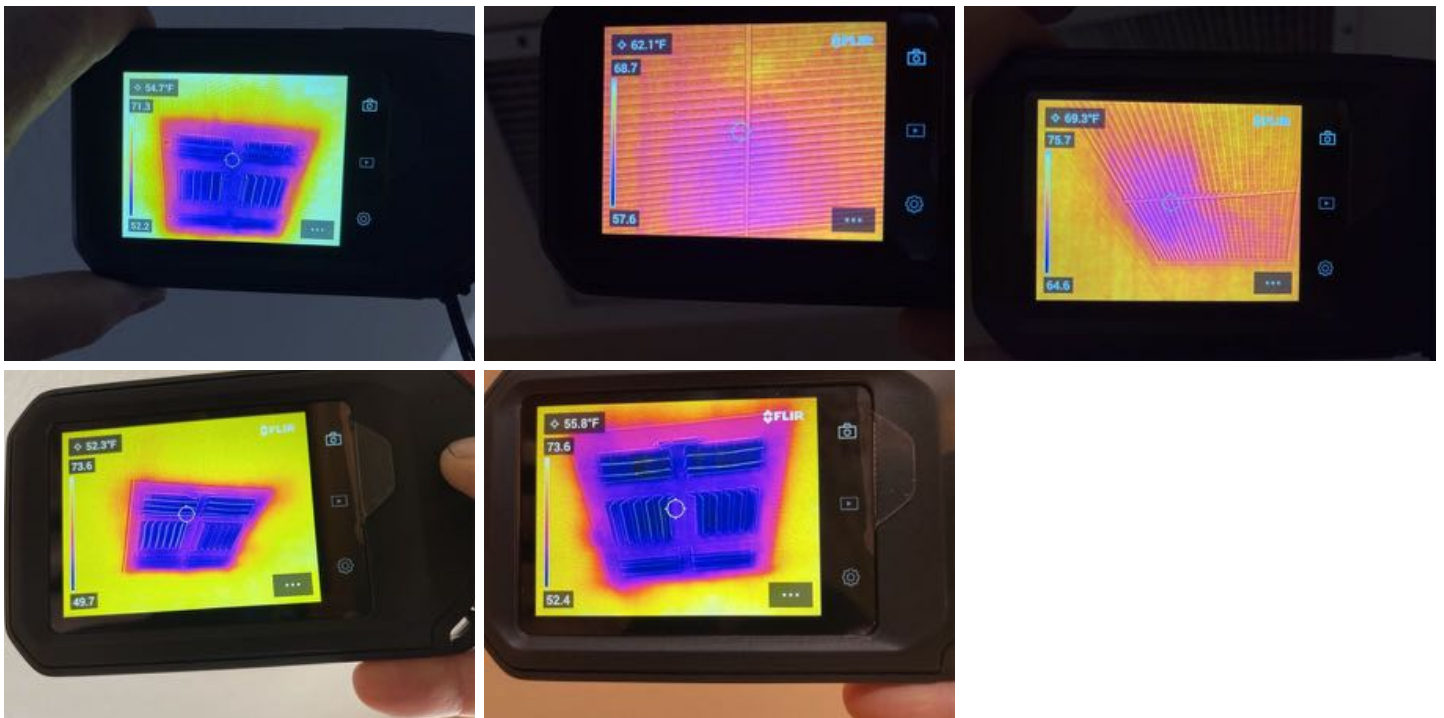
6.1.3 Central Cooling System(s)

The difference in temperature between the cooling system return and register is approximately 10 to 14 degrees. This would generally be considered low. I recommend the system be assessed by a licensed HVAC professional as there are many conditions that can lead to an under-performing cooling system.

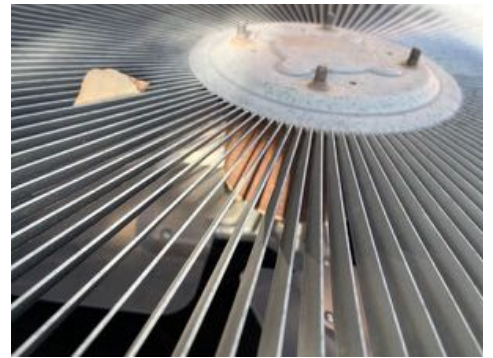
6.1.4 Central Cooling System(s)

Rust was observed at the condenser fan housing. This is often a result of age. The condenser fan was otherwise functional and not excessively noisy. Please note condenser fans are sometimes replaced prior to the replacement of the entire condenser unit. A qualified HVAC technician could be consulted to further assess if needed.

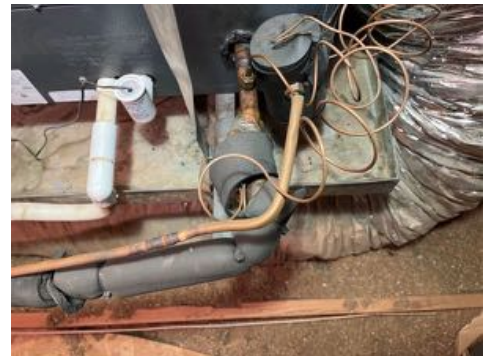
6.1.5 Central Cooling System(s)

Insulation for the cooling system refrigerant line is missing in the attic. This can lead to condensation accumulation and dripping into the attic. I recommend consulting a licensed HVAC professional for service.

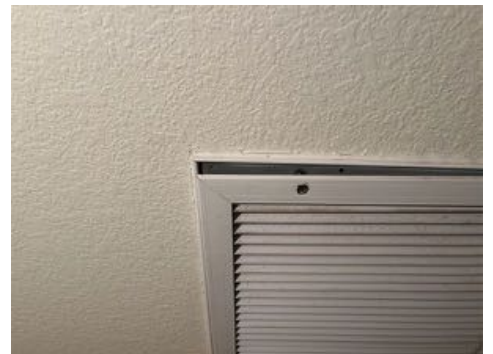
6.1.6 Central Cooling System(s)

A return vent attachment screw is missing. I recommend it be replaced by a qualified professional.

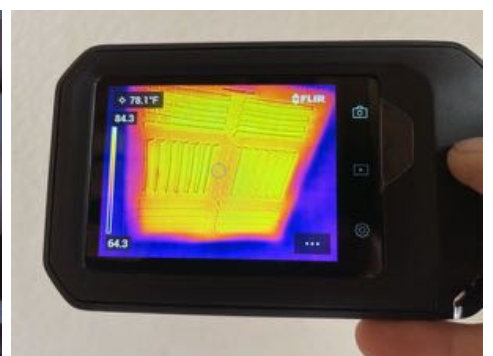
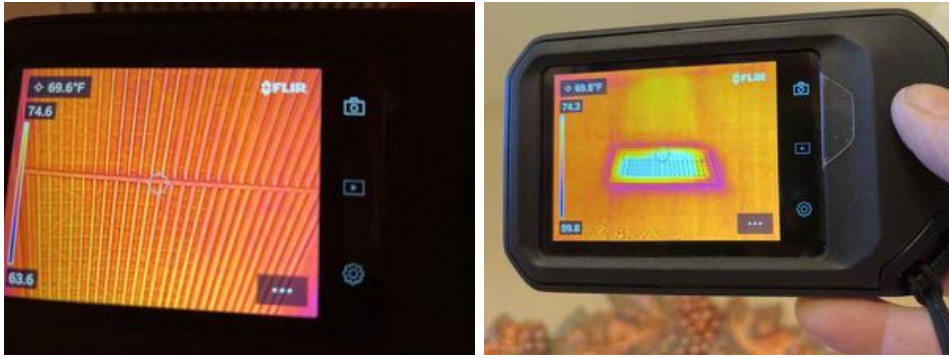
6.2.1 Heating System(s)

The heat output was under 15° when tested. I recommend the HVAC system be assessed/serviced by a qualified HVAC professional.

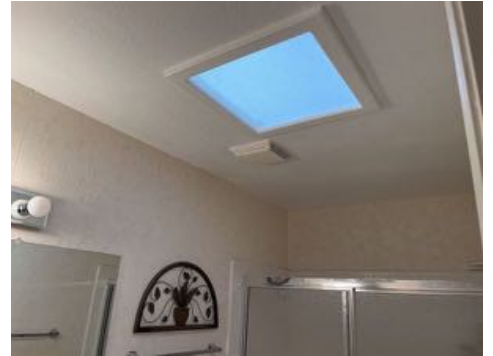
6.7.1 Interior Venting Systems (Fans)

The ventilation fan is or could be considered noisy while in use. The fan may be able to be serviced for quieter operation or may need to be replaced. A qualified professional/electrician can be consulted for service.

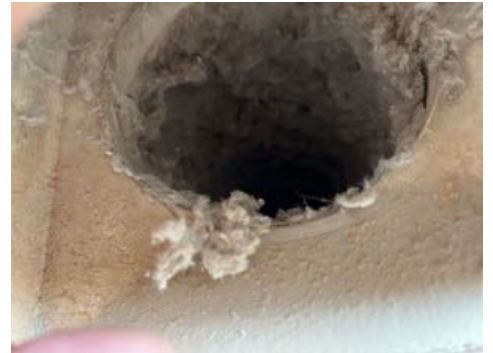
DRYER LINT IN VENT

Accumulation of dryer lint was observed in the dryer vent. Lint is flammable and should be cleared periodically. I recommend having the vent cleaned by a qualified vent cleaning professional.

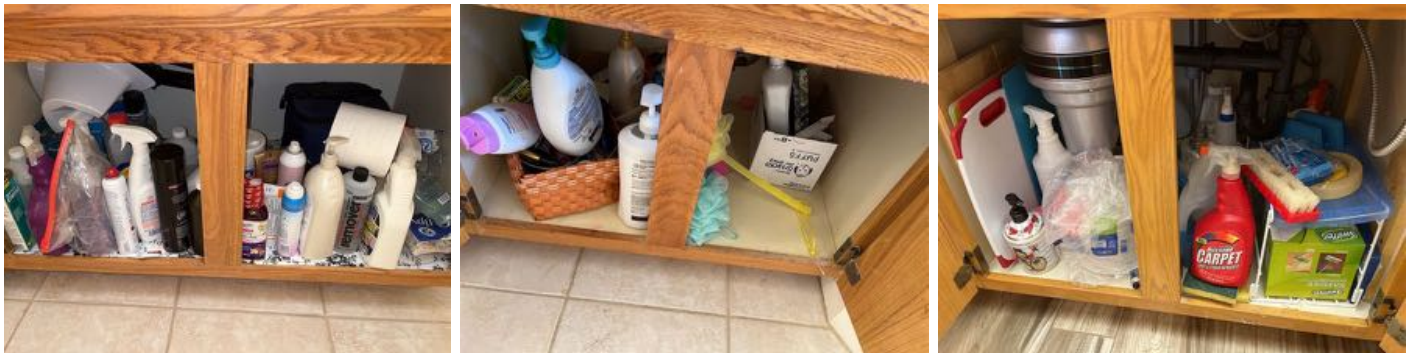
Sinks & Faucets : Limited inspection below sinks

Inspection of plumbing supply and drain components was limited under some sinks due to personal belongings.

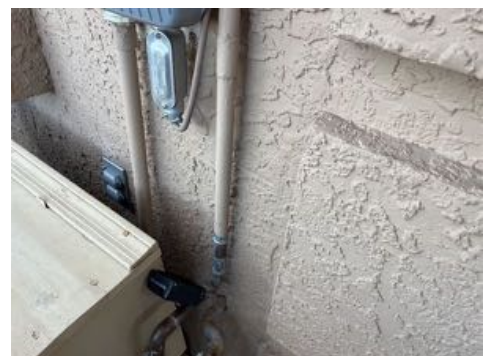
Plumbing distribution piping is loose/not secured. Distribution piping should remain secured to prevent movement and loosening of connections. A qualified professional/plumber can be consulted for service.

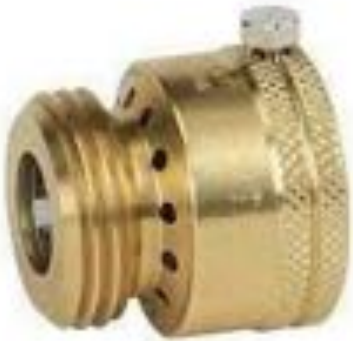
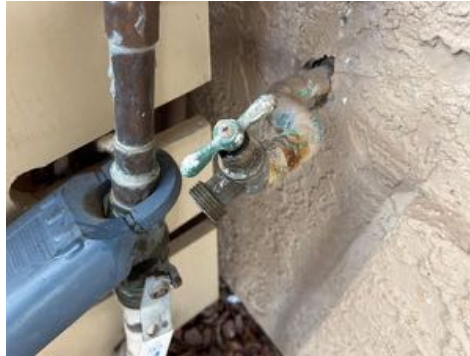
MISSING HOSE BIB VACUUM BREAKER(S)

A connected hose without a vacuum breaker may draw contaminated water into the clean/potable water supply. I recommend installing vacuum breakers where missing/before connecting hoses.
