RESIDENTIAL HOME INSPECTION REPORT

2149 S Olivewood
Mesa, AZ 85209

MARCH 11, 2024

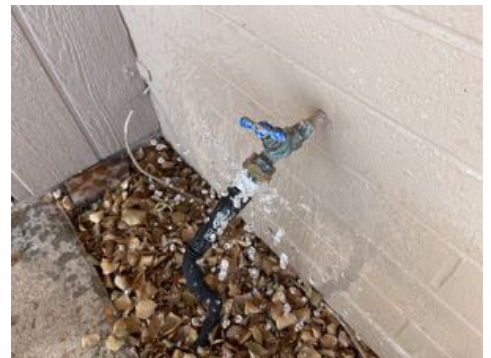
Water leaks through the hose bib vacuum breaker. I recommend securing or replacing the vacuum breaker to help prevent leaking.

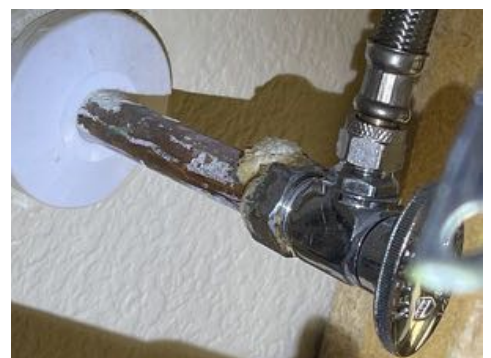
7.8.1 Sinks & Faucets

Evidence of leaking was observed. It is not evident that these leaks were serviced or repaired. Minor leaking can sometimes self seal however sinks should still be serviced/fittings should be tightened to prevent future leaking.

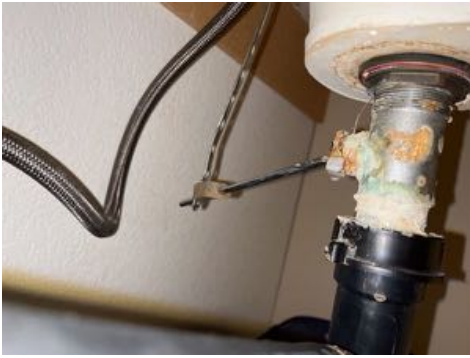
DRAIN LEAK

GUEST BATHROOM

Active sink drain leaking was observed when the sink was tested. I recommend repairs be performed by a qualified plumber in a timely manner as to not cause (additional) damage to cabinetry and nearby finish material.

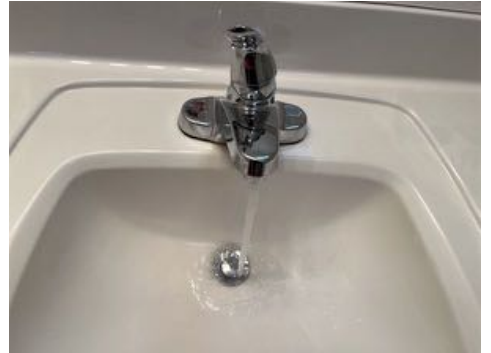
7.8.3 Sinks & Faucets

DRAIN STOP FUNCTION

The sink drain stop is inoperable and/or does not function as intended. A plumber can be consulted for service or replacement.

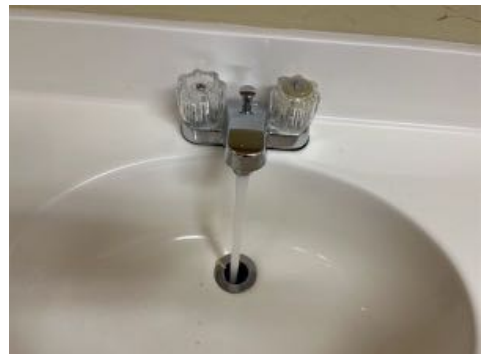
7.8.4 Sinks & Faucets

MISSING DRAIN STOP(S)

Missing drain stop(s) observed. Drain stops should be replaced as foreign objects may easily fall into the drain(s). A qualified professional/plumber can be consulted for service.

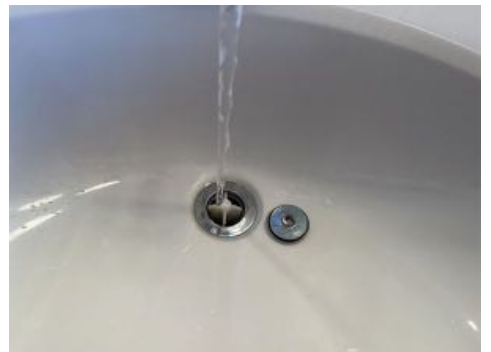
7.8.5 Sinks & Faucets

MISSING DRAIN STOP CAPS

Sink drain stop cap(s) are missing. Items could easily fall into the drains. Caps or drain stop assemblies should be replaced. A qualified plumber could be consulted for service.

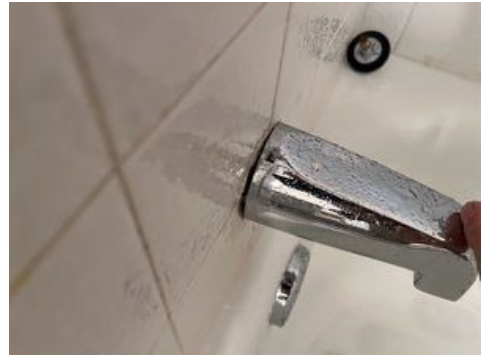
There is a gap and/or separated caulking between the tub spout and shower surround that could allow moisture intrusion into the wall cavity. I recommend sealing/caulking around the tub spout.

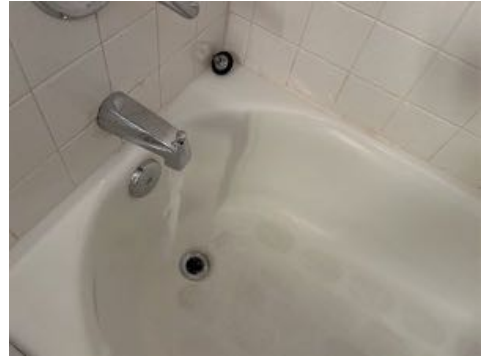
GUEST BATHROOM

The drain stop has been removed, possibly because it is no longer functional or is difficult to operate. A temporary rubber stop could be used or a qualified plumber could be consulted to reinstall a permanent stop.

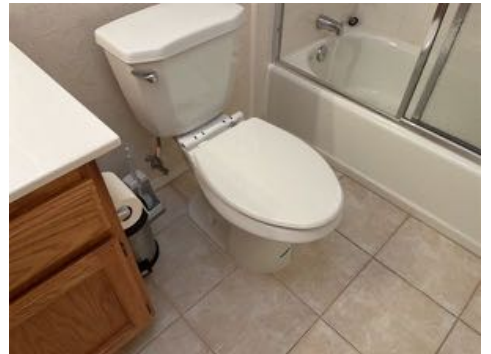
7.10.1 Toilets

LOOSE TOILET

GUEST BATHROOM

The toilet is loose/able to be rocked or shifted. Toilets should remain tightly secured to floors to avoid displacement of the seal. I recommend consulting a licensed plumber for service.

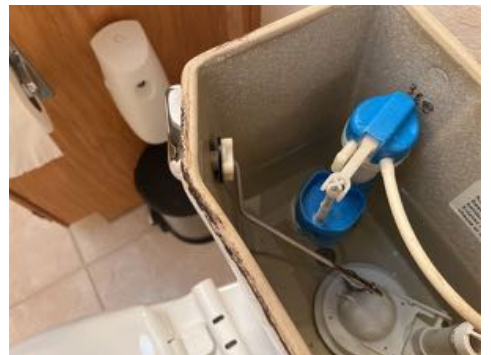
The flush handle is loose and will not tighten. I recommend consulting a qualified plumber to replace the handle.

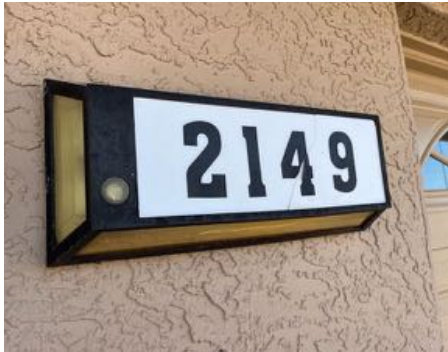
Light Fixtures, Ceiling fans and Switches : Photocell Lights

Exterior lights wired through photocells could not be tested. These lights would turn on at night if functioning properly. I recommend inquiry with the seller regarding functionality.

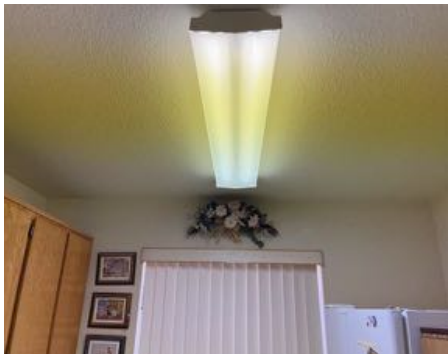
Laundry room

Light Fixtures, Ceiling fans and Switches : Loud fluorescent ballast

A loud ballast was observed however, the light is still functional. This could mean the ballast is weak or going out, but may last for sometime being noisy.

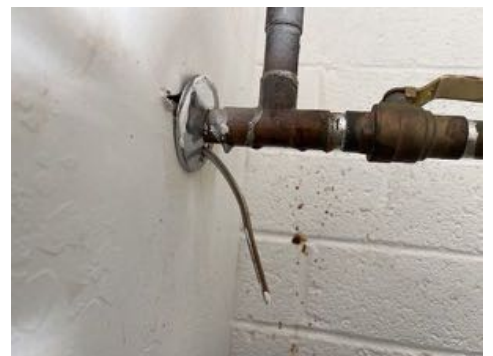
No electrical bond clamp for the metallic water distribution system was located. A bond is necessary to prevent shock due to accidental energization of metallic piping. I recommend consulting a licensed electrician to bond metallic plumbing.

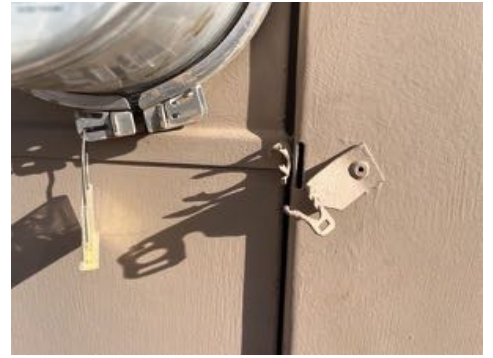
PANEL DOOR DIFFICULT TO CLOSE

The main electric service panel door is difficult to fully close and latch. A licensed electrician can be consulted for adjustment.

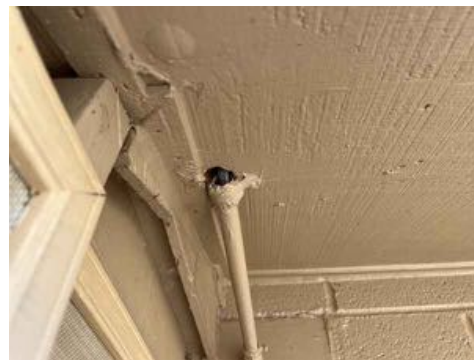
8.4.1 Conduit & Wiring

EXPOSED NON-METALLIC CABLING

Exposed non-metallic cable was observed. This type of electrical cable is intended for installation in areas such as wall cavities and in attics, not in open spaces where it may be contacted and damaged. I recommend consulting a licensed electrician for service/correction.

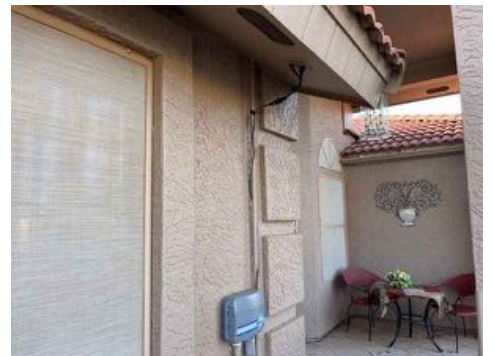
8.4.2 Conduit & Wiring

An extension cord is being used to power a permanently installed device/fixture. Extension cords are intended for temporary use only. I recommend consulting a licensed electrician for service/correction.

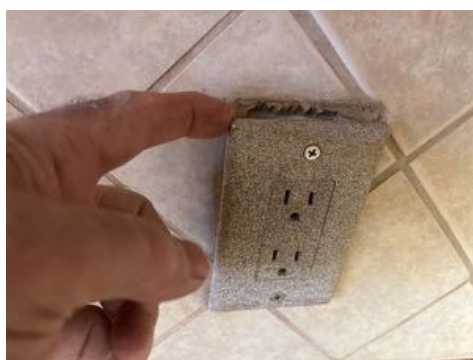
LOOSE RECEPTACLE(S)

Some of the receptacles are loose and easily moved within their enclosures or enclosures are loose in walls. I recommend securing where needed. An electrician can be consulted for service.

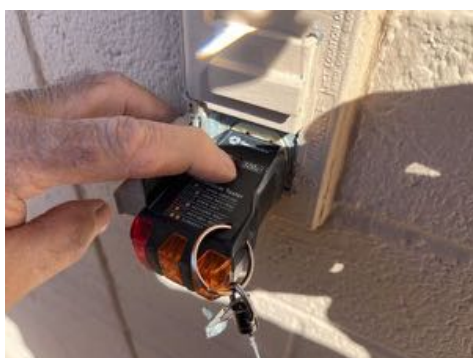
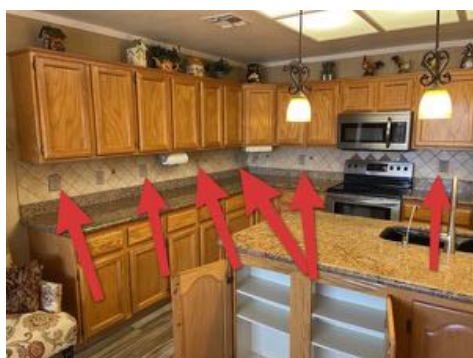
EXTERIOR AND KITCHEN

Ground fault circuit interrupters (GFCI's) are not installed in some locations where they are (now) required for safety purposes. I recommend consulting a licensed electrician to install GFCI protection where it is missing.

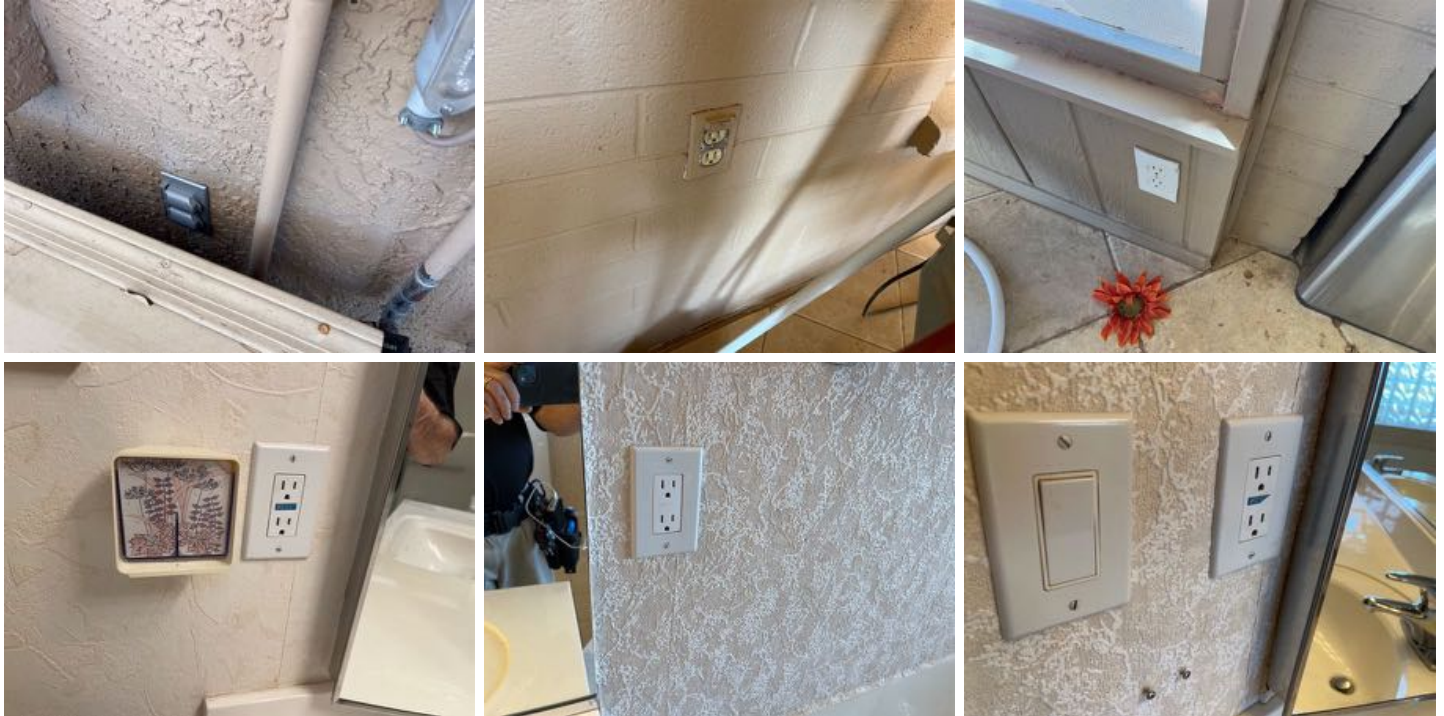
BOTH BATHROOMS & FRONT/REAR EXTERIOR

Receptacle(s) were not functional when tested. No power was indicated. All of these receptacles should be protected by a GFCI breaker. It is possible the GFCI breaker is in the garage, but it was not able to be located. A qualified electrician can be consulted for service.

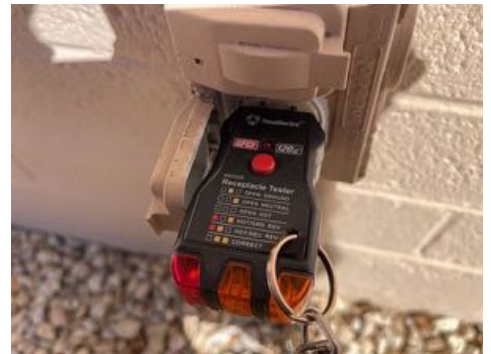
REAR SIDE

Receptacles are wired with reversed polarity (the hot and neutral conductors are reversed). I recommend consulting a qualified electrician to correct the wiring.

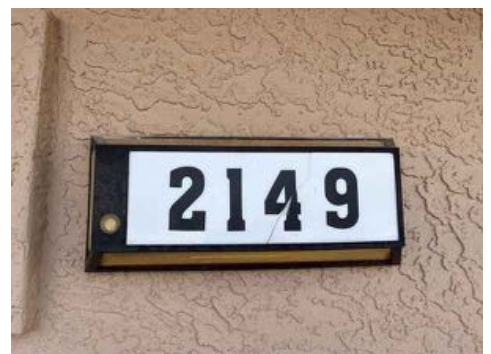
DAMAGED ADDRESS SIGN

The address sign is cracked/damaged and can be replaced as needed.

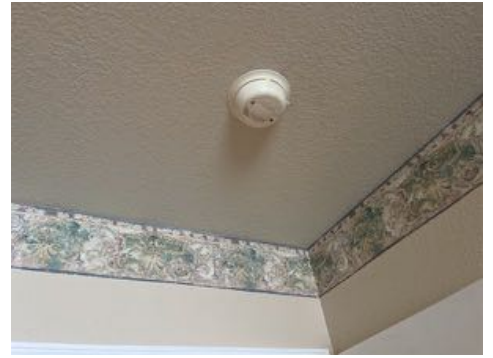
10+ YEARS OLD

Some smoke detectors appear as though they could be older than approximately 10 years. It is generally recommended that smoke detectors be replaced at ten year intervals or less. I recommend replacement where necessary by a qualified professional/electrician.

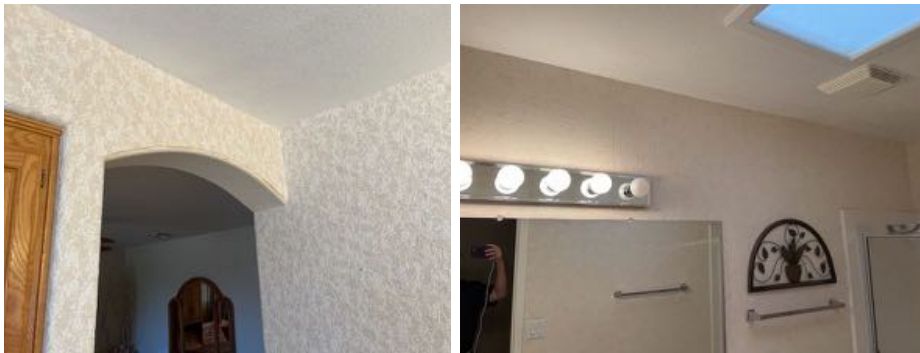
Walls & Ceilings : Wallpaper in bathroom(s)

Wallpaper is installed in one or more bathrooms. Please note that it is not uncommon for mildew-like growth to develop behind wallpaper due to high levels of moisture in bathrooms. Wallpaper is not removed or peeled during a standard Arizona home inspection.

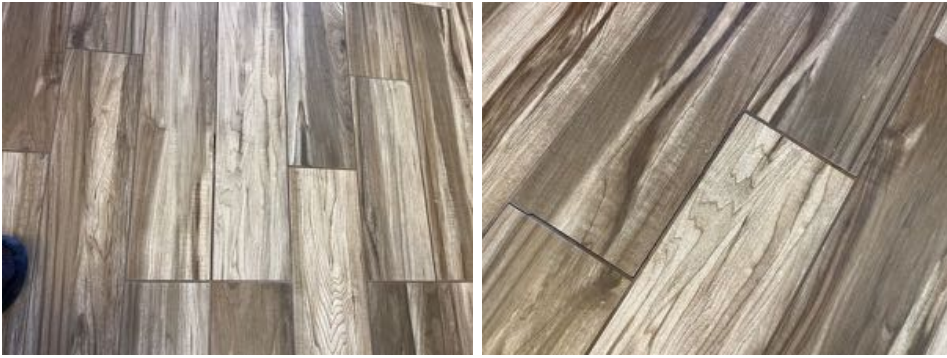
Areas of cracked and/or missing tile floor grout were observed. A tile flooring professional can be consulted to reapply grout or caulk where missing.

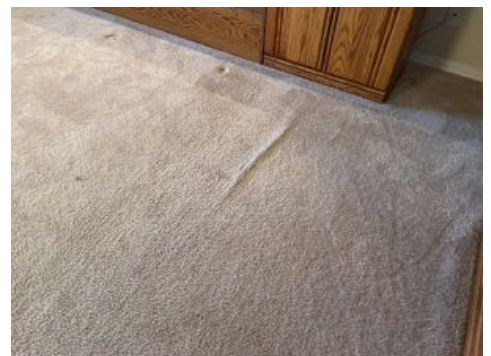
PRIMARY BEDROOM

Loose and buckled carpet was observed. Lifted carpet could be a trip concern. Carpet can typically be stretched and re-secured.

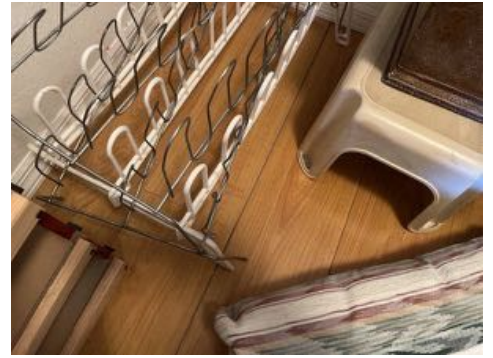
PRIMARY BEDROOM CLOSET

Inconsistent gaps/spacing between individual sections of laminate flooring were observed. A flooring repair and installation professional can be consulted for service as needed.

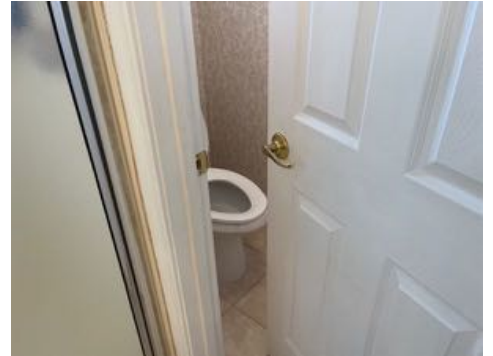
PRIMARY BATH TOILET

The interior door does not latch closed. Strike plate hardware can often be adjusted. A door repair professional can be consulted for service.

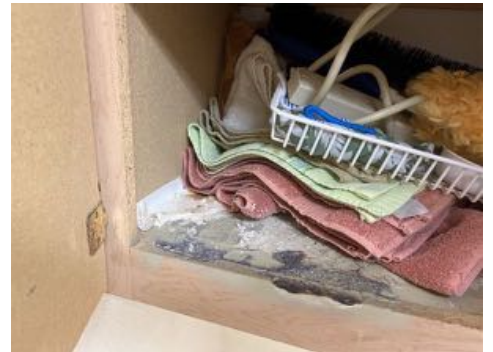
LAUNDRY ROOM

WATER/MOISTURE DAMAGE

Water/moisture damaged cabinet paneling was observed. I recommend consulting a cabinet repair professional to replace damaged materials. Please note, similar moisture damage conditions could exist in non-visible areas.

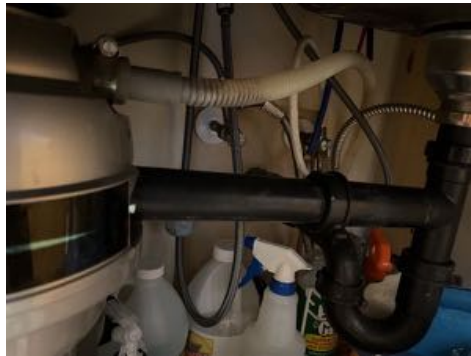
**MISSING HIGH LOOP**

The dishwasher drain is not secured in a manner that provides a high loop. A high loop will help to prevent waste water from draining from your sink to your dishwasher and will help keep water from settling in the hose after draining. I recommend securing the hose high under the sink between the dishwasher and sink drain or garbage disposal connection (as pictured).

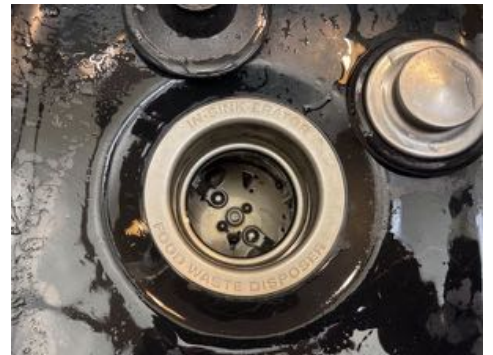
**Maintenance/Improvement Items****MISSING SPLASH GUARD**

The splash guard is missing. I recommend contacting an appliance professional for replacement of splashguard.

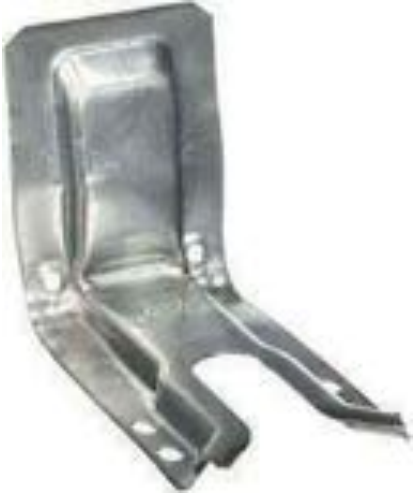
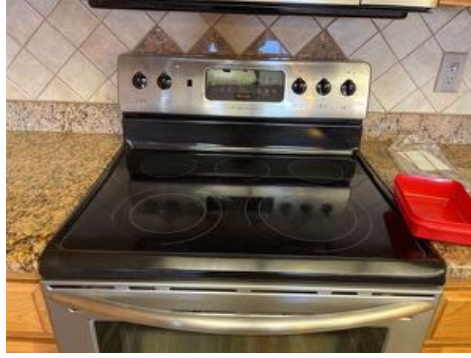
**MISSING ANTI-TIP DEVICE**

There is no anti-tip device installed to secure the oven to the floor. This is a potential safety concern. I recommend consulting a qualified professional to install anti-tip device.

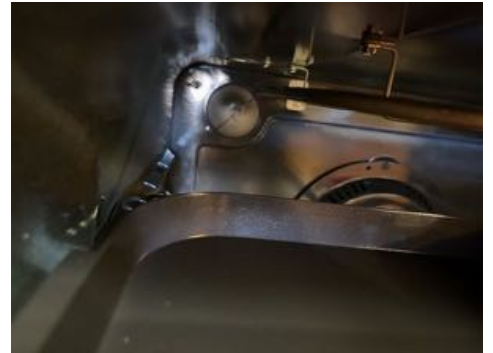
INOPERABLE OVEN LIGHT

The oven light did not respond when tested. I recommend requesting the bulb be replaced so the light may be retested at final walk-through.
